Preservation and Valorization of Palazzo Principi d'Acaia in Pinerolo (Turin, Italy): an In-Progress, Participatory Project

Preservation and Valorization of Palazzo Principi d'Acaia in Pinerolo (Turin, Italy): an In-Progress, Participatory Project / Mattone, Manuela; Rudiero, Riccardo. - In: SCIRES-IT. - ISSN 2239-4303. - ELETTRONICO. - 14:1(2024), pp. 265-276. [10.2423/i22394303v14n1p265]

PRESERVATION AND VALORIZATION OF PALAZZO PRINCIPI D'ACAIA IN PINEROLO (TURIN, ITALY): AN IN-PROGRESS, PARTICIPATORY PROJECT

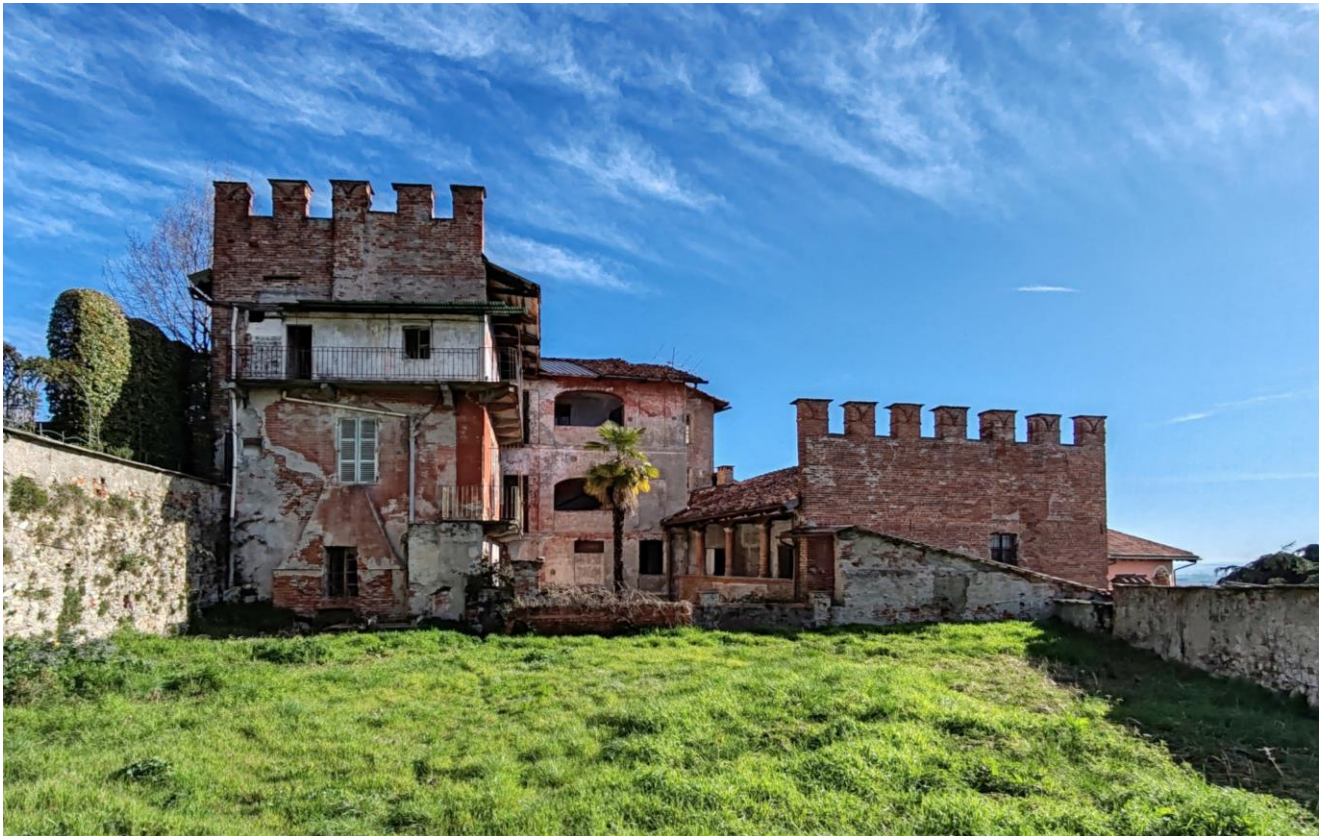
Fig. 1: Pinerolo, the so-called Palazzo dei Principi d'Acaia, seen from the garden. The building results from the amalgamation of several units, whose architectural language was later uniformed during the Renaissance period (R. Rudiero 2024).

The latter opens to the west onto a garden, enclosed by walls, and to the east onto a small courtyard surrounded by walls, too, which houses a well. The only street front has three stories above ground, while the other two wings are higher by one story each (Fig. 1).

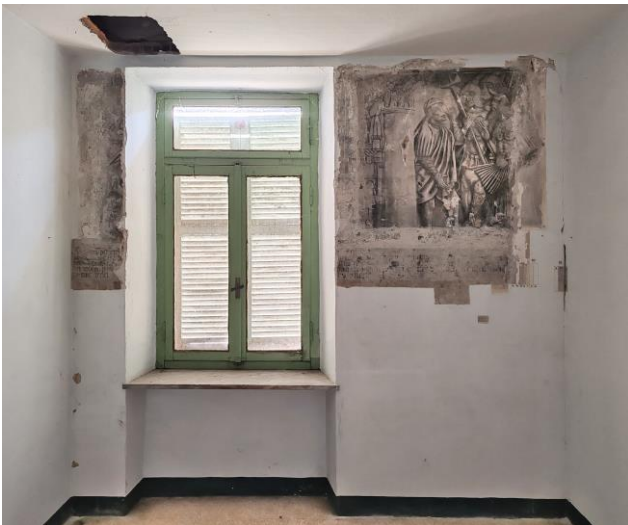
Fig. 3: One of the frescoed rooms on the second floor of the north wing belonging to an originally unified hall that was, over time, split with partitions and lowered with suspended ceilings. Note the superficial holes from the recent stratigraphic surveys and restoration of the building, as well as the deeper one to investigate its upward development (R. Rudiero 2024)

Therefore, the complex is now characterized by a series of stratifications that trace its transformation from a stately home to a functional building. These stratifications inevitably conceal some of the valuable qualities that characterized it. One example is the grisaille frescoes on the second floor of the north wing, which were consistently covered by successive layers of plaster and partly destroyed by the construction of partitions and the opening of new windows on the courtyard front (Fig. 3). Another example – from a functional point of view – is the disuse of the original cylindrical stair tower, which was replaced by a new and more operational ramp in the 19th century (Calliero & Moretti 2009b, p. 125). In contrast, anthropomorphic and phytomorphic terracotta window frames and string courses remain almost intact on the prospect along the street to the Castle (Fig. 2). The same is true for the articulation in the porch and overhanging loggia of the same building toward the inside of the courtyard. In particular, the brick columns on the ground floor are crowned with elegant stone capitals carved with scroll motifs (Fig. 8). On the upper floor, the wooden elements are carved instead, serving as a connection with the beam that supports the roof pitch (Fig. 5). In the interiors, wooden coffered ceilings are still present, partially visible thanks to fortuitous falls of the thatched ceilings due to water infiltration (this affected mainly the south wing, which has since been restored, but also the other ones, as shown in Fig. 11). Similarly, simplifications in the articulation of the ribbed vaults on the first floor have been deduced in the north wing of the building, including the addition of a thatched counter-vault (Fig. 4). Moreover, partial tests on the concrete brick floors have unveiled a decorated band and an additional

wooden ceiling on the floor where the frescoes are (Fig. 3).

provisional covering was added to the north wing to prevent further stormwater infiltration (Bosco, 2019) (Figs. 10-11). More recently, thanks – again – to the intervention of Italia Nostra, the Zonta Club Pinerolo, and Associazione Mellon, as well as the cooperation of the City of Pinerolo, the surface removal and restoration of the fresco cartouches in one of the Palace rooms were carried out in 2021 (Trombotto, 2022) (Fig. 3).

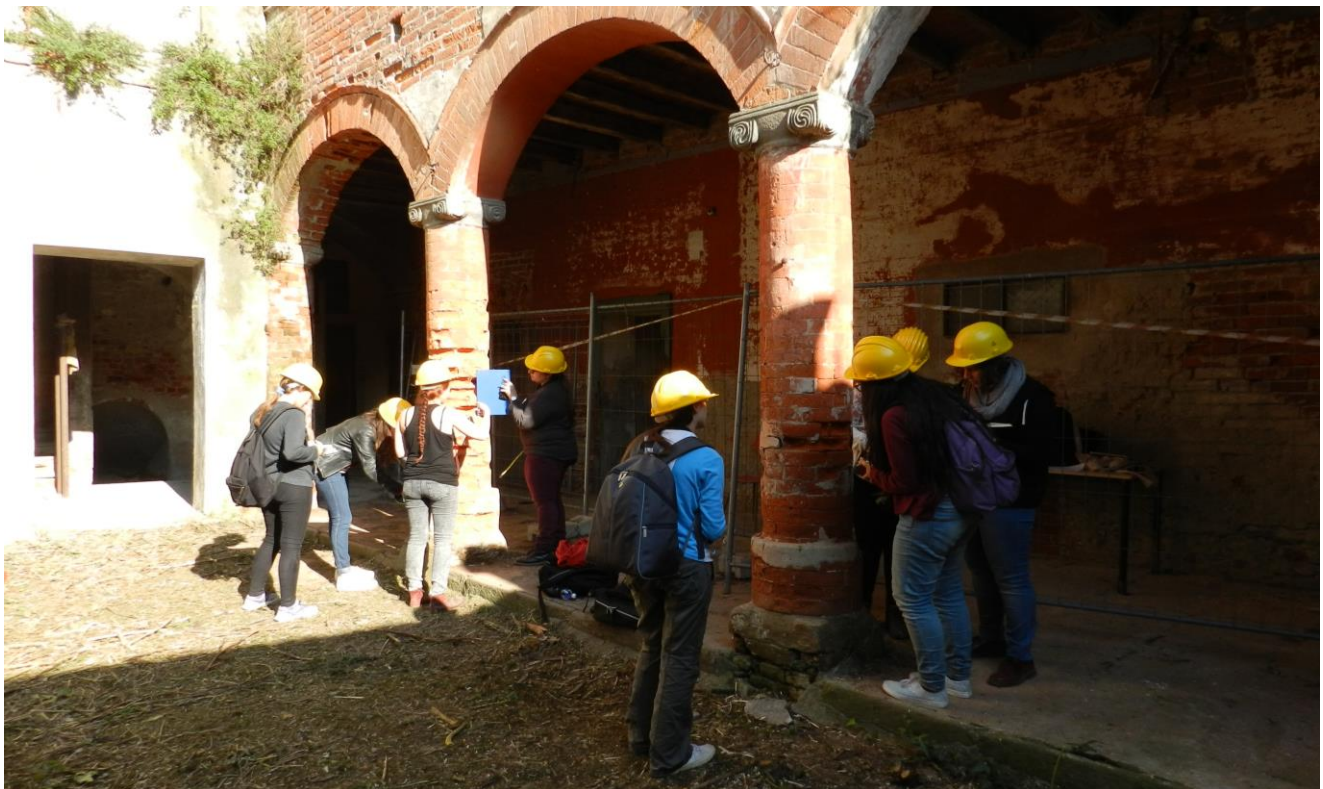
Fig. 6: Pinerolo, the so-called Palazzo dei Principi d'Acacia, seen from the court. Students engaged in activities to assess the state of preservation of brick columns (M. Mattone 2016).

The survey activity was conducted by professors and students of the Polytechnic University of Turin with the support of the specialists Arch. Monica Volinia and Mario Giroto of the Non-Destructive Diagnostics Laboratory of the Department of Architecture and Design. It allowed both to help define the stratigraphic palimpsest characterizing the building and to perform a punctual assessment of the state of preservation of some structural elements (particularly wooden beams and masonry

columns) (Fig. 6).

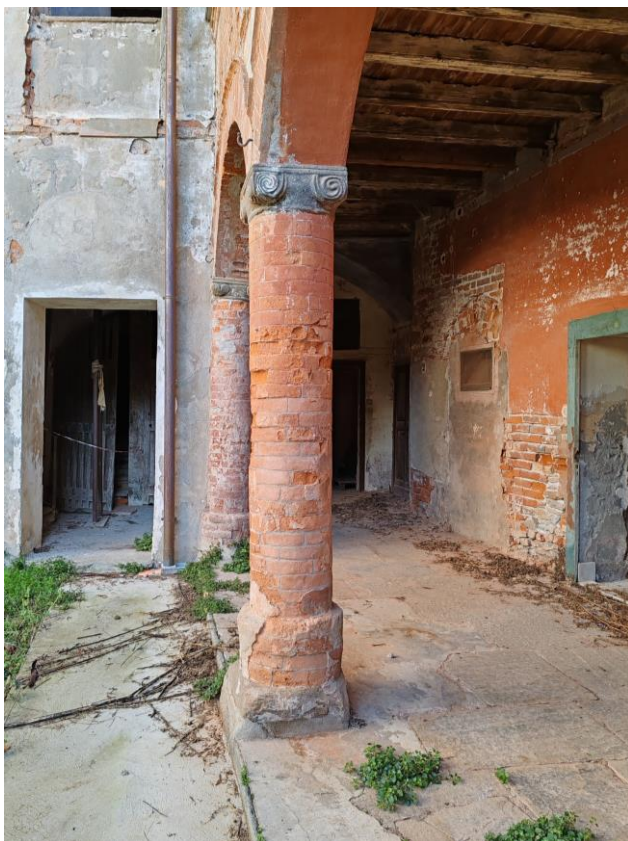
Fig. 8: The brick pillar of the porch on the ground floor, after restoration. The wooden ceiling of the covered side room has also undergone conservation work (R. Rudiero 2024)

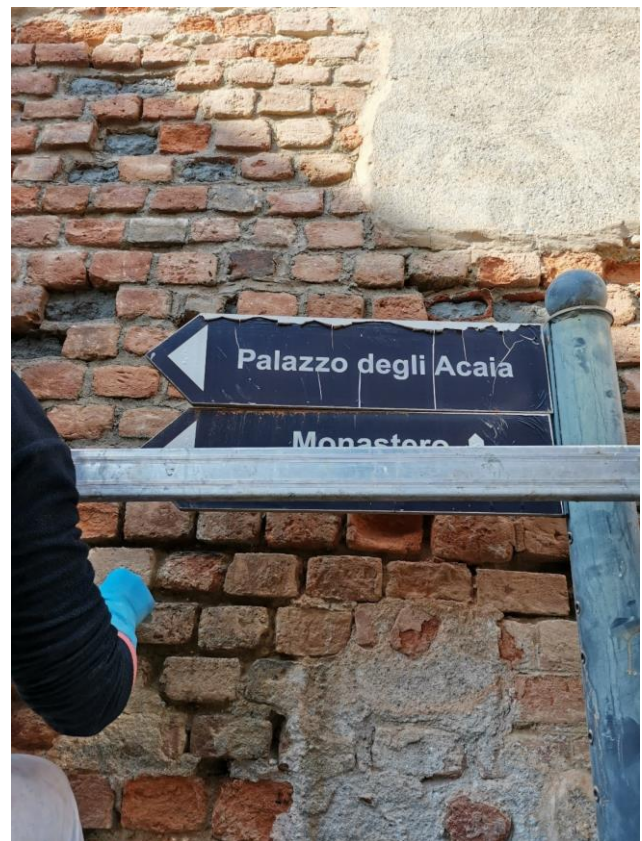
Fig. 9: Reintegration of detached bricks on the main exterior facade (R. Rudiero 2020)

Once this has been specified, it is essential to underline that the research carried out under the direction of the Polytechnic University of Turin was part of a broader and long-standing process, locally active through voluntary yet organically organized activities. They aimed to make the citizens aware of the values of an asset characterized by fragmentary knowledge and, above all, not properly preserved and used. So, with these renewed solicitations and the new analysis, the first restoration interventions designed to secure the Palace were carried out starting in 2019-2020. First, the roof of the south wing was rebuilt, and the wooden floor immediately below it was integrated and restored (Fig. 12). Analogous interventions were performed on the loggia floor. On its ground floor, the columns were consolidated (Fig. 8), and portions of eroded bricks pertaining to the dignified facade overlooking Via al Castello were reintegrated (Fig. 9).
