## PRESERVATION AND VALORIZATION OF PALAZZO PRINCIPI D'ACAIA IN PINEROLO (TURIN, ITALY): AN IN-PROGRESS, PARTICIPATORY PROJECT

*Manuela Mattone, Riccardo Rudiero\**

\*Polytechnic of Turin, Department of Architecture and Design, Turin, Italy.

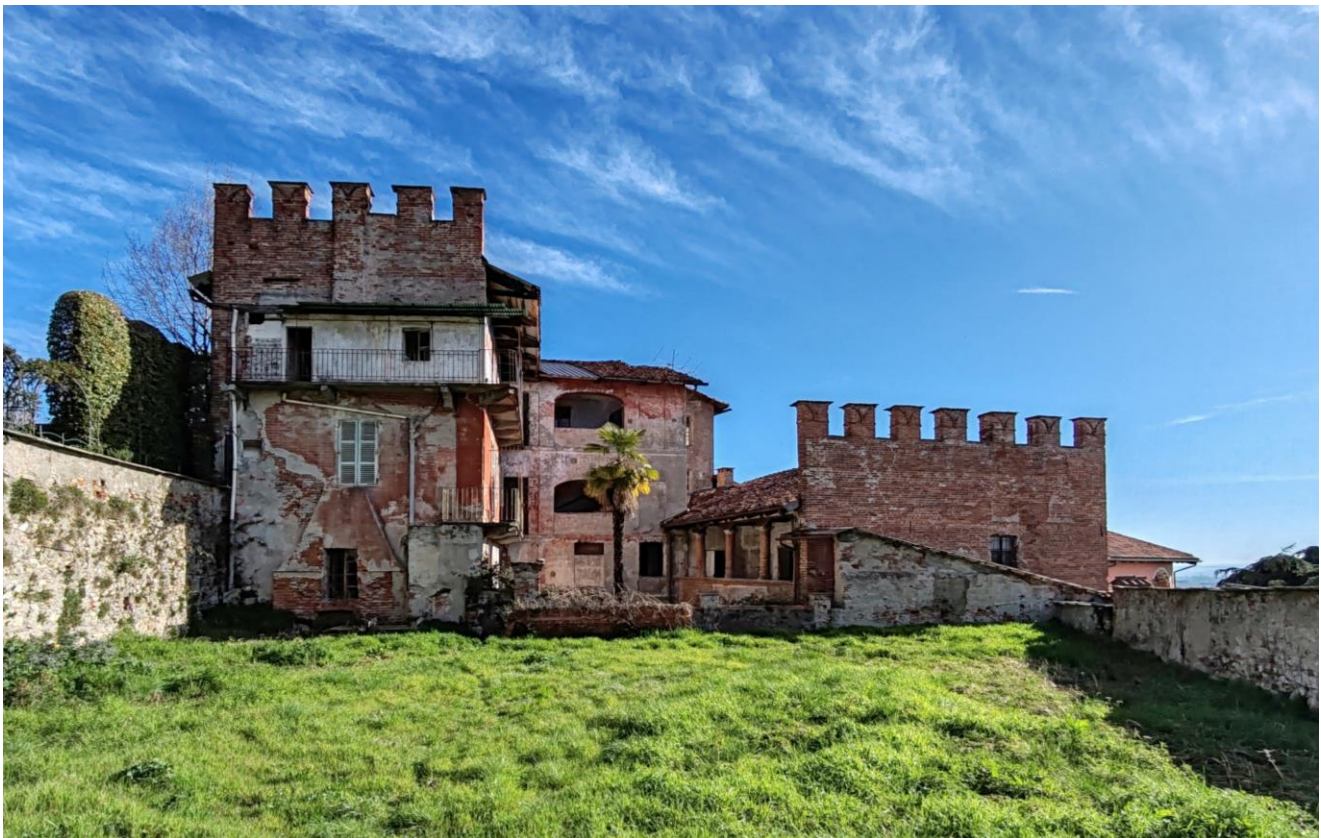
**Fig. 1:** Pinerolo, the so-called Palazzo dei Principi d'Acaia, seen from the garden. The building results from the amalgamation of several units, whose architectural language was later uniformed during the Renaissance period (R. Rudiero 2024).

Metropolitan City of Turin (Fig. 1). To contribute to the elaboration of an appropriate restoration, reuse, and valorization project for the Palace, a diagnostic survey campaign was deemed appropriate. This campaign allowed for a deeper understanding of the complex and its stratifications and a qualitative assessment of the state of conservation of some structural elements.

The latter opens to the west onto a garden, enclosed by walls, and to the east onto a small courtyard surrounded by walls, too, which houses a well. The only street front has three stories above ground, while the other two wings are higher by one story each (Fig. 1).

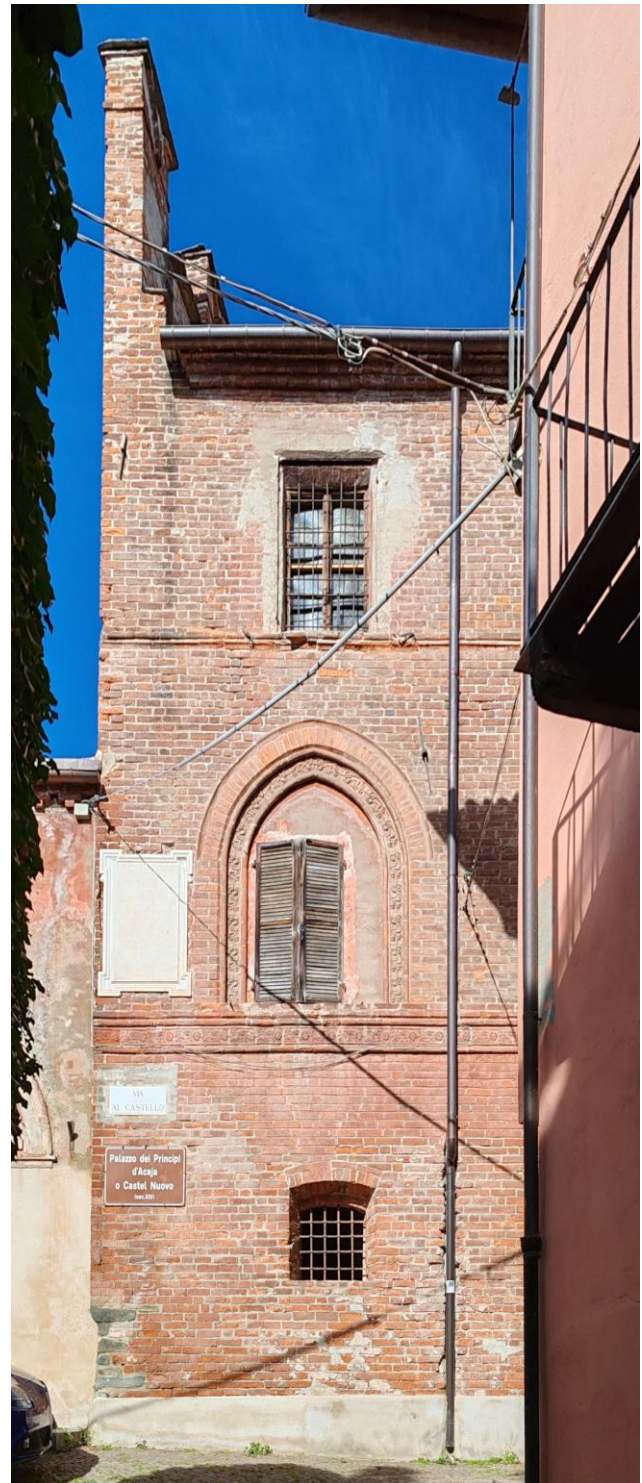
**Fig. 2:** The facade of the Palace on Via al Castello. Note the string course and one of the ogival openings with decorated terracotta elements (R. Rudiero 2024)

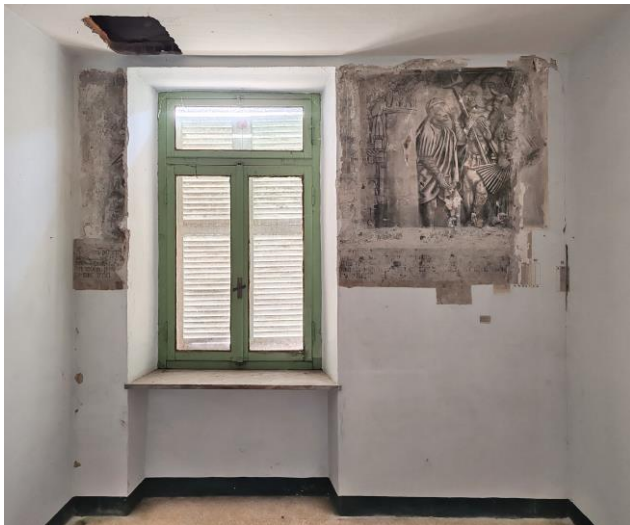
**Fig. 3:** One of the frescoed rooms on the second floor of the north wing belonging to an originally unified hall that was, over time, split with partitions and lowered with suspended ceilings. Note the superficial holes from the recent stratigraphic surveys and restoration of the building, as well as the deeper one to investigate its upward development (R. Rudiero 2024)

Therefore, the complex is now characterized by a series of stratifications that trace its transformation from a stately home to a functional building. These stratifications inevitably conceal some of the valuable qualities that characterized it. One example is the grisaille frescoes on the second floor of the north wing, which were consistently covered by successive layers of plaster and partly destroyed by the construction of partitions and the opening of new windows on the courtyard front (Fig. 3). Another example – from a functional point of view – is the disuse of the original cylindrical stair tower, which was replaced by a new and more operational ramp in the 19th century (Calliero & Moretti 2009b, p. 125). In contrast, anthropomorphic and phytomorphic terracotta window frames and string courses remain almost intact on the prospect along the street to the Castle (Fig. 2). The same is true for the articulation in the porch and overhanging loggia of the same building toward the inside of the courtyard. In particular, the brick columns on the ground floor are crowned with elegant stone capitals carved with scroll motifs (Fig. 8). On the upper floor, the wooden elements are carved instead, serving as a connection with the beam that supports the roof pitch (Fig. 5). In the interiors, wooden coffered ceilings are still present, partially visible thanks to fortuitous falls of the thatched ceilings due to water infiltration (this affected mainly the south wing, which has since been restored, but also the other ones, as shown in Fig. 11). Similarly, simplifications in the articulation of the ribbed vaults on the first floor have been deduced in the north wing of the building, including the addition of a thatched counter-vault (Fig. 4). Moreover, partial tests on the concrete brick floors have unveiled a decorated band and an additional

wooden ceiling on the floor where the frescoes are (Fig. 3).

provisional covering was added to the north wing to prevent further stormwater infiltration (Bosco, 2019) (Figs. 10-11). More recently, thanks – again – to the intervention of Italia Nostra, the Zonta Club Pinerolo, and Associazione Mellon, as well as the cooperation of the City of Pinerolo, the surface removal and restoration of the fresco cartouches in one of the Palace rooms were carried out in 2021 (Trombotto, 2022) (Fig. 3).

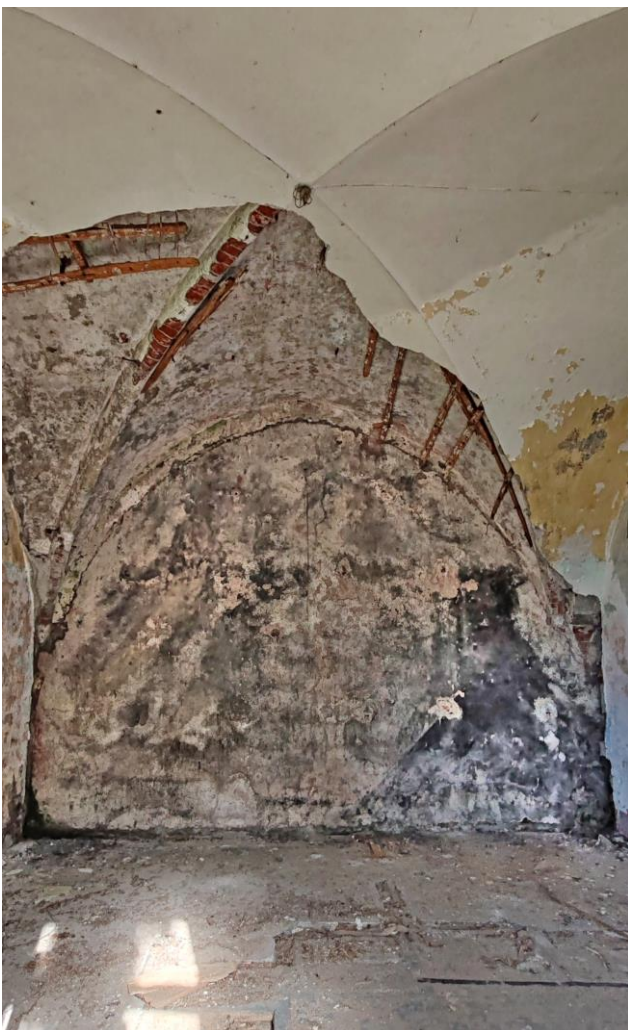
**Fig. 4:** The intervention to mask the ribbed vaults on the first floor of the north wing (R. Rudiero 2024)

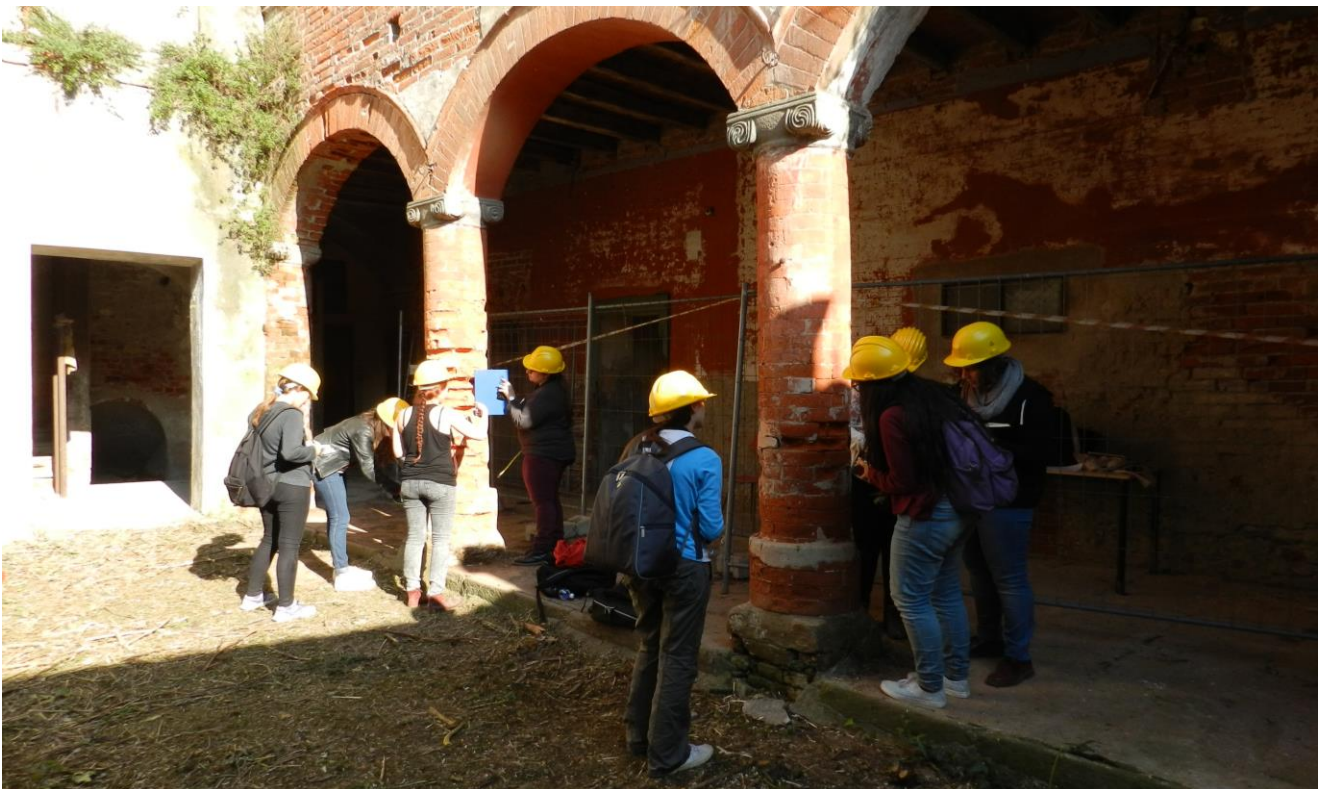
**Fig. 6:** Pinerolo, the so-called Palazzo dei Principi d'Acacia, seen from the court. Students engaged in activities to assess the state of preservation of brick columns (M. Mattone 2016).

The survey activity was conducted by professors and students of the Polytechnic University of Turin with the support of the specialists Arch. Monica Volinia and Mario Giroto of the Non-Destructive Diagnostics Laboratory of the Department of Architecture and Design. It allowed both to help define the stratigraphic palimpsest characterizing the building and to perform a punctual assessment of the state of preservation of some structural elements (particularly wooden beams and masonry

columns) (Fig. 6).

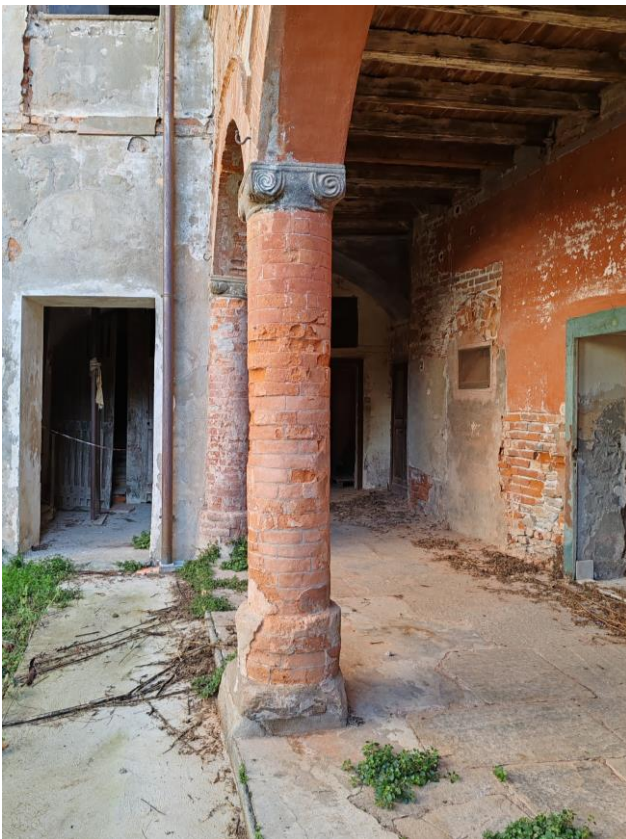
**Fig. 8:** The brick pillar of the porch on the ground floor, after restoration. The wooden ceiling of the covered side room has also undergone conservation work (R. Rudiero 2024)

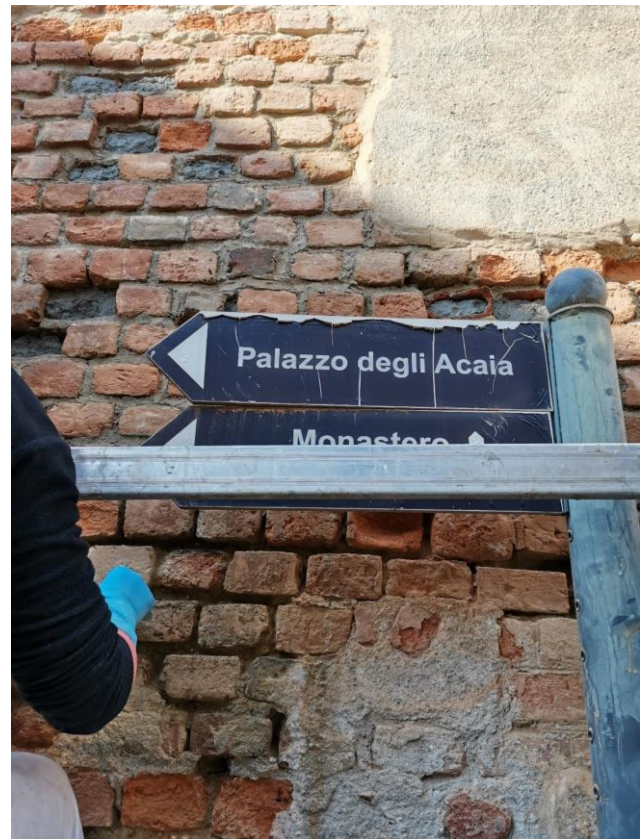
**Fig. 9:** Reintegration of detached bricks on the main exterior facade (R. Rudiero 2020)

Once this has been specified, it is essential to underline that the research carried out under the direction of the Polytechnic University of Turin was part of a broader and long-standing process, locally active through voluntary yet organically organized activities. They aimed to make the citizens aware of the values of an asset characterized by fragmentary knowledge and, above all, not properly preserved and used. So, with these renewed solicitations and the new analysis, the first restoration interventions designed to secure the Palace were carried out starting in 2019-2020. First, the roof of the south wing was rebuilt, and the wooden floor immediately below it was integrated and restored (Fig. 12). Analogous interventions were performed on the loggia floor. On its ground floor, the columns were consolidated (Fig. 8), and portions of eroded bricks pertaining to the dignified facade overlooking Via al Castello were reintegrated (Fig. 9).

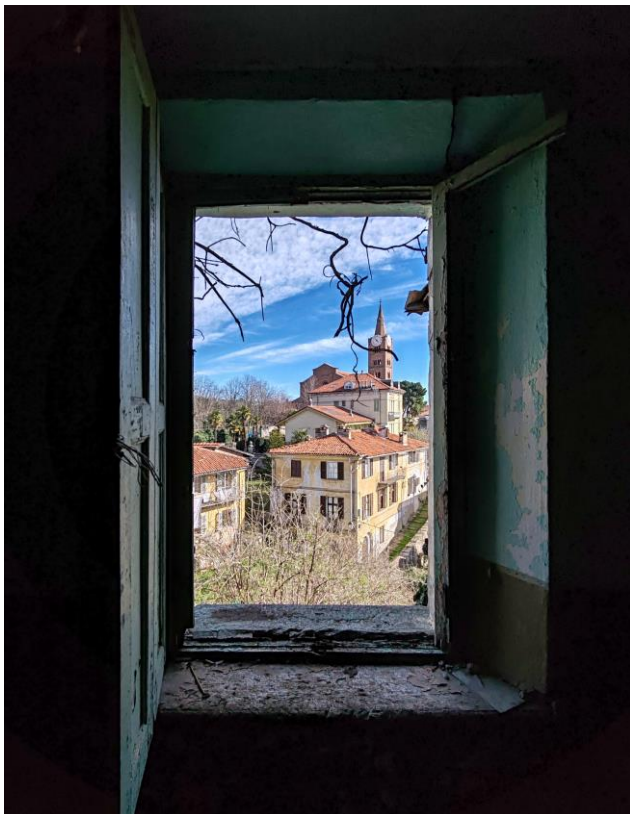
**Fig. 10:** View from one of the rooms on the top floor of the north wing. The proximity to the church of St. Maurizio, already part of the Borgo, clarifies the possible unintentional mystification about the Palace's ownership (R. Rudiero 2024)

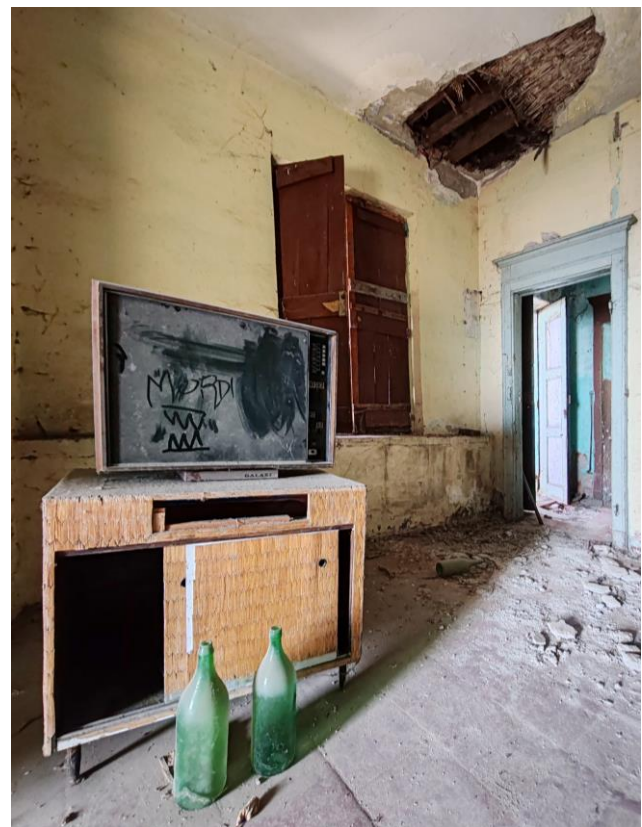
**Fig. 11:** Room on the upper floors of the east wing. The presence of furniture and furnishings denounces the Palace's last function, residence. Also note the partial fall of the thatched ceiling due to water infiltration, which required introducing a temporary covering to counteract the situation (R. Rudiero 2024)

In 1664, the Palace was foreclosed to the heir of the Vastamiglio family, Michele Rorencho (Trombotto, 2002, p. 317). Thus, it ceased to be a stately residence and became, almost seamlessly, a hospital for the poor until 1836, when it was used as a Hospice for the Catechumens (Calliero & Moretti, 2009b, p. 127). After being progressively fractionated into small houses, it assumed the function of residence for families in need from the postwar period onward. In 1983, it was acquired by the municipality – and is still in its possession; around the 2000s, it was decommissioned and abandoned – this event increased the process of deterioration already taking place (Fig. 11).

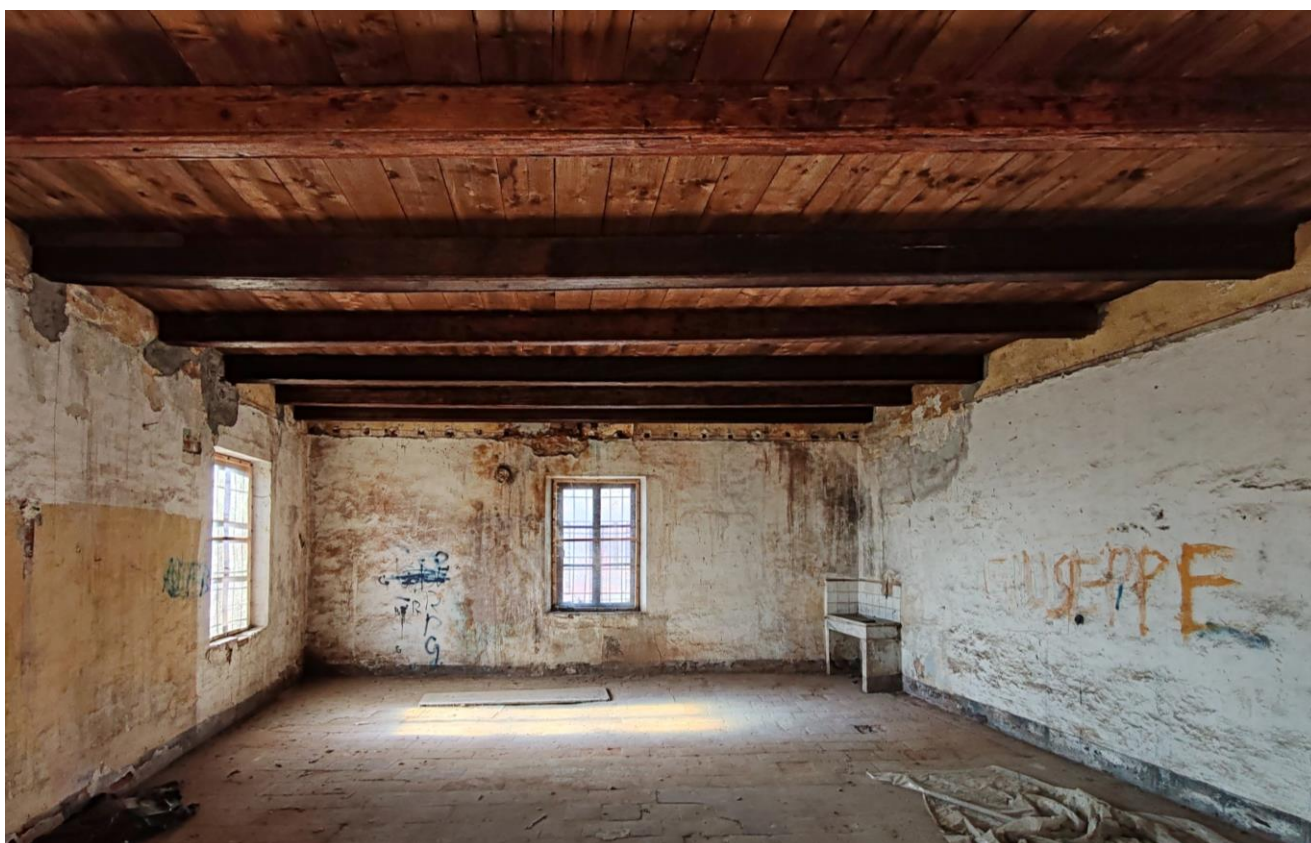
**Fig. 12:** Restoration work on the first-floor hall of the south wing. Subject to consistent deterioration due to infiltration, a new roof was recently built, and the corresponding floor underneath, previously concealed by a thatched ceiling, was restored. Most planks in this room have been replaced; instead, where possible, original beams have been kept (R. Rudiero 2024).
