One-year dynamic monitoring of an eight story CLT building

Abstract. This paper outlines the initial findings derived from a year-long dynamic monitoring of an eight-story Cross-Laminated Timber (CLT) building situated in As, Norway. The authors conducted bi-daily dynamic response measurements of the structure since November 2022. In tandem, the environmental humidity, and wind speed were also monitored. A key aspect of the study lies in examining of the interplay between environmental factors and modal parameters, with a specific emphasis on temperature. The analysis reveals that the first two bending modes of the structure exhibit a positive correlation with external temperature, with coefficients of determination of 0.44 and 0.25, respectively. The study also discusses the expected negative correlation between the natural frequencies and moisture content of wood, based on general wood behavior principles.

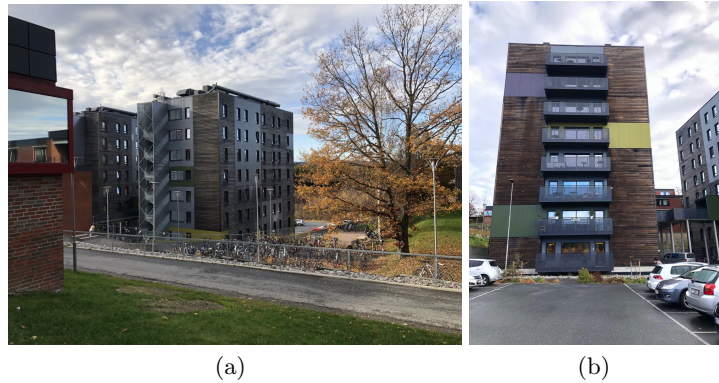
Fig. 1. (a) Pictures of student housing in Ås (Norway) and (b) details of the permanent monitoring system.

This paper focuses on an eight-storey residential building for students, situated in Ås, Norway. This edifice is 27 m high. It has rectangular footprint measuring 23 by 15 m. The primary construction material is CLT, employed in load-bearing walls and the elevator shaft. The building is characterized by extensive monolithic walls which considerable length-to-height ratios. These walls are built using a variety of fastening mechanisms, including tie-downs, angle brackets, and screws. Underneath the interior walls, there is a 10 mm sound insulation. The building's external façade is clad with wooden boards, each 20 mm in thickness. Inside, the walls are mostly finished with 25 mm plasterboard, although some are left in their natural state.

In the latter part of 2022, specifically in October, a comprehensive monitoring system was established on the building's rooftop, as depicted in Fig.1(d). This system includes three piezoelectric accelerometers and a fully-equipped weather station, complete with an anemometer and sensors for both temperature and humidity.
