Resilience and sustainability assessment of a prestressed concrete viaduct

ABSTRACT: The paper explores Greece's Polyfytos viaduct, the nation's second-longest bridge spanning 1,372 meters, renowned also for providing access to key power plants in South-East Europe. A resilience analysis of different retrofitting scenarios was conducted, including both transitability and structural capacity aspects, employing visual inspections, digital data collection, and advanced modeling techniques. The viaduct, conceptualized by Prof Riccardo Morandi and built in 1972-1975, displays typical degradation seen in prestressed and reinforced concrete bridges. Unlike previous research focused solely on retrofitting with LCA and LCC assessments, this study integrates resilience assessment, marking a pioneering holistic approach to viaducts refurbishment.

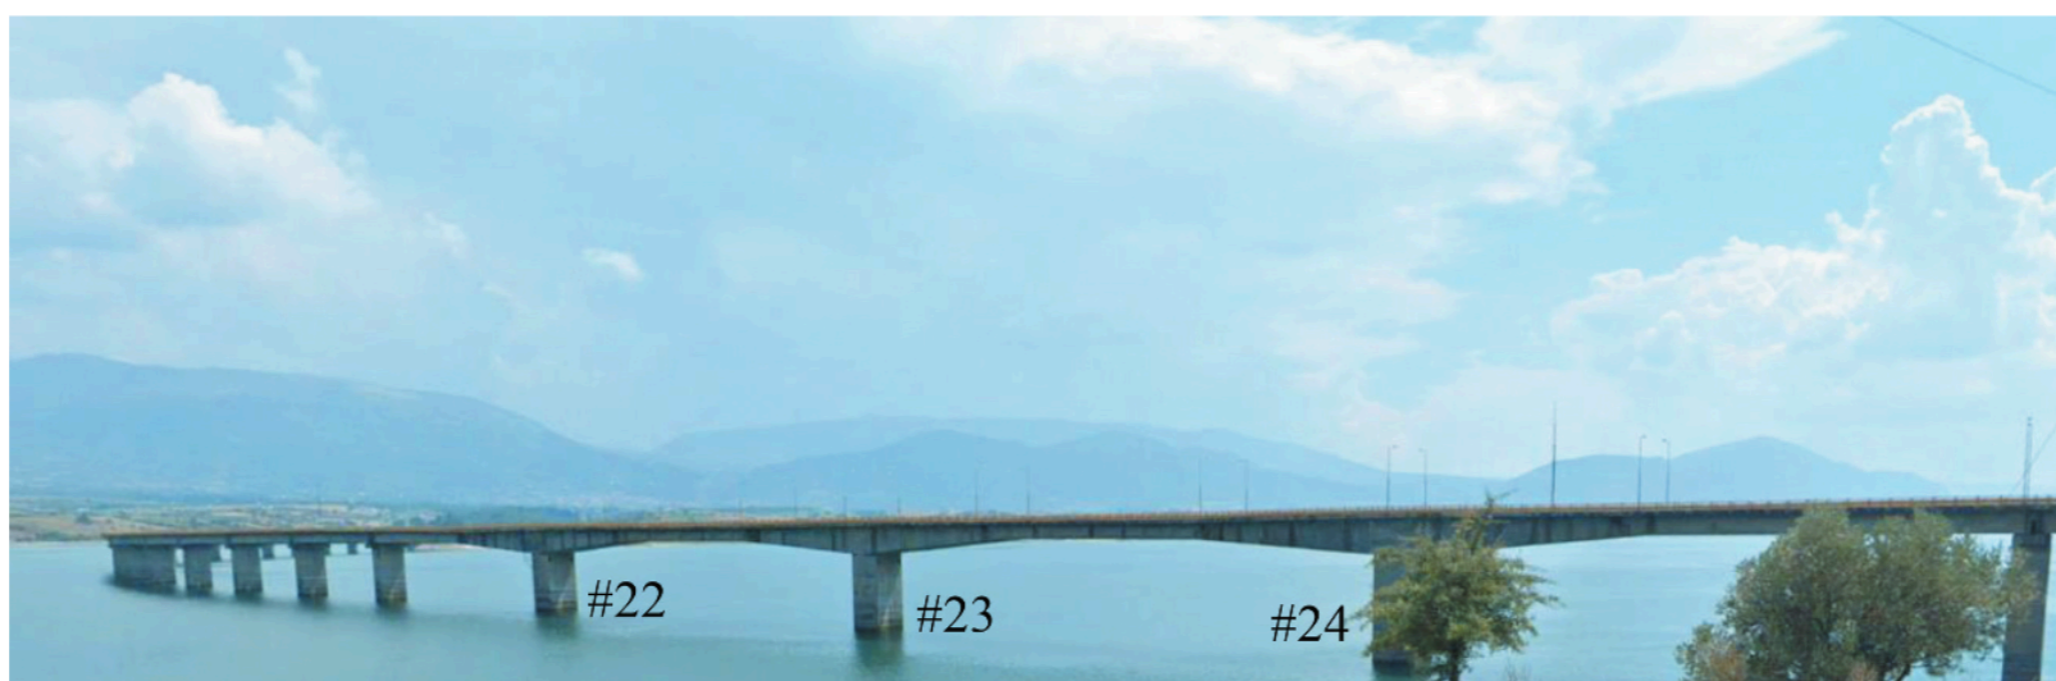
Figure 1. The Polyfytos bridge and the three piers under evaluation.

The Polyfytos Bridge, constructed in 1975 within the Municipality of Western Macedonia, Kozani, Greece, stretches over the artificial Polyfytos lake, playing a crucial role in connecting local and national road networks. One section of the bridge, spanning 260 meters between piers 22, 23, and 24 (Figure 1), was built using the balanced cantilever method, contributing to the bridge's overall length of 1372 meters. Recent inspections, carried out by multiple inspectors, including one of the authors of this paper, revealed excessive deflections at the free ends of the cantilevers, a common issue in aging bridges constructed using this method (Markogiannaki et al. 2022). Initial evaluations highlighted corrosion and localized concrete damage, raising significant concerns about the bridge's structural soundness. Consequently, traffic restrictions, such as weight limitations for heavy vehicles and reduced speed limits, were imposed to minimize dynamic impacts.
