Resilience and sustainability assessment of a prestressed concrete viaduct

ABSTRACT: The paper explores Greece's Polyfytos viaduct, the nation's second-longest bridge spanning 1,372 meters, renowned also for providing access to key power plants in South-East Europe. A resilience analysis of different retrofitting scenarios was conducted, including both transitability and structural capacity aspects, employing visual inspections, digital data collection, and advanced modeling techniques. The viaduct, conceptualized by Prof Riccardo Morandi and built in 1972-1975, displays typical degradation seen in prestressed and reinforced concrete bridges. Unlike previous research focused solely on retrofitting with LCA and LCC assessments, this study integrates resilience assessment, marking a pioneering holistic approach to viaducts refurbishment.

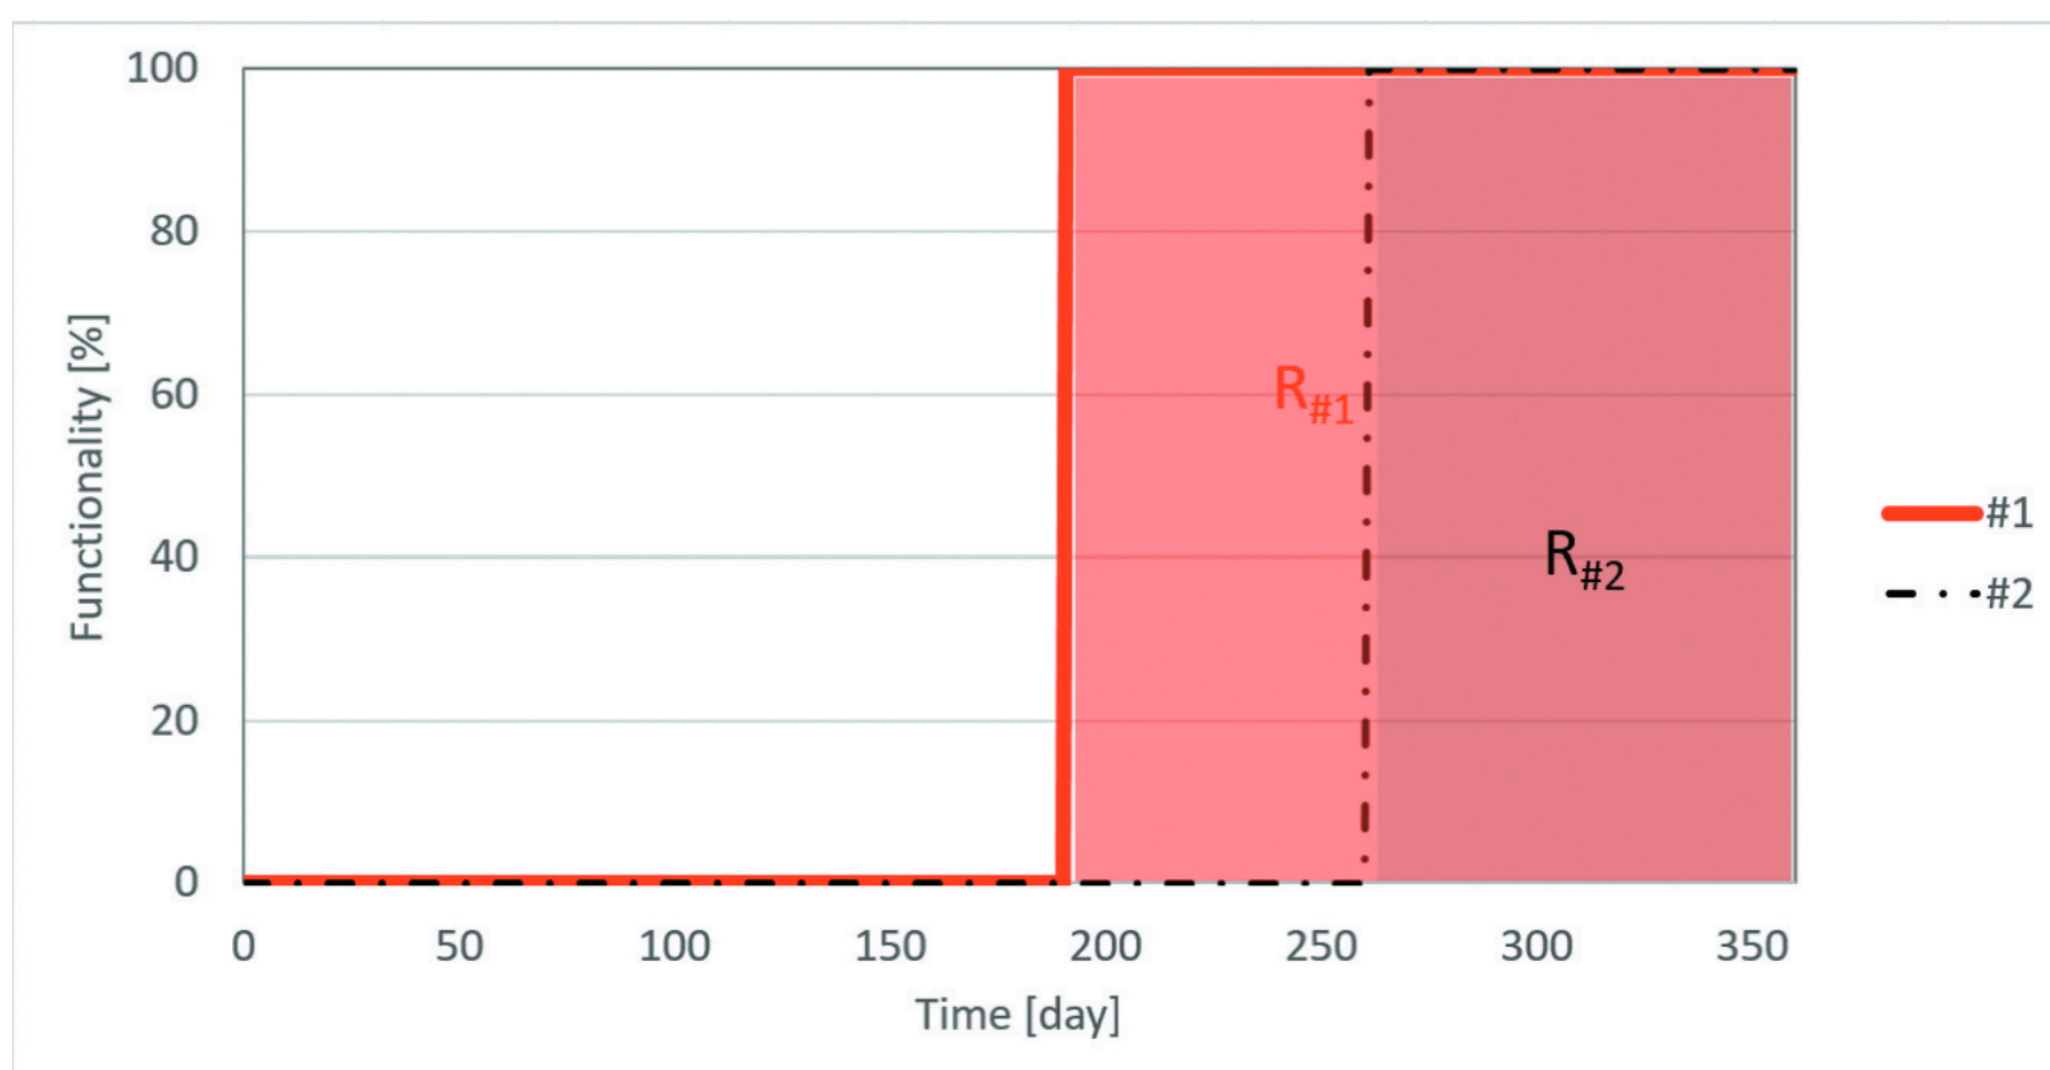
Figure 2 illustrates the functionality curves for the proposed solutions, starting at time 0 when either the whole deck or Gerber beams only are demolished, resulting in a complete bridge closure. In Scenario #1, demolition using explosives is estimated to take around 10 days, while for Scenario #2, controlled demolition of the Gerber beams will take approximately 20 days.

Figure 2. Functionality curves and resilience (transitability).

For the solution involving deck replacement or a portion of it, it is assumed that before demolition starts, the replacement structure is prepared nearby for swift replacement. Specifically, installing the new deck is estimated to take 3 months for Solution #1. Scenario #2, involving new Gerber beams and external prestressing cables for the cantilevers, is estimated to take 5 months.

Upon construction completion, the estimated timeline for testing, processing (technical-administrative approval), and full bridge reopening is set at 90 days. Post this period, it is assumed that the bridge's transit capability will be restored to 100%. Resilience values for the different scenarios considering a maximum closure period of 360 days are tabulated in Table 3.

Scenario	#1	#2
Resilience	0.47	0.28
