Point clouds and surface analyses to detect anomalies

Point clouds and surface analyses to detect anomalies / Sammartano, G., Patrucco, G., Perri, S., Spano', A. - In: The Halls of Turin Exhibition Center by Pier Luigi Nervi: a multi-disciplinary approach for diagnosis and preservationELETTRONICO. - Los Angeles : Getty foundation, 2023. - pp. 154-167

3c Point clouds and surface analyses to detect anomalies

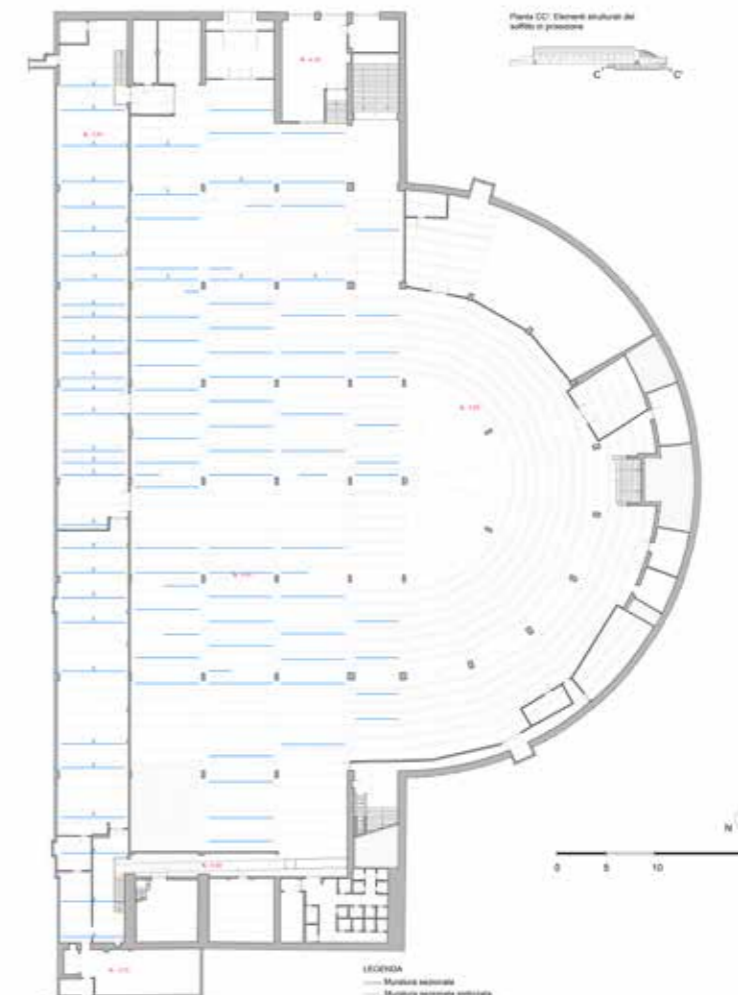
This clear reconnaissance of the basement mesh and the constant comparison with photos depicting the ceiling made it possible to map the entire crack pattern of the underground rooms. It was also decided that when a crack was so big it could be read on the cloud or on the mesh, i.e. of such a size as to cause a variation in the continuity of the surface acquired

with the laser scanning technique, it was classified as main. If, on the other hand, the cracks were visible on the photo, but not on the surface, the lesion was interpreted as secondary, i.e. it substantially affects the plaster. Figure 3c 2.4 represents the final result of the mapping described above.

3c 2.4: Basement plan showing the map of the cracks detected both by the triangulated surface (main lesions) and by visual on-site inspection and with the support of photos (secondary lesions).

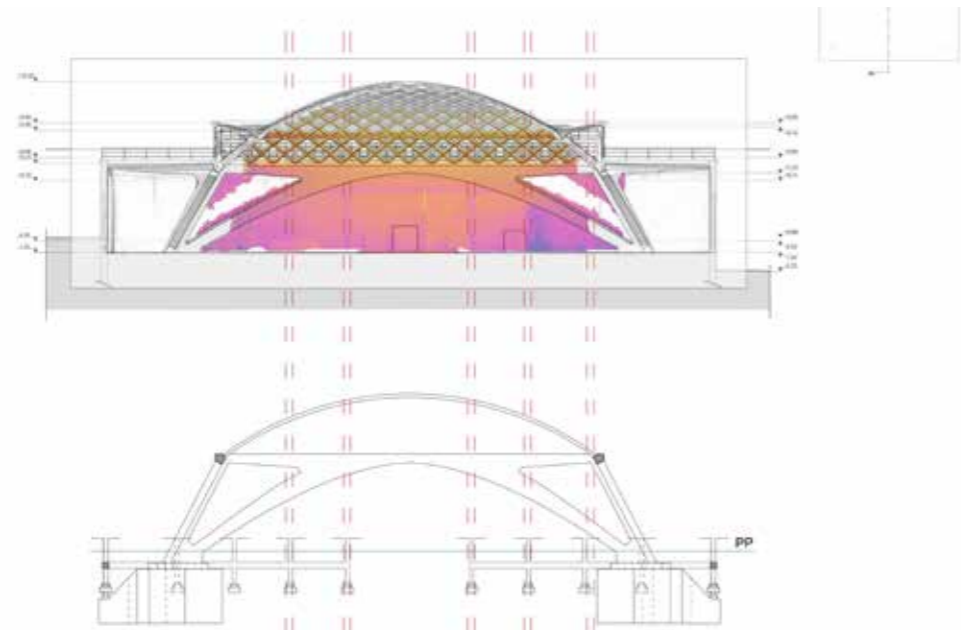
were previously assigned a reclassification to standardize the graphic scale for the variation in temperatures. The merge process of the thermal images was produced by means of a rigorous photogrammetric process to identify homologous points on the 3D model and determine the projection center of thermograms, which enabled a good mosaic to be obtained. (Figures 3c 3.5 - 3c 3.6)

3c 3.5: Comparison between the position of pillars from the thermal survey and positions from Nervi's drawings for the east interior wall. (elab. Patucco, Cofano)

It can be clearly seen that something occurred to the pillars and foundation design in Hall C prior to the construction site. Whereas the correspondence between the pillars and the project foundations for the interior east front is very precise,

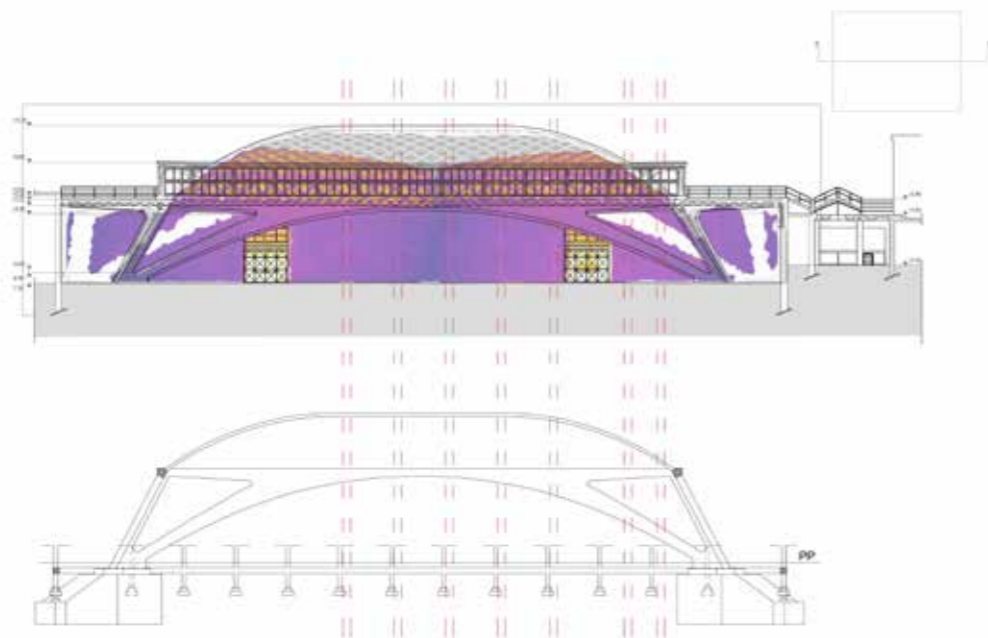
3c 3.6: Comparison between the position of pillars from the thermal survey and positions from Nervi's drawings for the south interior wall. (elab. Patucco, Cofano)

a significant deviation can be observed for the interior south front. This is a sign that once again the plan of the foundations should not have been the definitive plan.
