## ARTICLE

# Performance of historical ferrocement specimens subjected to corrosive environments

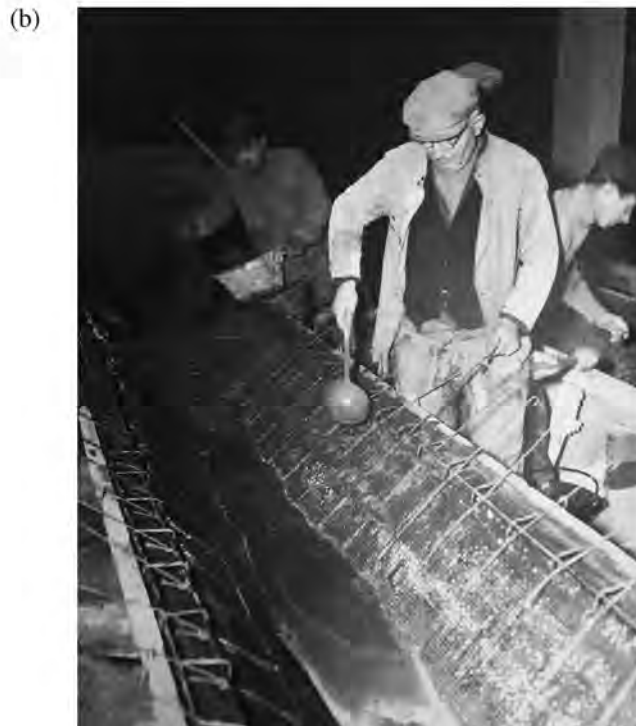
FIGURE 2 (a) Illustration of construction details related to ferrocement corrugated beams.<sup>30</sup> It is possible to appreciate the number of the wire mesh layers and the variations in thickness in the cross section. (b) Prefabrication on site of the undulated beams in ferrocement (1949–1950).<sup>17</sup>

The corrugated beam consisted of a precise combination of reinforcement, with wire mesh and high-quality cement mortar. Its cross-sectional area was not constant but increased from the outside inward towards the arches, where it reached its maximum size (Figure 2a). The element was 0.94 m wide, 9.5 m long, as mentioned

before, and with a height ranging from 0.26 to 0.44 m at the highest part. It is a modular element with remarkable strength characteristics, despite its slight thickness (2–4 cm). From the original design, the internal reinforcement of the corrugated beam in Hall C consisted of three layers of wire mesh weighing  $0.600 \text{ kg/m}^2$ , both above and below the ordinary reinforcement, to form the characteristic curved shape<sup>25,27,30</sup> (Figure 2b).

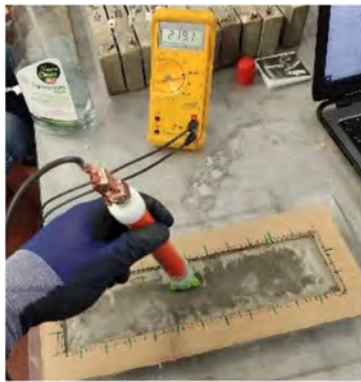
FIGURE 8 (a) Corrosion potential measurement. (b) Corrosion potential measurements scheme showing the 20 points of acquisition.

Half-cell corrosion potential measurements are carried out with a Cu/CuSO<sub>4</sub> reference electrode (Figure 8a). Half-cell corrosion potential is measured before starting the aging cycle, and every 2 weeks, during the aging process. All the data collected are evaluated in accordance ASTM C876 Guidelines<sup>35</sup> for corrosion potential of reinforcement steel without cover in concrete. The values are evaluated as follows:

(Figure 8b). Before performing the measurements, the treated surface is wetted by spraying water.

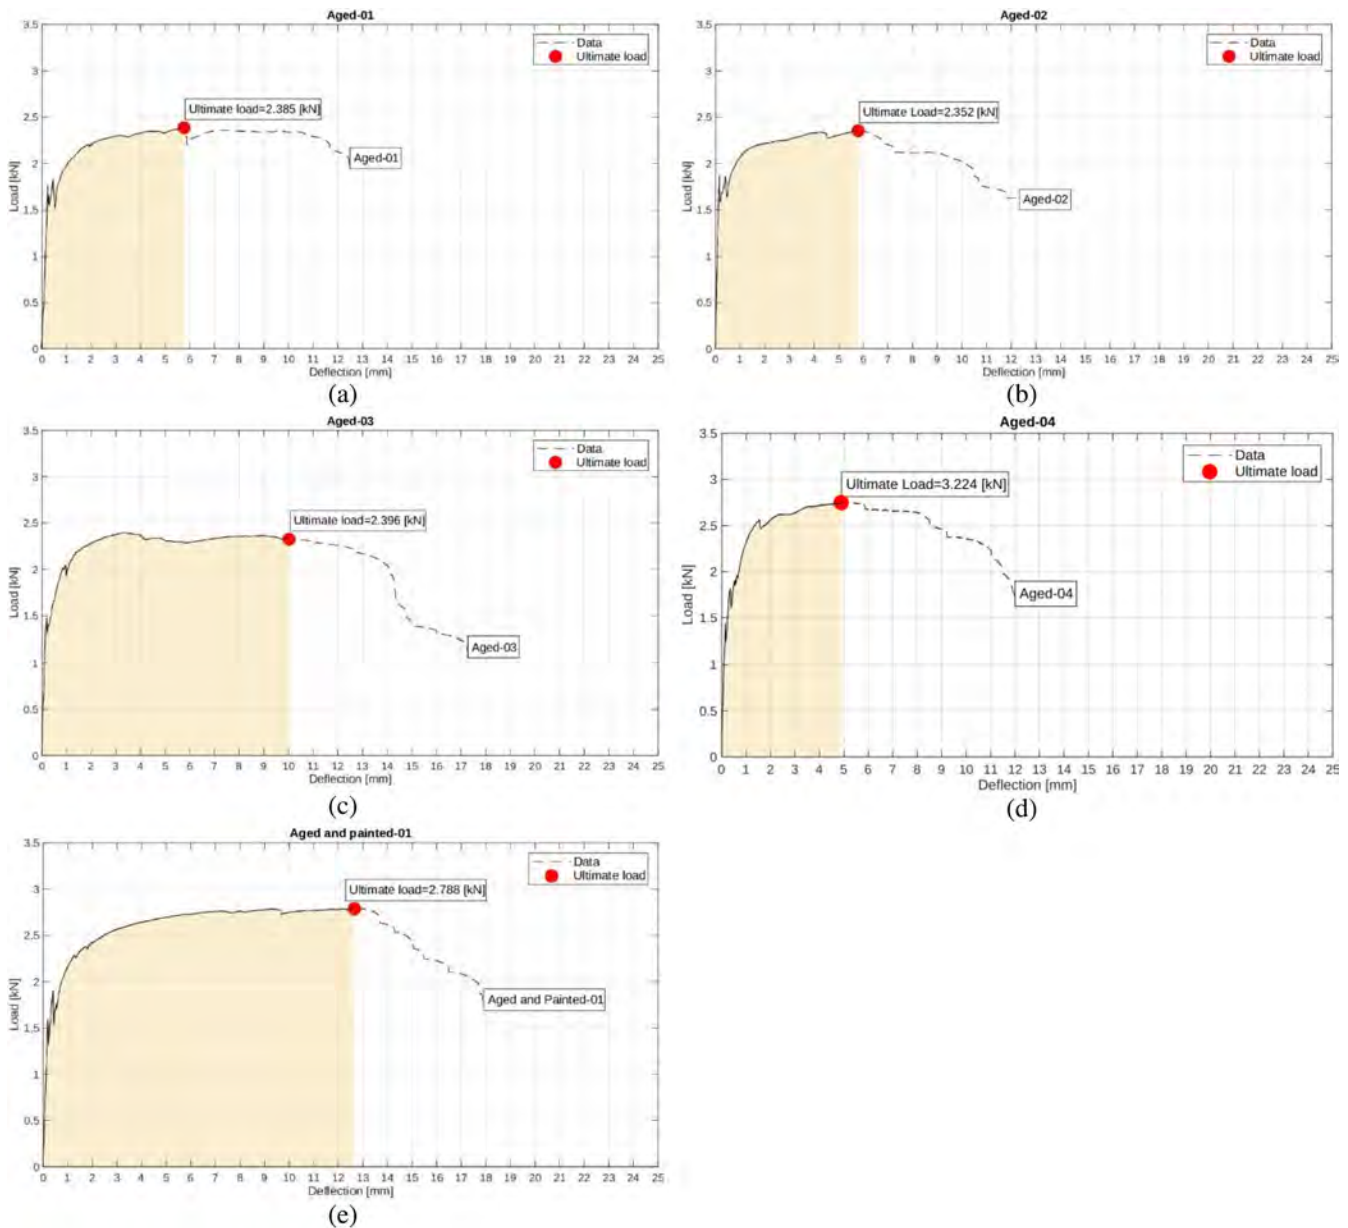
FIGURE 13 Four-point bending test load-deflection pattern with ultimate load point and work highlighted, aged samples from (a) to (d), painted and aged (e).

Table 9 reports the results of the flexural tests of aggregated samples in terms of ultimate load and  $\delta_u$  (defined as the deflection at the ultimate load). Results are used to evaluate the mechanical properties of the ferrocement samples by comparing the performance of the aged and non-aged ones. Table 10 reports the results in terms of mean values and their standard deviation for each parameter (ultimate load, work, and  $\delta_u$ ). The comparison is done in terms of percentage loss compared to the non-aged samples; moreover, an additional parameter useful to evaluate the ductility of the material is by comparing the loss of work, which is represented by the underlying area of the load-deflection (Figures 13 and 15).

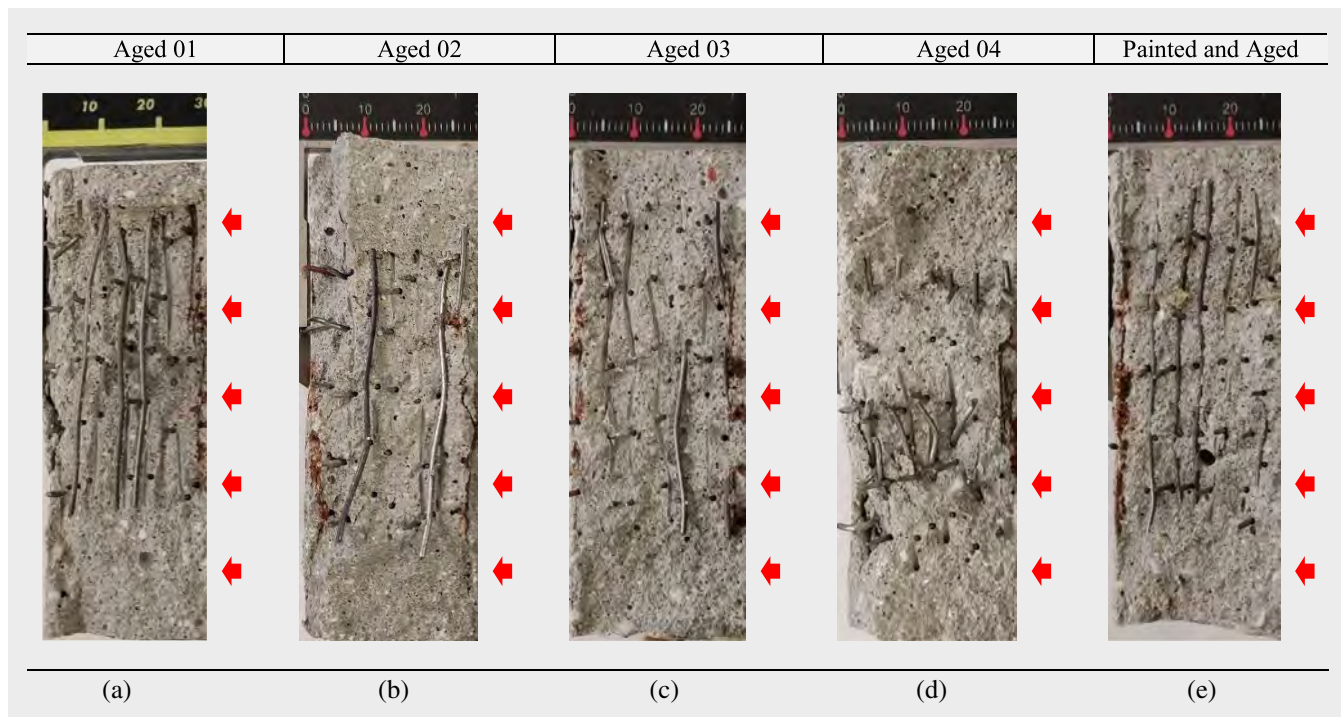
TABLE 12 Samples section after aging and four-point bending test, from (a) to (d) aged, (e) Painted and aged (the red arrows indicate the sample's side exposed to aging, subjected to tension during the four-point bending test).

Moreover, the rupture sections of the aged samples, reported in Table 12, confirm how corrosion generally affected the first layer of reinforcement and, in some points (Table 12b), even the second layer. At failure, the ferrocement wires of the first layer were broken in different points, but by observing the load-deflection graphs (Figure 13) it is possible to assert that slip have occurred, especially considering the characteristics of the employed mesh (smooth wires of steel and not welded texture) also enhanced by the presence of corrosion.
