Bridges monitoring and assessment using an integrated bim methodology

D. Rodriguez Polania¹ · F. Tondolo¹ · A. Osello¹ · M. Piras² · V. Di Pietra² · N. Grasso²

Abstract

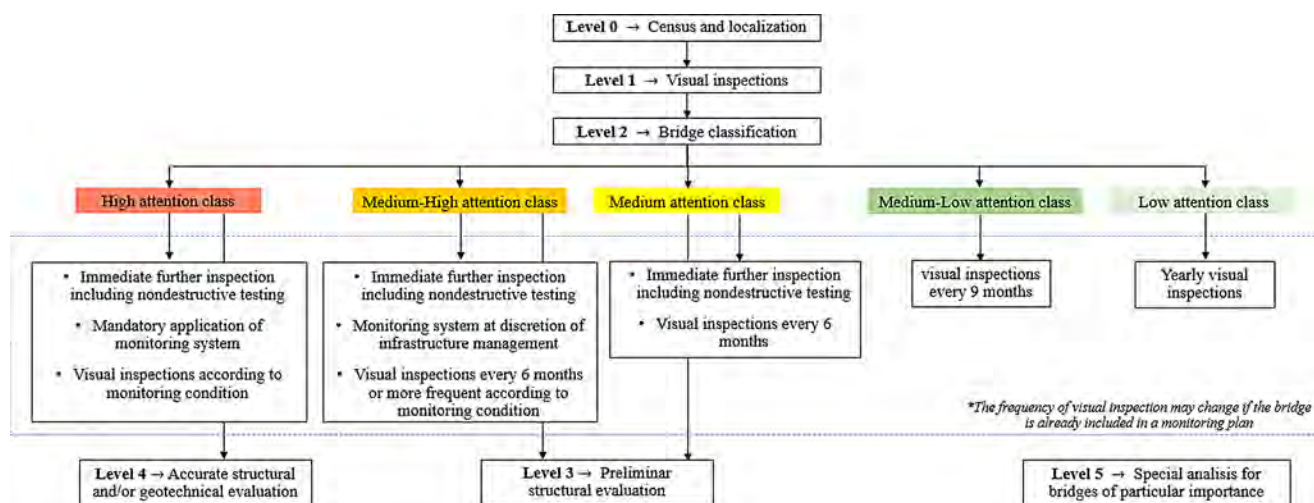
**Fig. 1** Decision-making procedure for bridge assessment described in the Italian guidelines in 2020 for bridge risk evaluation, classification, and monitoring

explanation of the level of analysis can be seen in Table 1 while the decision-making process proposed by the guidelines can be seen in Fig. 1. All bridges in the Italian network are subject to levels 0, 1, and 2; however, the complexity of further analyses depends on the bridge classification—termed “Attention Class”—assigned at level 2. Notably, as demonstrated in Fig. 1, the sequence of analyses after classification at level 2 is not necessarily linear. For example, a bridge may advance directly from level 2 to level 4 without undergoing the intermediate levels of analysis.
