Resonance Frequency as an Indicator of the Damage in Carbon Composite Plates: Analysis on Composites Prepared with Conventional and Sustainable Resins Subjected to Impact Tests / Ciardiello, R., Boursier Niutta, C., Tridello, A.. - In: POLYMERS. - ISSN 2073-4360. - 17:2(2025). [10.3390/polym17020141]

Resonance Frequency as an Indicator of the Damage in Carbon Composite Plates: Analysis on Composites Prepared with Conventional and Sustainable Resins Subjected to Impact Tests

Abstract: This paper experimentally investigates the impact response of composite laminates made with conventional and bio-based epoxy resin. Drop tower impact tests were conducted at varying energy levels, including repeated low-energy impacts, to evaluate perforation resistance. The laminates' residual strength and damage tolerance were assessed using the Damage Index (DI) and by analysing the resonance frequency variations through the Impulse Excitation Technique (IET). The study demonstrates a strong correlation between the DI and the resonance frequencies of the specimens, suggesting that IET can effectively track damage progression in composite laminates. Bio-based resin laminates exhibited higher energy

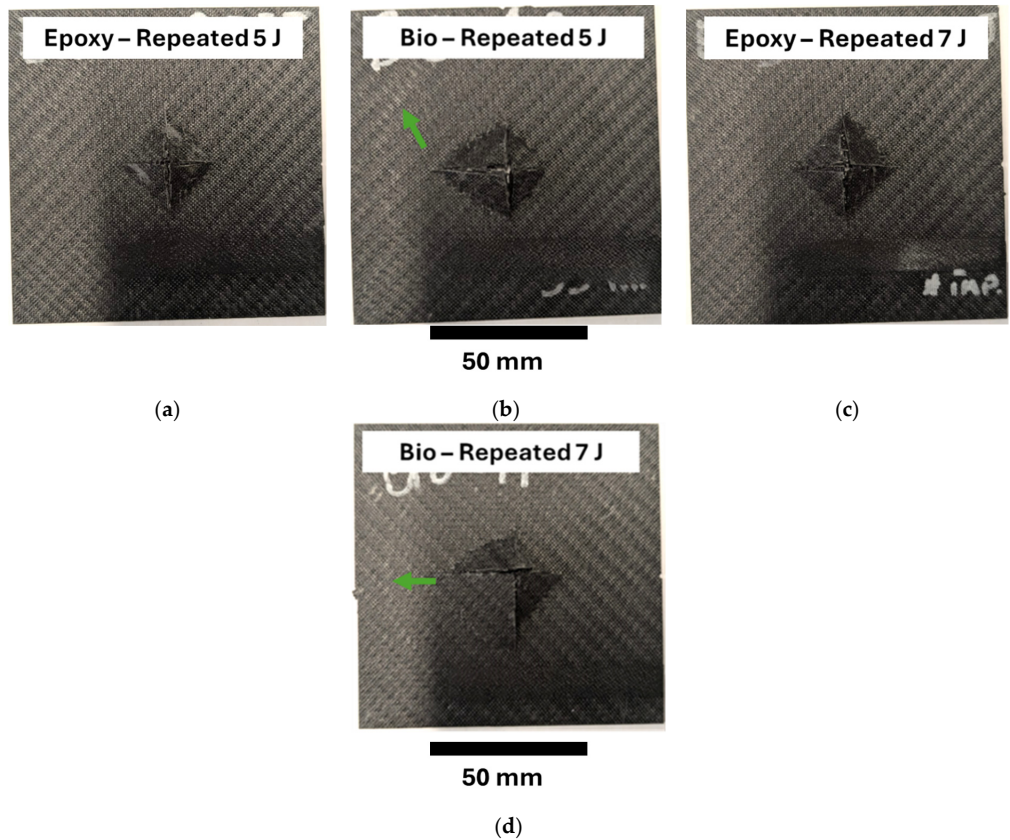
Figure 10. Fracture surfaces for the specimens subjected to repeated impact tests at 5 J and 7 J: (a) Epoxy 5 J, (b) Bio 5 J, (c) Epoxy 7 J, (d) Bio 7 J.

Figure 10 reports the specimens subjected to repeated impact tests at 5 J, Figure 10a and Figure 10b, and at 7 J, Figure 10c and Figure 10d, respectively, for plates prepared with epoxy and bio-resins. Figure 10 shows that the plates prepared with the epoxy resin and impacted at 5 J and 7 J presented similar fracture surfaces. The size of the damaged area and the shape were symmetric and quite close to the specimens impacted at 30 J, where complete perforation occurred. On the other hand, the plates prepared with the bio-based resin and impacted at 5 J and 7 J presented similar damage areas that were slightly longer on the left side, Figure 10b,c. This indentation was the result of the higher number of impacts that these specimens bore. The damaged area was slightly higher for bio-based due to the higher displacement that these specimens bore. Likely, the ductile behaviour of the plates prepared with bio-based resin triggers a different damage mechanism, and the interlaminar crack propagates before the final fragile failure. This behaviour involved a wider part of the plates in the damage progression. Indeed, the plates presented a tiny indentation close to the circular support, as shown by the green arrow. The frequencies computed throughout the IET also showed that this technique could detect greater damage. Indeed, the specimens impacted at 5 J presented a final value of 0.86 and 0.90 for the specimens prepared with bio and epoxy resins, respectively. The final values for specimens impacted at 7 J were 0.82 and 0.88, respectively, for the bio and epoxy resins. Thus, the plates with greater damage, the biospecimens, presented a higher drop in frequency.
