9th CIRP Global Web Conference – Sustainable, resilient, and agile manufacturing and service operations :
Lessons from COVID-19

A machine vision-based automatic inspection system for power station coal bunkers maintenance

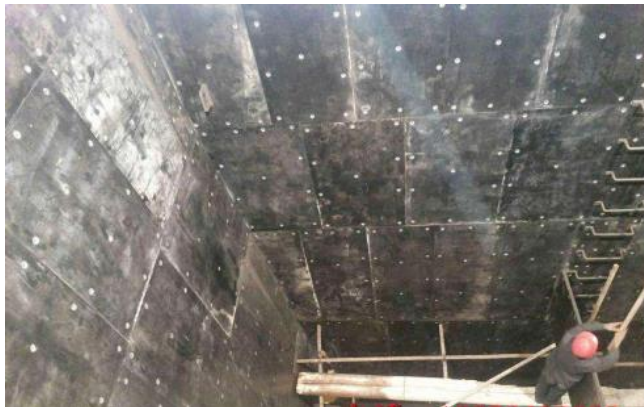
Fig. 2. Inside of coal bunker

In coal power plants, the raw material, is stored in a coal bunker (Fig. 2), generally realized in stainless-steel [6]. Generally, raw coal is fed through conveyor belt to a mill unit to be dried and grinded into powder. Pulverized coal is sorted and fed into a boiler furnace for combustion [6]. Environmental and mechanical factors can have a negative impact on the storage and feeding quality of coal through the plant. In this respect, high humidity can cause coal agglomeration yielding to the bunker clogging [7]. Concerning the mechanical stresses, due to the wear scratches caused by the long-term friction between the coal and the coal bunker surface, the fastener bolts and the welds between liners become vulnerable to the acid corrosion when exposed to the coal [8]. Such conditions can potentially clog the coal feeder inlet, and to ensure the safe and stable operation of the equipment, it is particularly important to regularly inspect the lining plates of the coal bunker. Defects such as fastener oxidation and corrosion and liner edge warping are recurrent in coal bunkers, requiring maintenance and repair in order to avoid inner wall damages, compromising the safe operation of the whole power plant. Automation technologies in coal power plants available in specialized literature are generally focused on the coal handling systems [9, 10].
