Structural adaptations: The role of existing structures in adaptive reuse projects

Structures and Architecture | Volume 3

*Structural adaptations: The role of existing structures in
adaptive reuse projects*

Case study: Adaptive reuse of abandoned industrial buildings in Oklahoma

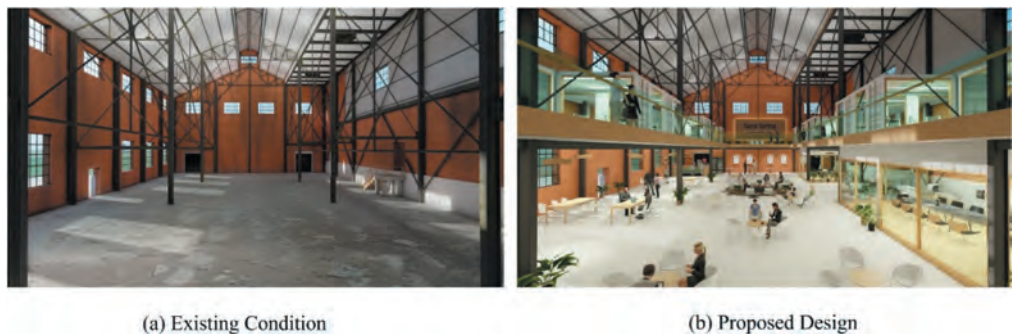
Figure 11. Rendered interior perspective of Area 3, a) before and b) after proposed architectural design (By authors).

As shown in Figure 11b, old containers are used to create a mezzanine level in the northeast block of the building. This area provides a certain degree of privacy for the office spaces while creating opportunities for social interaction at the ground level. Due to the addition of the mezzanine level, it is recommended that the structural frame system be re-evaluated to ensure the structure's strength.

After analyzing the urban context and reviewing the existing structural system of the power plant, an architectural design has been proposed. Restaurants and rentable small co-working spaces are considered the most efficient urban functionalities for the adaptive reuse of the power plant. This approach meets the community's expectations of preserving the power plant's unique architectural style while redeveloping it. Skylights and reopening of existing windows allow for cross ventilation and natural light into the interior. The light interior color, indoor plantation, and lighting add new life to the unused building. The proposed raw flooring in the south block adds richness to the rustic building and can be converted into a more relaxed area. Additionally, to connect with the local community, transforming half of a large unused outdoor space into a garden and a dining courtyard for the restaurant is proposed to fulfill the client's desire. Figure 11 shows the rendered interior perspective images of Area 3 in the existing and proposed conditions used as co-working spaces.

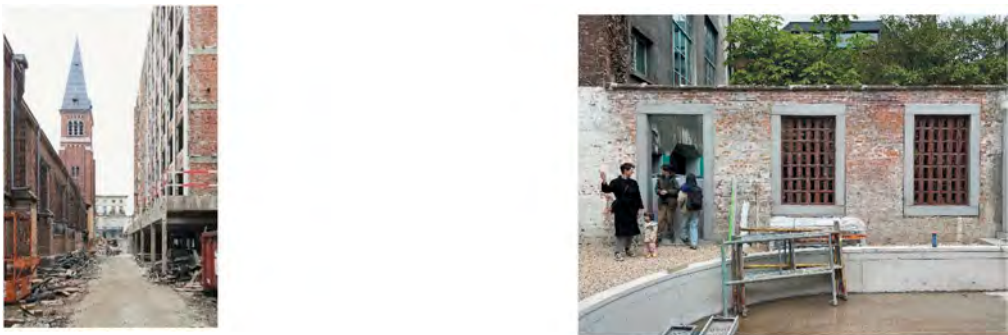
Figure 10. Left: Freeing the church of the added storage volumes gives some air to the public garden-to-be and allows for a strip of fertile soil; Right: Reinforced concrete beams are disguised as garden elements such as a pond, stairs and a bench, creating the possibility for heavier loads (greenery). (©ono architectuur).
