Material Degradation and NaTech Risk: A Case Study to Discuss Bidirectional Vulnerability in Industrial Systems

At approximately 01:15 Central Standard Time on 25 January 2014, a natural gas pipeline rupture and ignition occurred in the vicinity of Otterburne, MB, Canada. As a result, a crater approximately 24 m long and 12.5 m wide was formed, caused by an explosion, with debris projected approximately 100 m from the crash site (Figure 1). The technical data of the Otterburne case are reported in Table 1, which also summarises the main parameters and the evidence emerging from the analysis.

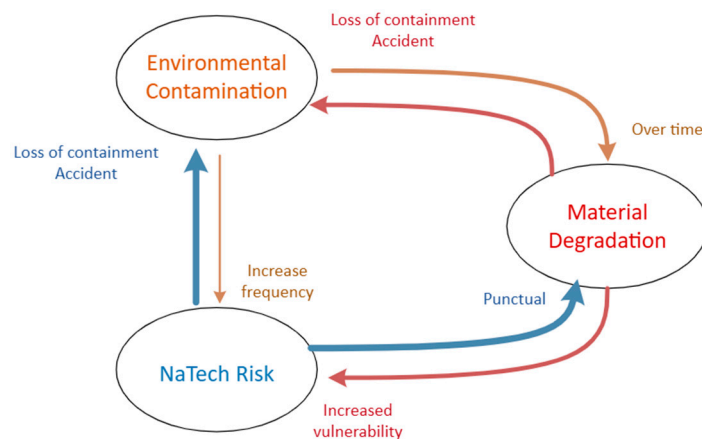
Figure 3 represents the conceptual model of bidirectional vulnerability, enriched with graphical elements that enhance its analytical capacity. The three main domains are colour-coded: orange highlights the effects of environmental contamination, blue highlights those associated with NaTech risk, and red highlights those resulting from material degradation. The directional arrows represent the causal relationships between model domains and vary in thickness to indicate the intensity of their influence. Specifically, thicker arrows correspond to high-intensity interactions, i.e., phenomena that generate immediate and significant effects on the system, such as the accidental release of hazardous substances or the NaTech escalation. Conversely, thinner arrows represent low-intensity influences, typically associated with slow, cumulative, or indirect processes, such as progressive corrosion or the alteration of the mechanical properties of materials over time. This visual coding allows for the distinction between acute and chronic impact mechanisms. and supports the integration of degradation indicators into NaTech vulnerability models, providing a foundation for future quantitative developments.

Figure 3. Conceptual model of the bidirectional relationship between material degradation and NaTech risk. The colours distinguish the risk domains; the thickness of the arrows represents the intensity of the causal influence, from indirect effects to acute impacts.

Moreover, the diagram emphasises the cyclical and interconnected nature of the three domains. Each element can act as both cause and effect, generating a systemic vulnerability loop. Environmental contamination can increase the frequency and intensity of extreme natural events, which accelerate material degradation processes. Degradation, in turn, can compromise the structural resistance of infrastructure and contribute to the release of hazardous substances, further fuelling environmental contamination and closing the cycle.

This is depicted in Figure 3, which shows the scheme devised in the study conducted by Pilone et al. [28], integrating the notion of material degradation and its influence on NaTech risk.

Therefore, from Figure 3 emerges that natural events can influence material degradation in short timescales, material degradation can influence natural events, but the impact on frequency occurs much more slowly and gradually. Therefore, during the risk analysis, it is essential to consider the state of infrastructure on the consequences of natural events. Consequently, it is crucial to incorporate this factor into the NaTech risk assessment.

The conceptual model presented in Figure 3 describes bidirectional vulnerability as the dynamic interaction between material degradation and NaTech risk. Applying this framework to the Otterburne case, it is possible to observe how a latent defect made the infrastructure vulnerable for decades. The extreme natural event acted as an external trigger, accelerating the failure process.
