# Pattern recognition approaches for the detection of alteration and degradation phenomena in hyperspectral and UAV multispectral imagery: the case study of a historical masonry water bridge

Alessandra Spadaro <sup>1</sup>, Francesca Matrone <sup>1</sup>, Andrea Maria Lingua <sup>1</sup>, Ramin Rashidi Alavijeh <sup>1</sup>

**Keywords:** Hyperspectral imaging, Multispectral imagery, Decay mapping, UAV, OBIA, Machine Learning.

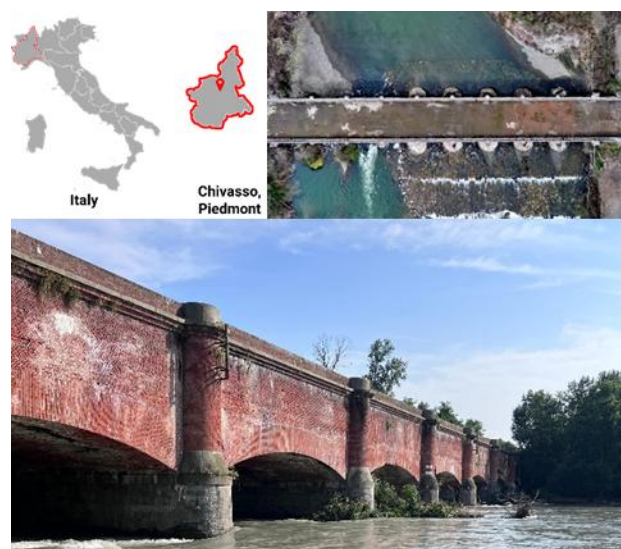
Figure 1. The Cavour Canal water bridge over the Dora Baltea River (Saluggia, Italy), a 19th-century masonry hydraulic structure characterized by a multi-arch configuration and a continuous water conveyance system.

The selected case study is the Ponte Canale Cavour over the Dora Baltea River (Figure 1), located near the municipality of Saluggia in Vercelli, north-western Italy. This structure represents the first and one of the most important hydraulic crossings within the canal system, completed in 1864. The bridge is characterized by a monumental masonry architecture, consisting of approximately 193.6 m in length, with nine masonry arches supported by eight piers and two abutments. The structural system is primarily composed of fired clay bricks, with localized use of stone elements (e.g., granite slabs) in the lower portions of the piers to enhance resistance to hydraulic erosion.

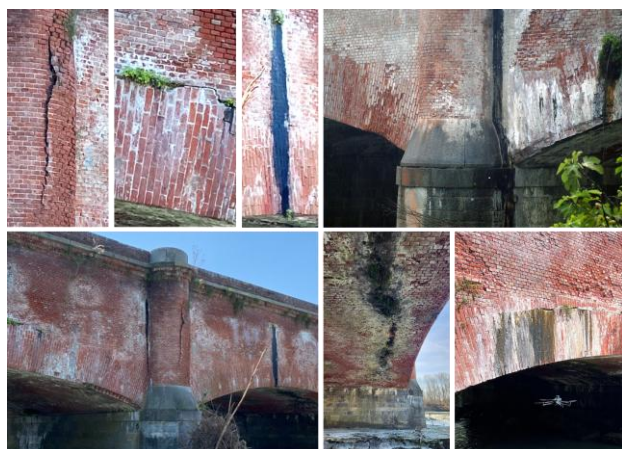
Figure 2. Examples of degradation phenomena affecting the masonry structure, including moisture infiltration and biological growth, contribute to material decay and structural weakening.

of implementing fast, repeatable, and scalable diagnostic procedures. Figures 2 illustrates the main degradation phenomena affecting the masonry surfaces.
