Understanding the structures of Pier Luigi Nervi: a multidisciplinary approach

# Understanding the structures of Pier Luigi Nervi: a multidisciplinary approach

**Abstract:** The paper describes the strategies adopted to carry out the knowledge campaign on Hall C built by Pier Luigi Nervi at Torino Esposizioni, between 1949 and 1950, and belonging to the architectural heritage of the 20th century. The structure was built by combining reinforced concrete and ferrocement elements, thus implementing what for Nervi would later become the distinctive construction system of his artwork, which combined the use of precast in situ and cast-in-place elements.

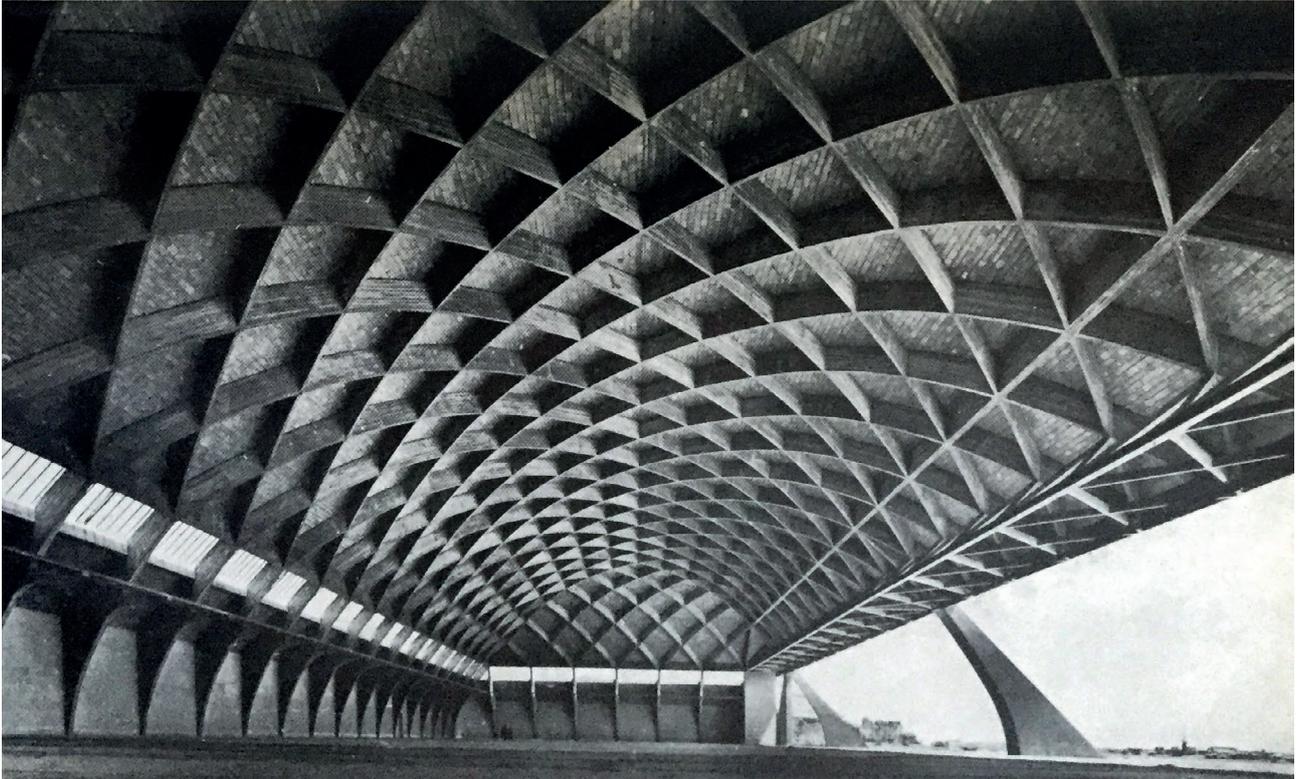
Figure 1 | Structure of the Orvieto hangar. Photographic negative preserved at CSAC Archives in Parma, courtesy of the Pier Luigi Nervi Foundation.

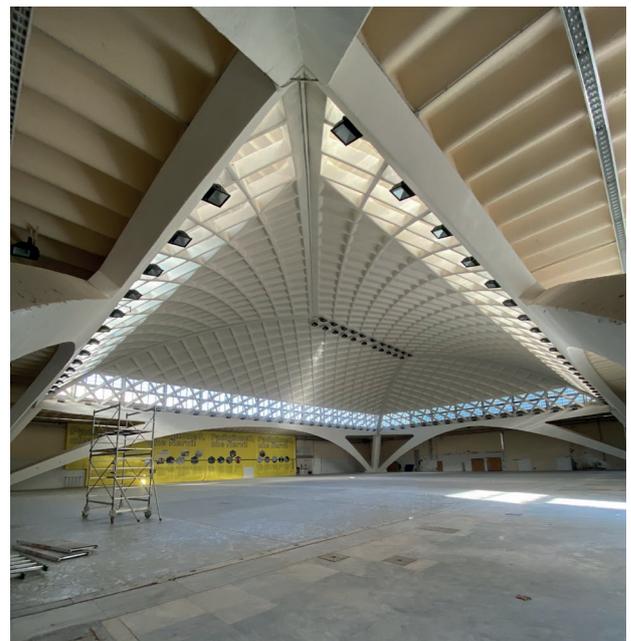
Figure 2 | View of the interior of Hall C, where it is also possible to appreciate the detail of the inclination of the arches supporting the vault and perimeter slabs.

ferrocement corrugated beams (Fig. 2), the insertion of which is useful in correcting the horizontal thrust of the vault. Finally, the inclination of the arches is determined by the resultant of the loads of the various supported elements, corresponding to the sum of the thrust of the arch and the perimeter floors.

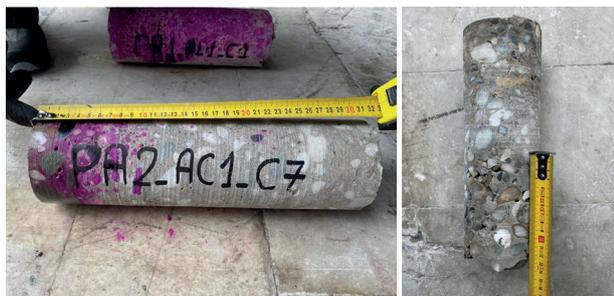
Figure 10 | Sample in the portion of the arch presumably made with Type 680 concrete (on the left), and a sample in the portion of the arch presumably made with Type 500 concrete.

and elastic modulus of concrete and to measure carbonation phenomena. In this case, the sampling was limited mainly to the arch since they are the most monolithic and massive elements in the entire hall, while two other samples were extracted to characterize a beam and a lateral pillar. One of the main objectives in the choice of sample extraction was to identify the presence of the two types of conglomerates hypothesized by Nervi, so core sampling was carried out at the points where this dissimilarity could be appreciated (Fig. 9). On the basis of the extracted samples, it was possible to state, even from visual inspection alone, the presence of different types of concrete, recognizable by the different size and quality of the aggregates found: samples taken from the struts, such as sample PC1\_C5 shown in Fig. 10, generally have a lower quality of aggregates than samples taken from the portions of the arches where Nervi had identified a Type 680 mix, such as sample PA2\_AC1\_C7, shown in Fig. 10.

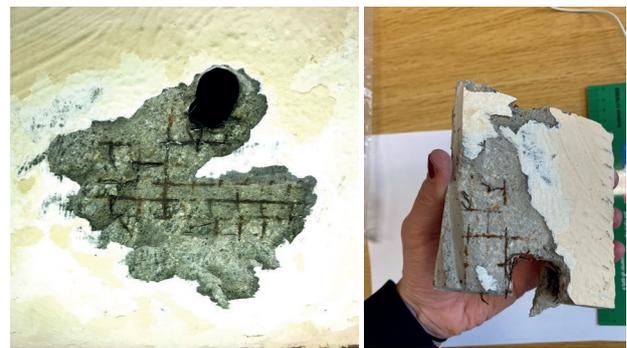
Figure 11 | Sample in the portion of the arch presumably made with Type 680 concrete (on the left), and a sample in the portion of the arch presumably made with Type 500 concrete.

In addition, a specimen of approximately 12 cm×12 cm in size (Fig. 11) was taken to undergo petrographic and physical-chemical analysis for replication. This is due to the extremely small thicknesses of the elements, as well as the fact that substantial portions of the elements would have to be removed to test their mechanical properties. Possible destructive tests on the ferrocements could be carried out through the construction of mock-ups that would be subjected to durability tests and mechanical characterization.
