Understanding the structures of Pier Luigi Nervi: a multidisciplinary approach

Erica Lenticchia¹, Rosario Ceravolo¹, and Paolo Faccio²

Abstract: The paper describes the strategies adopted to carry out the knowledge campaign on Hall C built by Pier Luigi Nervi at Torino Esposizioni, between 1949 and 1950, and belonging to the architectural heritage of the 20th century. The structure was built by combining reinforced concrete and ferrocement elements, thus implementing what for Nervi would later become the distinctive construction system of his artwork, which combined the use of precast in situ and cast-in-place elements.

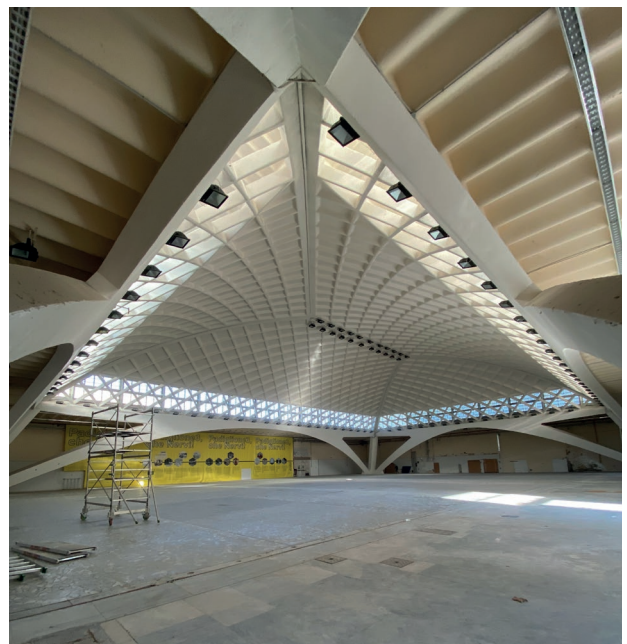
Figure 2 | View of the interior of Hall C, where it is also possible to appreciate the detail of the inclination of the arches supporting the vault and perimeter slabs.

The static scheme of the solution adopted by Nervi is of striking straightforwardness (Nervi, 1950): the four inclined reinforced concrete arches support not only the large vault but also the perimeter slab made of precast

ferrocement corrugated beams (Fig. 2), the insertion of which is useful in correcting the horizontal thrust of the vault. Finally, the inclination of the arches is determined by the resultant of the loads of the various supported elements, corresponding to the sum of the thrust of the arch and the perimeter floors.

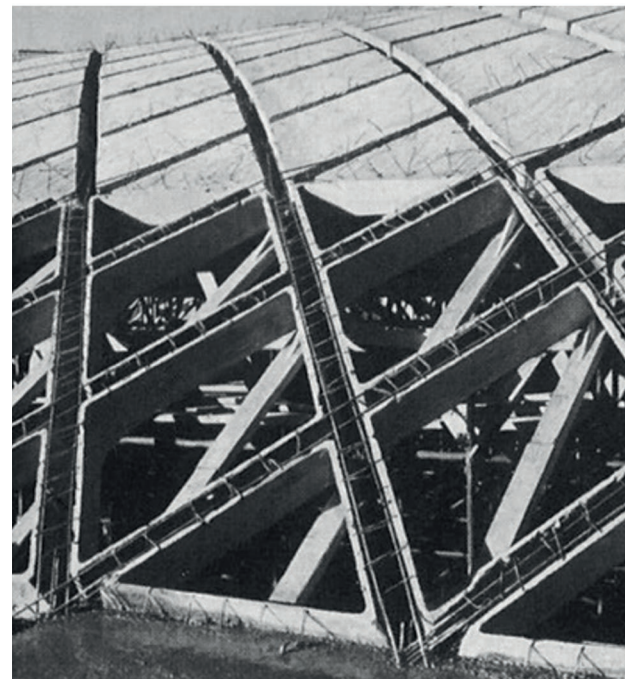
Figure 3 | Detail of the site during the construction phase of the ribbed pavilion vault. In the image it is possible to see the hollows for the casting of the ribs. Università di Firenze, Biblioteca di Scienze Tecnologiche (BST) - Archivi di Architettura, Fondo Pier Luigi Nervi (024-2783).

The pavilion vault is developed on a rectangular plan of 45.8×30.8 m and is characterized by ribs arranged at 45°. The vault was built through the use of prefabricated ferrocement elements, used as a disposable formwork in which to cast the ribs and the roof slab (Fig. 3). In the lower part of the vault, the solid elements leave room for openings to allow natural lighting of the interior.

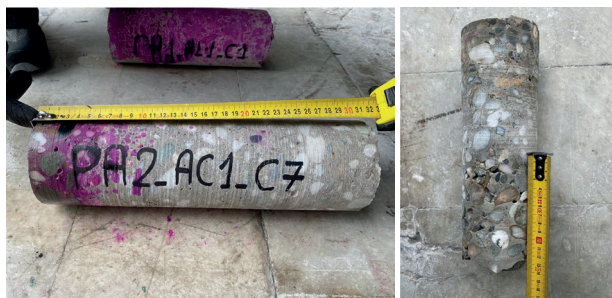
Figure 10 | Sample in the portion of the arch presumably made with Type 680 concrete (on the left), and a sample in the portion of the arch presumably made with Type 500 concrete.

and elastic modulus of concrete and to measure carbonation phenomena. In this case, the sampling was limited mainly to the arch since they are the most monolithic and massive elements in the entire hall, while two other samples were extracted to characterize a beam and a lateral pillar. One of the main objectives in the choice of sample extraction was to identify the presence of the two types of conglomerates hypothesized by Nervi, so core sampling was carried out at the points where this dissimilarity could be appreciated (Fig. 9). On the basis of the extracted samples, it was possible to state, even from visual inspection alone, the presence of different types of concrete, recognizable by the different size and quality of the aggregates found: samples taken from the struts, such as sample PC1_C5 shown in Fig. 10, generally have a lower quality of aggregates than samples taken from the portions of the arches where Nervi had identified a Type 680 mix, such as sample PA2_AC1_C7, shown in Fig. 10.

Tests were performed on all extracted samples to determine the depth of carbonation using the phenolphthalein method. Overall, in the case of the elements of the arches, the depth of carbonation was either zero or with a minimal advance front (less than the concrete cover). The element with a higher carbonation level was found in the sample extracted from a perimeter pillar. The results of these tests are in accordance with what was found with the corrosion test results.
