The timber roof structure of Chapel XVI at Sacro Monte of Orta: an example of conservative strengthening work

THE TIMBER ROOF STRUCTURE OF CHAPEL XVI AT SACRO MONTE OF ORTA: AN EXAMPLE OF CONSERVATIVE STRENGTHENING WORK

Marco Zerbinatti, Alessandro Grazzini, Sara Fasana, Giovanni Vercelli

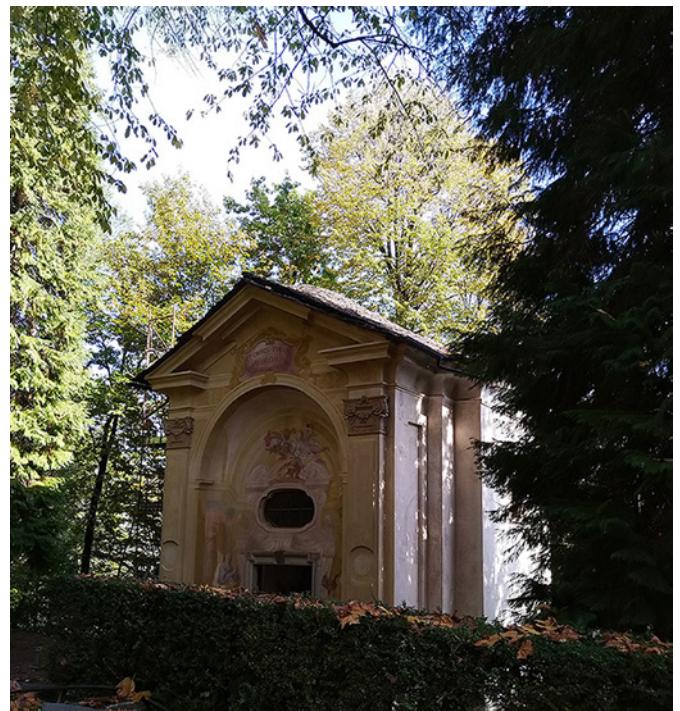
Fig. 1. The XVI Chapel at the Sacro Monte di Orta.

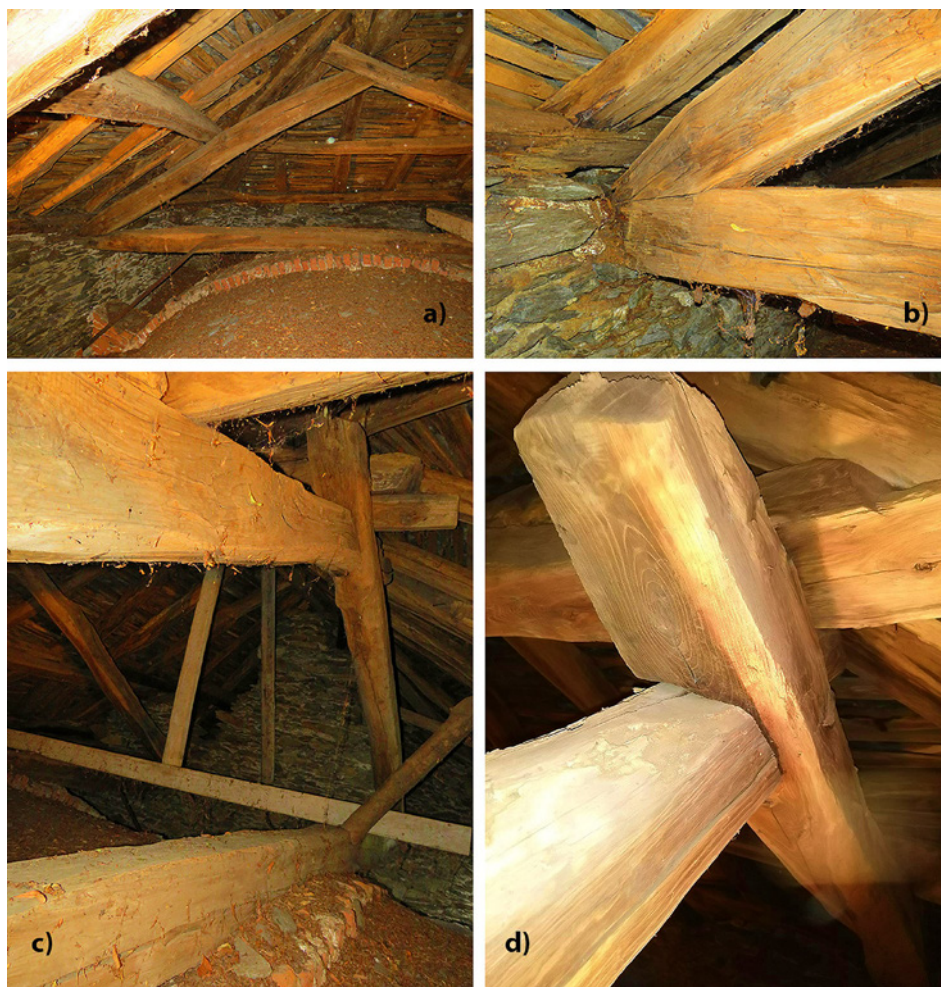
Both trusses are made up of timber tie beams, section 20 cm x 20 cm, resting on the East and West walls and timber rafters of a similar section (Fig. 5a). The connections of the rafters on the tie beams are arranged as common practice, with the support surface oriented according to the bisector of the angle of incidence (Fig. 5b). It should be noted that the tie beams of the trusses have metal elements inserted into the masonry walls and connected to anchoring brackets on the external sides, thus

forming a metallic tie of the ribs of the masonry vault (Fig. 5a). Both tie beams rest on the extrados of the vaults and are slightly curved (deformation just under 10 cm), with the supports at lower altitudes than the center lines (Fig. 5c). The top of the rafters has a *half-lap* coupling connection, therefore without the presence of the classic connection by the king post, with both rafters continuing in the complete section beyond the coupling area (Fig. 5d). The North truss has the supporting section of the tie beam totally degraded, corresponding on the East side (Fig. 5b), with a partial impairment of the coupling surface of the corresponding rafter. The South truss has conditions of partial degradation of the tie beam in the middle section and at the East final part. The East rafter presents conditions of partial deterioration in the top portion. The trusses support a quay beam on the fork generated by the crossing of the rafters (Fig. 5d). This beam is made up of the overlap of two beams in order to reach the correct support level for the cantonal beams and the

Fig. 5. (a) North truss; (b) detail of the tie beam-rafter connection, in evident degradation inside the masonry support; (c) tie beam rests on the extrados of the vaults; (d) detail of a half-lap coupling connection.

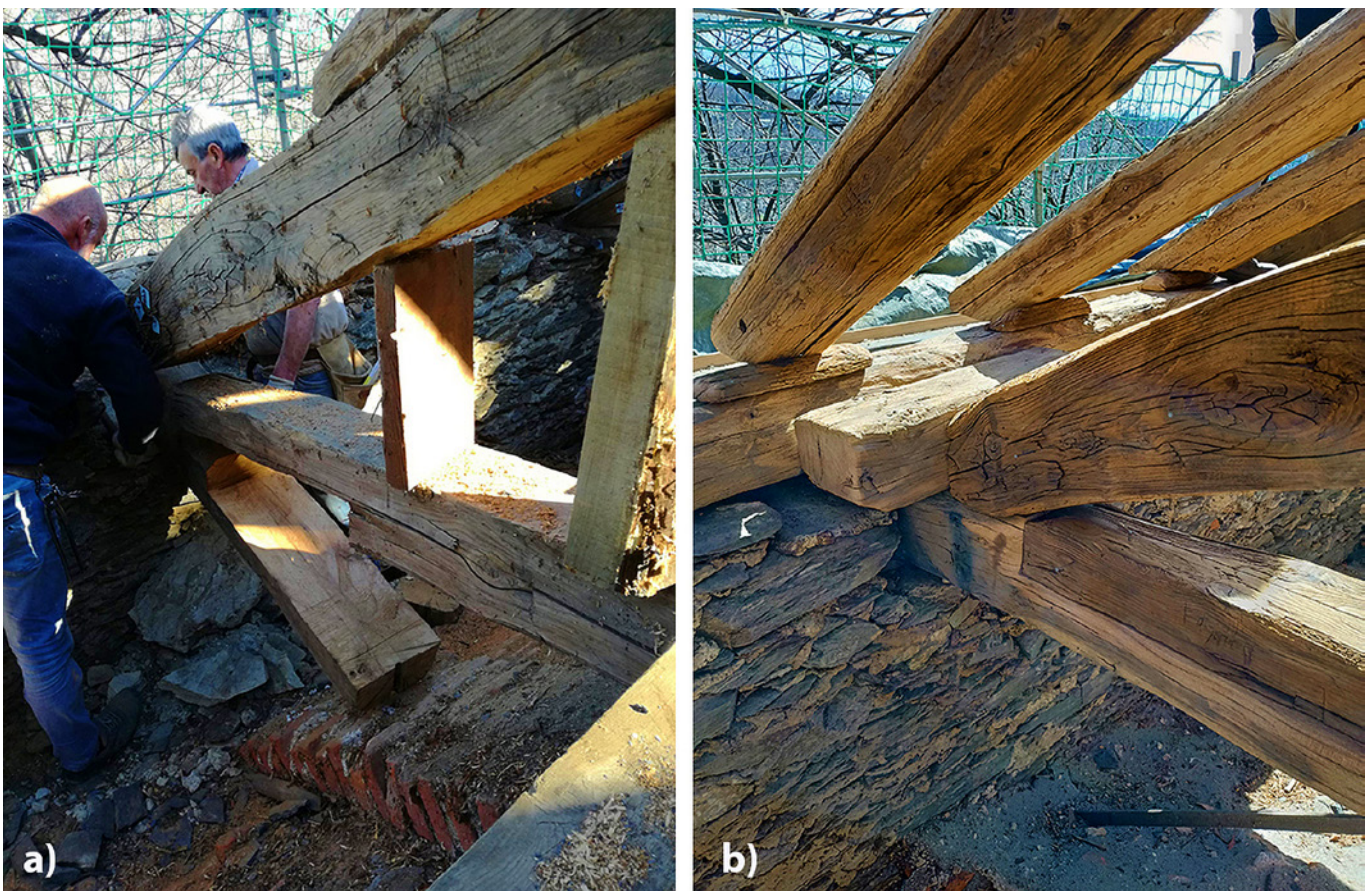
Fig. 9. (a) Positioning of the timber prosthesis; (b) the timber-timber prosthesis performed.

Also, it has been planned to replace all quay beams on the North, East, and South slopes and the angular elements, preserving the quay beam incorporated in the West masonry while still ensuring the connection with the new elements of the other layers. The replacement of the quay beams took place by the slight lifting of the minor rafters acting in such a way as not to unbalance the entire structure, prop it up and fan it to ensure the stability of the whole. Moreover was planned to replace the ridge beam and add two cross beams parallel to the same beam, creating a frame/scheme with a more precise structural concept. The supporting knot of the South truss, compromised by the material degradation, was reinforced with a conservative solution by means of timber-wood prosthesis inserted in contrast with clamping screws, without resorting to epoxy resin prosthesis of undoubted/unproven compatibility (Fig.

9). The main connection was made with screws passing from the extrados rafter to the intrados of the tie beam and between the integrative transverse element and the tie beam.

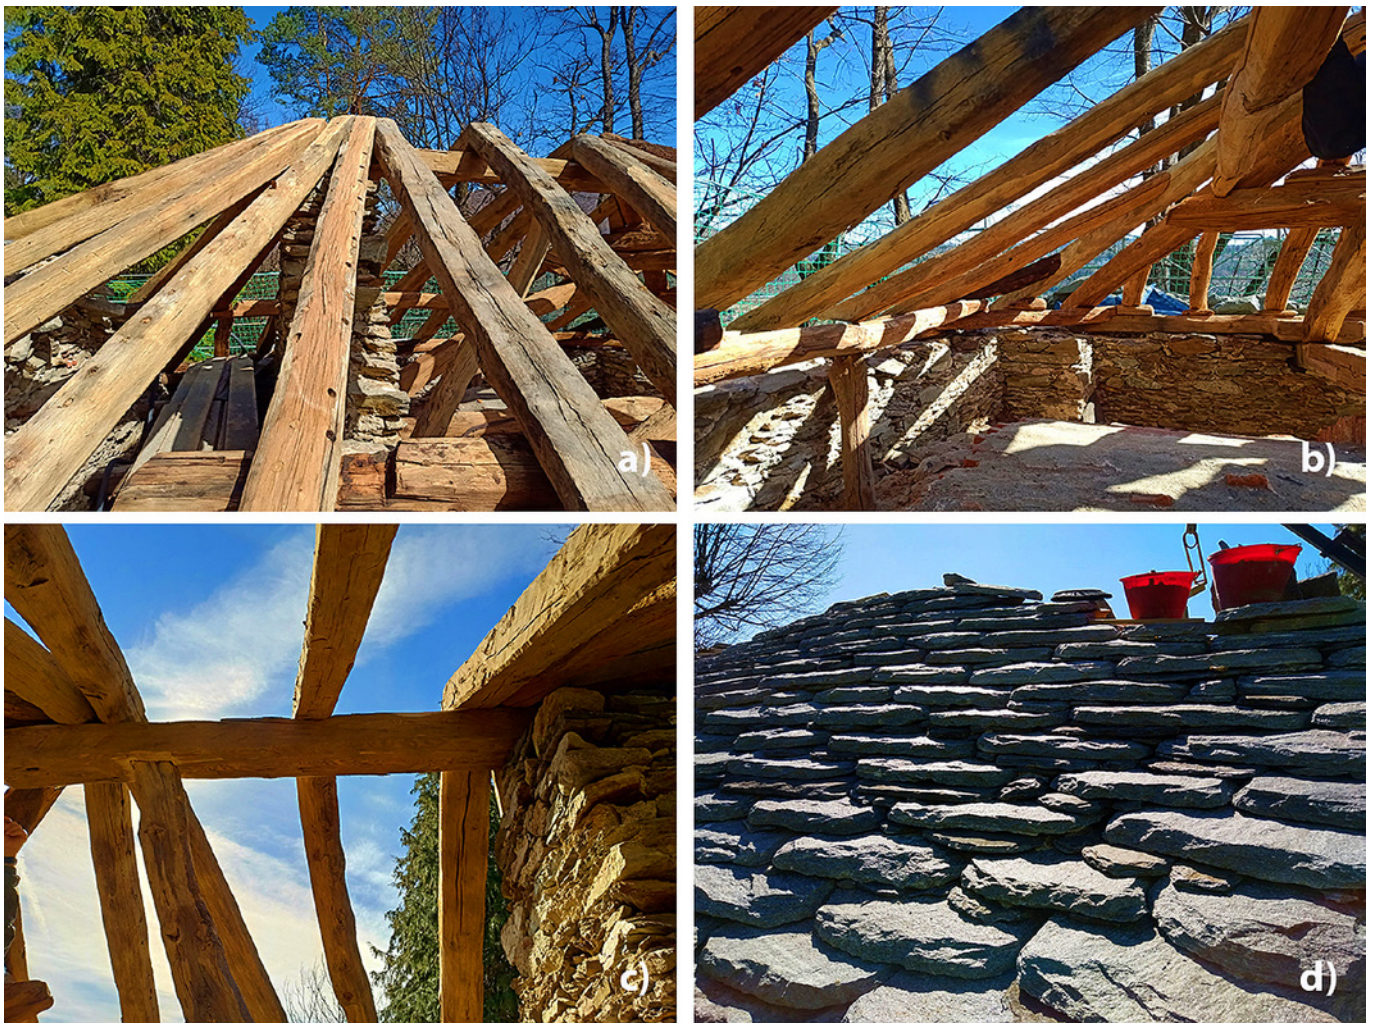
Fig. 10. (a) Placement of new timber elements alongside the original ones cleaned up; (b) integration of the new quay beams into the original structural scheme; (c) cleaning and static improvement of the area around the ridge beam; (d) reconstruction of the original stone roof covering.

During disassembly, the timber elements were separated by distinguishing elements in good conservation conditions from degraded elements to be eliminated (Fig. 10a). The separation of the elements was submitted to the Work Director for approval. The direction of the work was carried out by eng. Giovanni Vercelli, with the support of the technicians of the Ente di Gestione dei Sacri Monti. Recoverable elements have been cleaned and treated to improve their conservation (Fig. 10b, c). During the repositioning phase, the timber elements were remodeled in order to adapt to the geometry of the bearing structure, alternating the recovery elements with the replacement elements in chestnut wood (Fig. 10a, b).

The existing stone roof covering has been relocated following the traditional construction techniques (Fig. 10d), replacing the minor support degraded elements and adapting to the new stone slabs.
