The timber roof structure of Chapel XVI at Sacro Monte of Orta: an example of conservative strengthening work

The timber roof structure of Chapel XVI at Sacro Monte of Orta: an example of conservative strengthening work / Zerbinatti, Marco; Grazzini, Alessandro; Fasana, Sara; Vercelli, Giovanni. - In: TEMA. - ISSN 2421-4574. - ELETTRONICO. - 8:Special Issue(2022), pp. 42-52. [10.30682/tema08Slp]

THE TIMBER ROOF STRUCTURE OF CHAPEL XVI AT SACRO MONTE OF ORTA: AN EXAMPLE OF CONSERVATIVE STRENGTHENING WORK

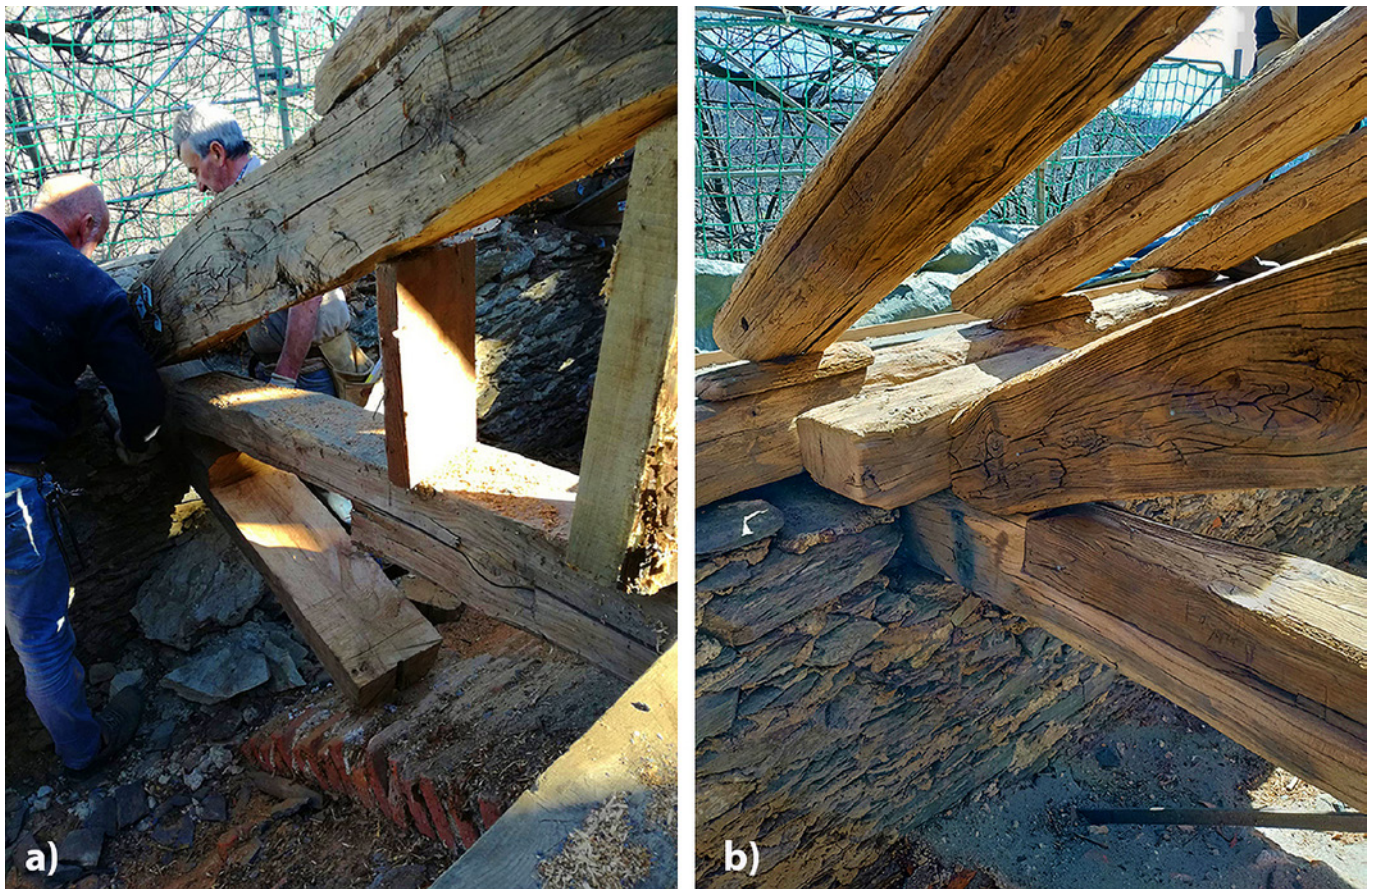
Fig. 9. (a) Positioning of the timber prosthesis; (b) the timber-timber prosthesis performed.

Also, it has been planned to replace all quay beams on the North, East, and South slopes and the angular elements, preserving the quay beam incorporated in the West masonry while still ensuring the connection with the new elements of the other layers. The replacement of the quay beams took place by the slight lifting of the minor rafters acting in such a way as not to unbalance the entire structure, prop it up and fan it to ensure the stability of the whole. Moreover was planned to replace the ridge beam and add two cross beams parallel to the same beam, creating a frame/scheme with a more precise structural concept. The supporting knot of the South truss, compromised by the material degradation, was reinforced with a conservative solution by means of timber-wood prosthesis inserted in contrast with clamping screws, without resorting to epoxy resin prosthesis of undoubted/unproven compatibility (Fig.

9). The main connection was made with screws passing from the extrados rafter to the intrados of the tie beam and between the integrative transverse element and the tie beam.

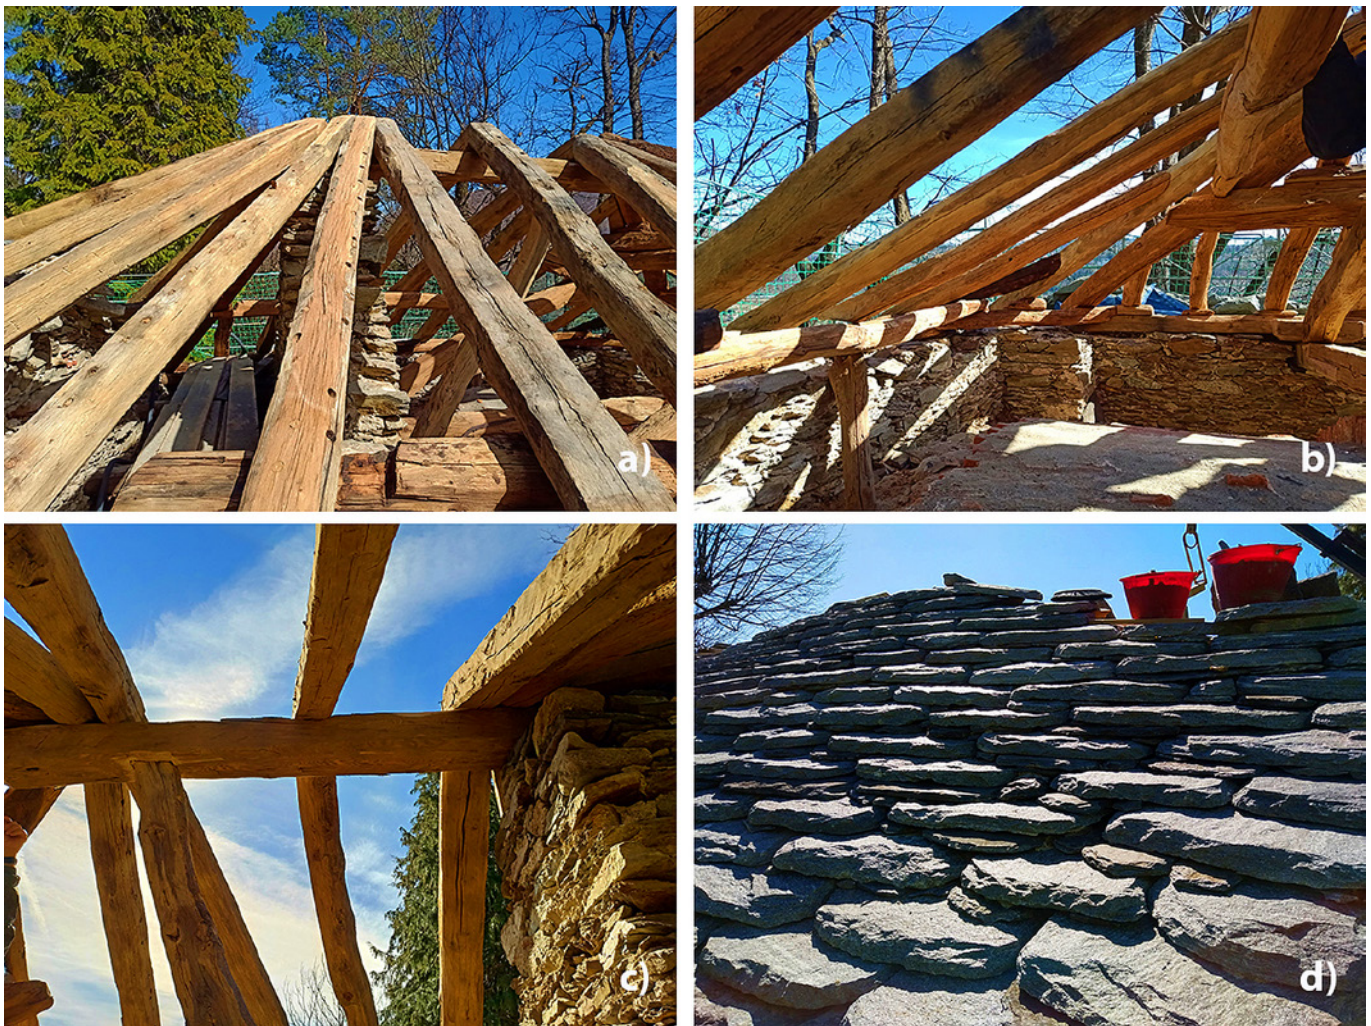
Fig. 10. (a) Placement of new timber elements alongside the original ones cleaned up; (b) integration of the new quay beams into the original structural scheme; (c) cleaning and static improvement of the area around the ridge beam; (d) reconstruction of the original stone roof covering.

During disassembly, the timber elements were separated by distinguishing elements in good conservation conditions from degraded elements to be eliminated (Fig. 10a). The separation of the elements was submitted to the Work Director for approval. The direction of the work was carried out by eng. Giovanni Vercelli, with the support of the technicians of the Ente di Gestione dei Sacri Monti. Recoverable elements have been cleaned and treated to improve their conservation (Fig. 10b, c). During the repositioning phase, the timber elements were remodeled in order to adapt to the geometry of the bearing structure, alternating the recovery elements with the replacement elements in chestnut wood (Fig. 10a, b).

The existing stone roof covering has been relocated following the traditional construction techniques (Fig. 10d), replacing the minor support degraded elements and adapting to the new stone slabs.
