Performance of historical ferrocement specimens subjected to corrosive environments

Performance of historical ferrocement specimens subjected to corrosive environments / Lenticchia, Erica; Sorrentino, Gerardo; Ceravolo, Rosario; Tondolo, Francesco. - In: STRUCTURAL CONCRETE. - ISSN 1464-4177. - (2024).
[10.1002/suco.202400579]

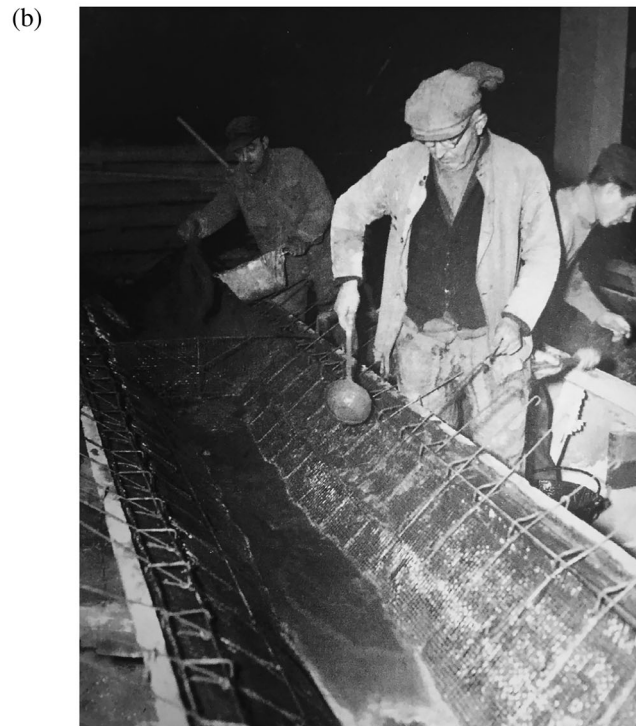
FIGURE 2 (a) Illustration of construction details related to ferrocement corrugated beams.³⁰ It is possible to appreciate the number of the wire mesh layers and the variations in thickness in the cross section. (b) Prefabrication on site of the undulated beams in ferrocement (1949–1950).¹⁷

The corrugated beam consisted of a precise combination of reinforcement, with wire mesh and high-quality cement mortar. Its cross-sectional area was not constant but increased from the outside inward towards the arches, where it reached its maximum size (Figure 2a). The element was 0.94 m wide, 9.5 m long, as mentioned

before, and with a height ranging from 0.26 to 0.44 m at the highest part. It is a modular element with remarkable strength characteristics, despite its slight thickness (2–4 cm). From the original design, the internal reinforcement of the corrugated beam in Hall C consisted of three layers of wire mesh weighing 0.600 kg/m^2 , both above and below the ordinary reinforcement, to form the characteristic curved shape^{25,27,30} (Figure 2b).

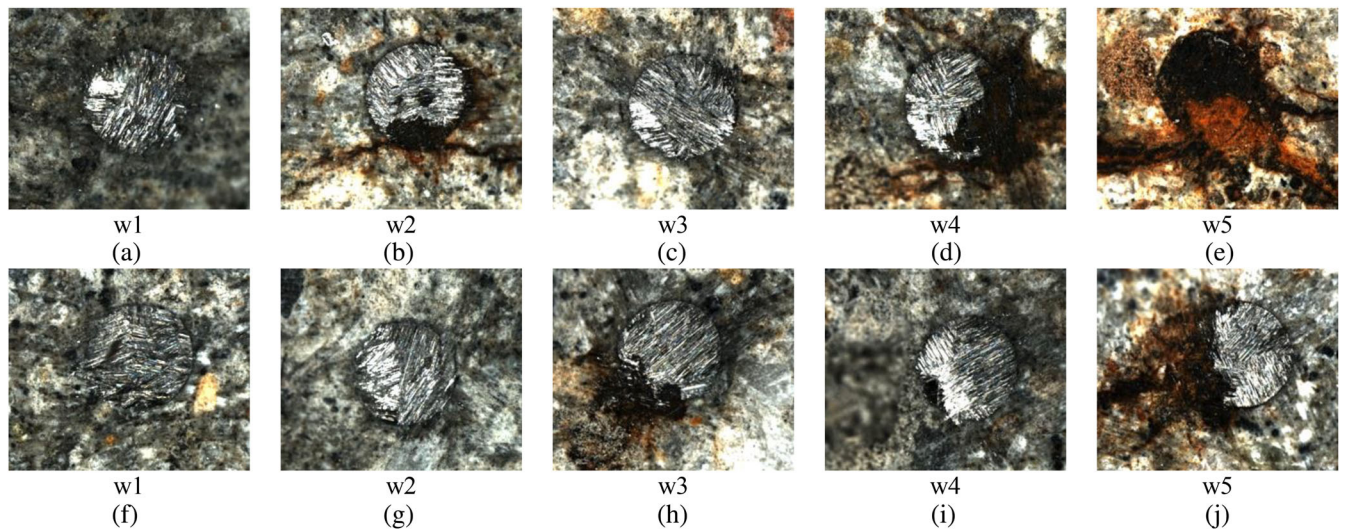
FIGURE 17 Photographic acquisitions of the corrosion state of wires of sample Aged_02 (a–e) and the painted and aged sample (f–j), by means of the optical microscope (magnification 5×).

The corrosion was then measured for each wire of the first layer of mesh (highlighted in red in Figure 16c), which was the one closest to the surface exposed to the aging action of the chlorides. Figure 17 shows the photographic acquisition of the corrosion state of the wires of sample Aged_02 and the sample Aged and painted. Corrosion was detected in all samples, besides the different levels of seriousness in the different wires, ranging from no corrosion (e.g., Figure 17a,c, f,g,h) to the total corrosion of the area (Figure 17e). Results of the measurements of the cross-sectional corrosion-loss of the wires of each sample are reported in Table 8, while Figure 18 shows a detail of the measuring on a wire.
