Roughness and SEM Analysis of Manual and Ultrasonic Instrumentation over Different Crown Materials for Dental Implants Restorations

Abstract: The use of new prosthetic materials makes it necessary to establish adequate hygienic protocols. It was decided to make prosthetic crowns from four different materials: composite, lithium disilicate, metal ceramic, and zirconium, and to evaluate the effects on the surfaces of four different instruments through SEM and roughness analysis: manual steel curette, manual titanium curette, ultrasonic steel insert, and ultrasonic peek insert. Forty crowns were made, ten of each type of material. For each material, five crowns were manually instrumented with steel inserts (curette 11-12, PDT, Missoula, USA) and titanium (Wingrove 3-4, PDT, Missoula, USA) on the lingual and buccal surfaces, respectively, and the other five crowns were instrumented with an ultrasonic peek insert (ICS-IC1, Mectron, Carasco, Italy) on the buccal surface and steel (PS, EMS, Nyon, Switzerland) on the lingual surface. At this point, surface roughness analysis was carried out. The data were analyzed with a Kolmogorov–Smirnov test. Therefore, it was decided to conduct two an

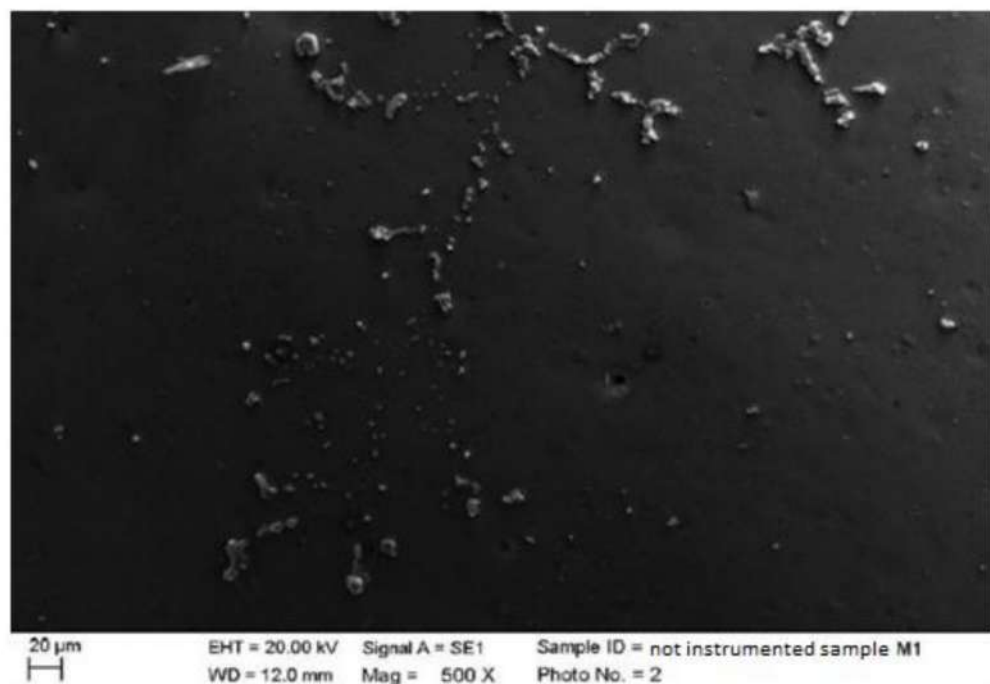
Figure 4. Non-instrumented ceramic sample M1 (500×).

As for the elements made of ceramic material with a metal substructure, we could see, in an increasingly defined manner as the magnification increased (500×), residues from the processing of the material itself. In particular, the residues incorporated within the structure of the material were visible to the maximum degree (2000×) as if they were covered by a thin film. There were also small depressions, which confirmed that the ceramic material was a hard but, at the same time, fragile material (Figure 4).

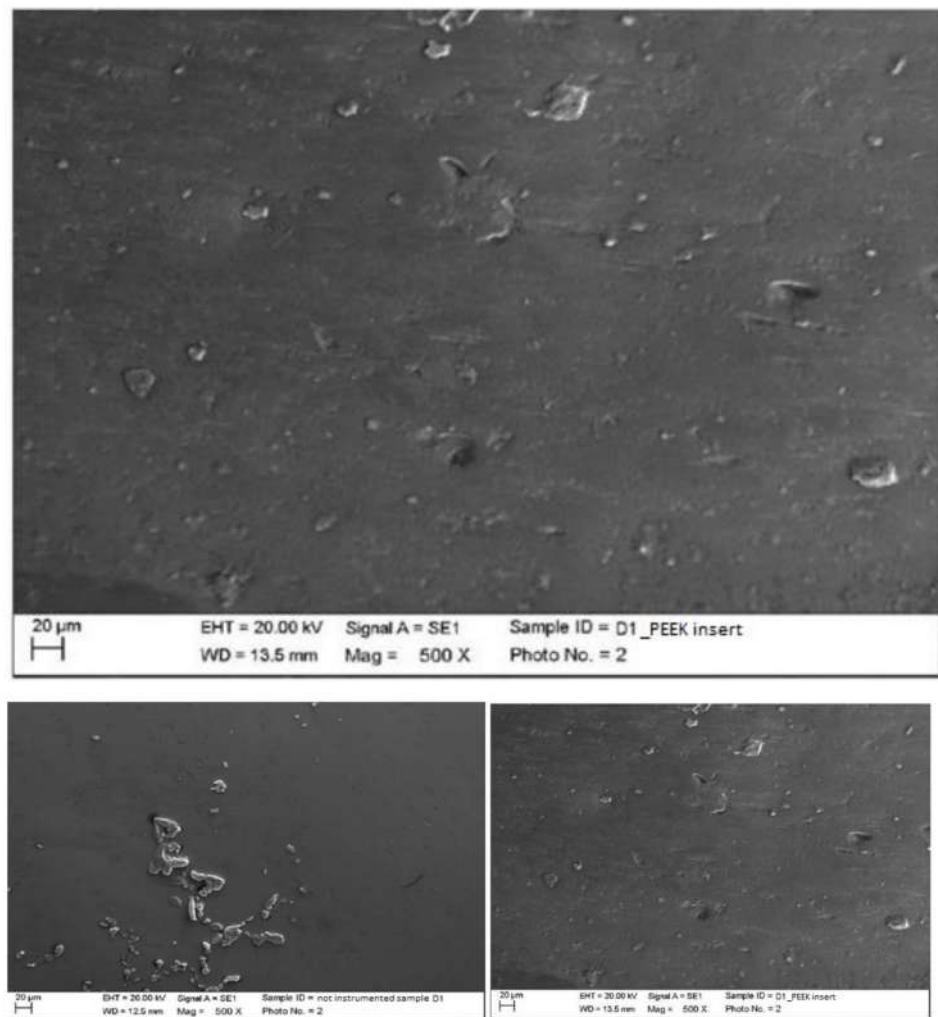
Figure 11. Instrumented disilicate sample D1 with peek insert (500×). Comparison before/after instrumentation.

The peek created major alterations on the surface of the lithium disilicate. In fact, the dendritic formations (or primary crystals) representing the origin of the material were clearly visible, exposed precisely following the instrumentation of the surface itself. However, it was not possible with surface analysis to establish whether the formations were abraded disilicate or residual peek; to verify this, chemical–physical analysis of the surface should be carried out. A photo was taken at 3800 magnification, where it is possible to see in detail the areas from which the crystals were formed (Figure 11).

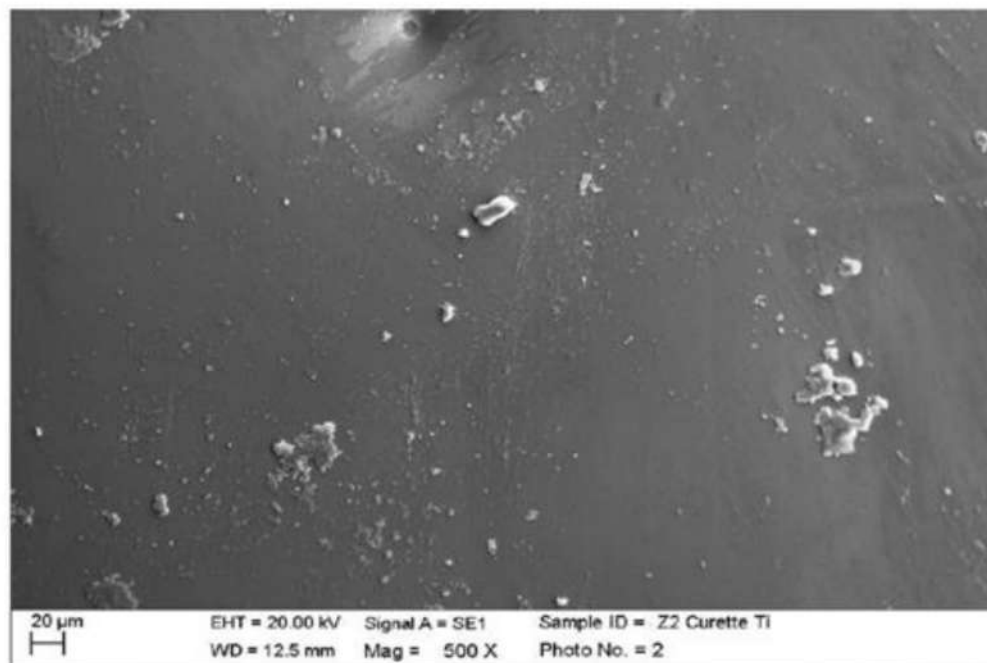
Figure 21. Instrumented zirconium sample Z2 with titanium curette (500 \times).

Instrumented zirconium with titanium curette (Wingrove 3-4, PDT, Missoula, MT, USA). The titanium curette created slight superficial incisions visible at higher magnifications, leaving few processing residues. On the left side of the enlargement, 2000 super-surface residues from finishing were still visible (Figure 21).
