Roughness and SEM Analysis of Manual and Ultrasonic Instrumentation over Different Crown Materials for Dental Implants Restorations

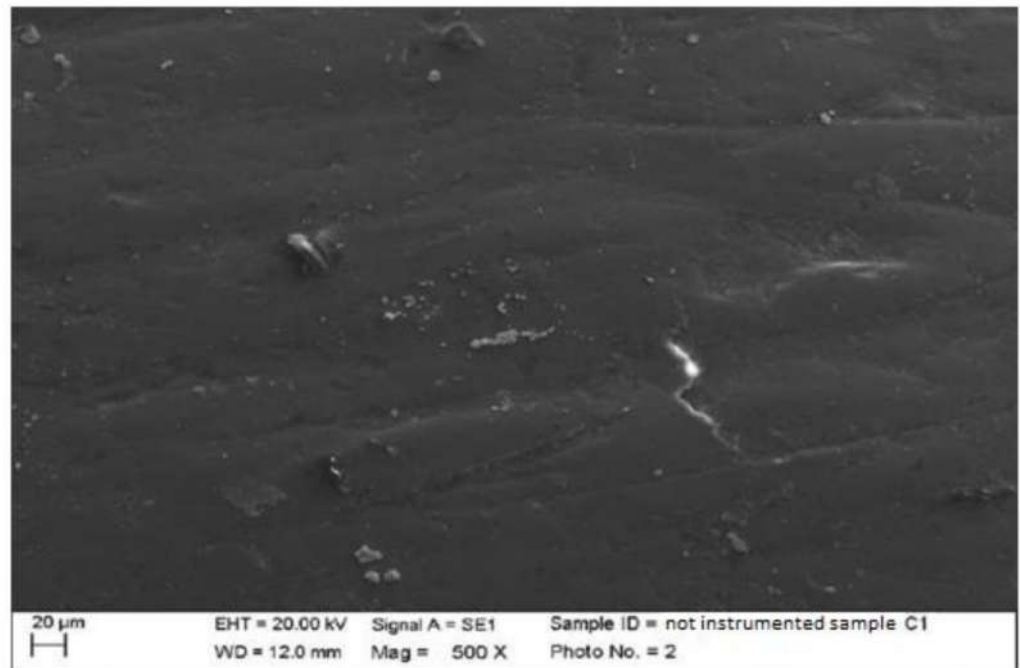
Figure 1. Non-instrumented composite sample C1 (500×).

There were processing residues on the composite, but to a lesser extent than on the ceramic, as can be seen in the following images. Some streaks and concavities with clear edges that represent the irregularity of the surface of the prosthetic element were clearly visible in the highest magnifications ($500\times$, $2000\times$) (Figure 1). In the second sample, it is possible to notice at the $500\times$ magnification the presence of slight surface incisions caused by the tools used for the final polishing of the composite element (Figure 2).

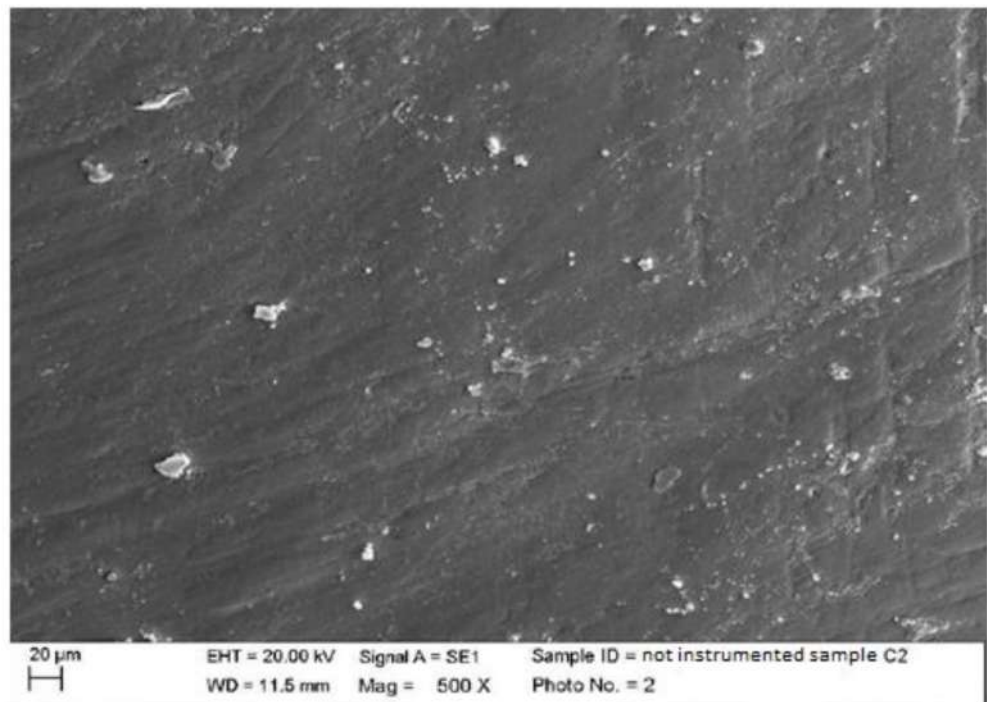
Figure 2. Non-instrumented composite sample C2 (500×).

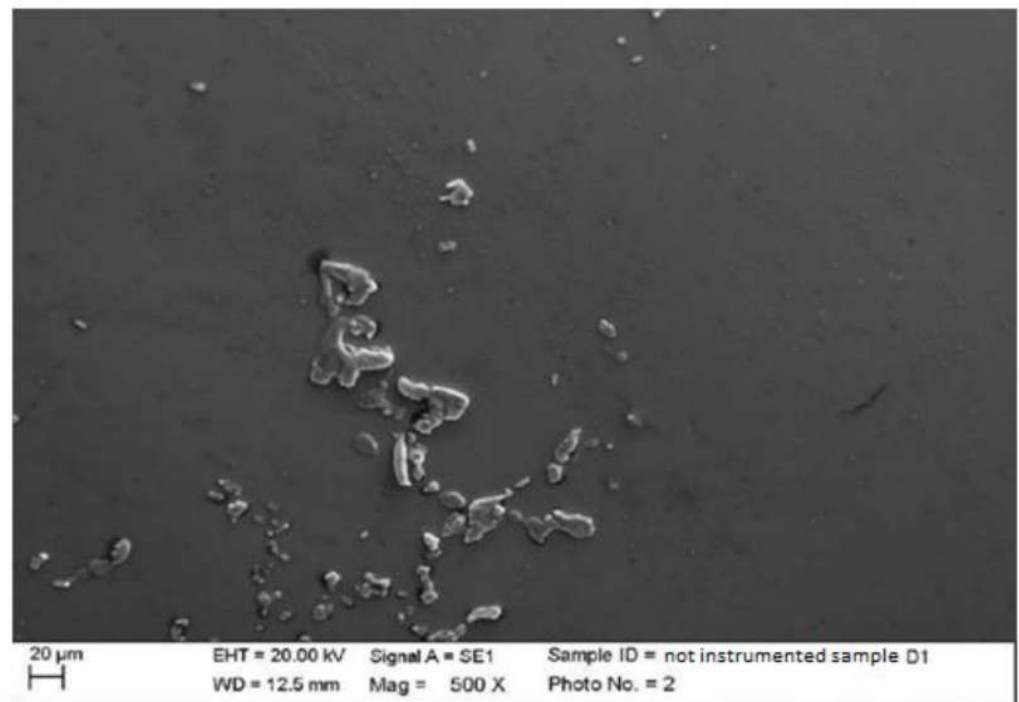
Figure 3. Non-instrumented disilicate sample D1 (500×).

The surface of the lithium disilicate had a very smooth appearance. Processing residues, especially subsurface, were present, but in smaller quantities than the other materials; however, the dimensions of the individual particles were larger (Figure 3).

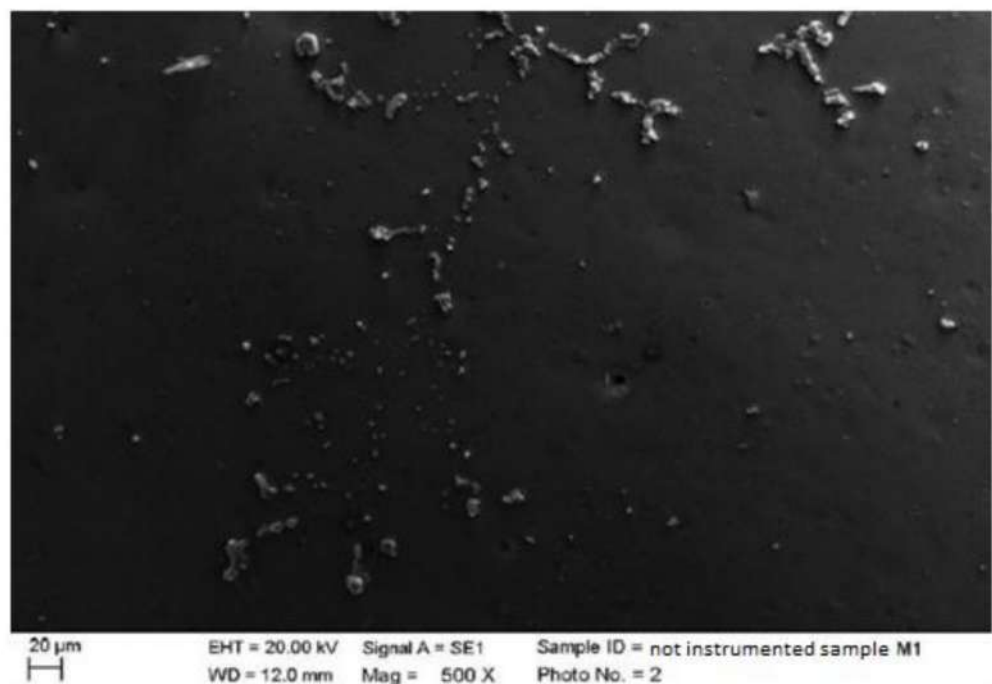
Figure 4. Non-instrumented ceramic sample M1 (500×).

As for the elements made of ceramic material with a metal substructure, we could see, in an increasingly defined manner as the magnification increased (500×), residues from the processing of the material itself. In particular, the residues incorporated within the structure of the material were visible to the maximum degree (2000×) as if they were covered by a thin film. There were also small depressions, which confirmed that the ceramic material was a hard but, at the same time, fragile material (Figure 4).

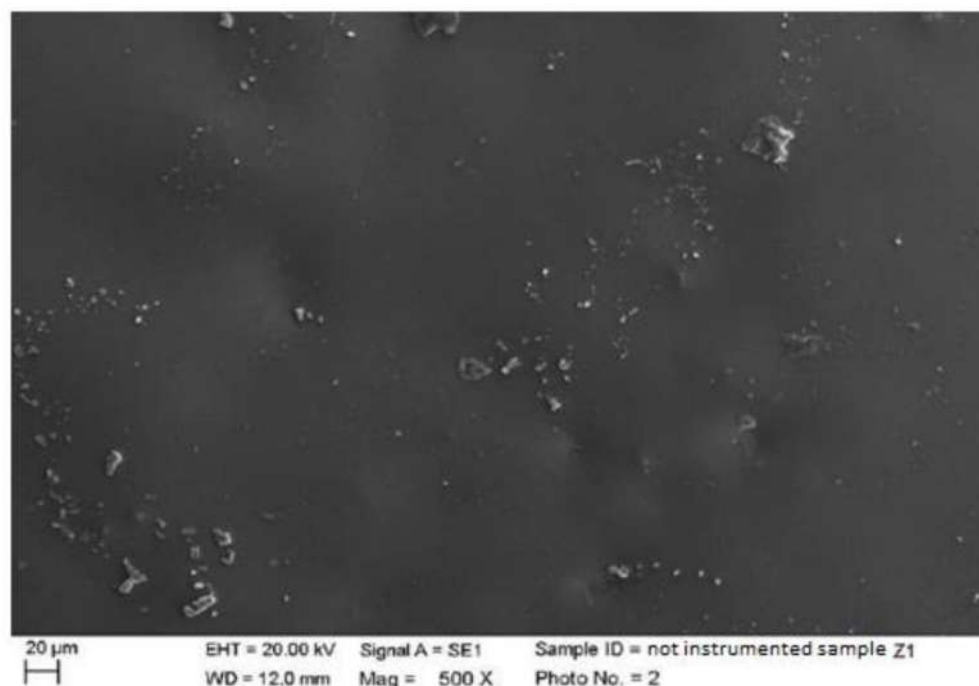
Figure 5. Non-instrumented zirconium sample Z1 (500 \times).

Zirconium, similar to lithium disilicate, had a surface with few processing residues of rather large dimensions. Similar to ceramic, on the other hand, it had a fracture area with clear edges caused by the finishing process of the element and determined by the greater hardness of this material (Figure 5).

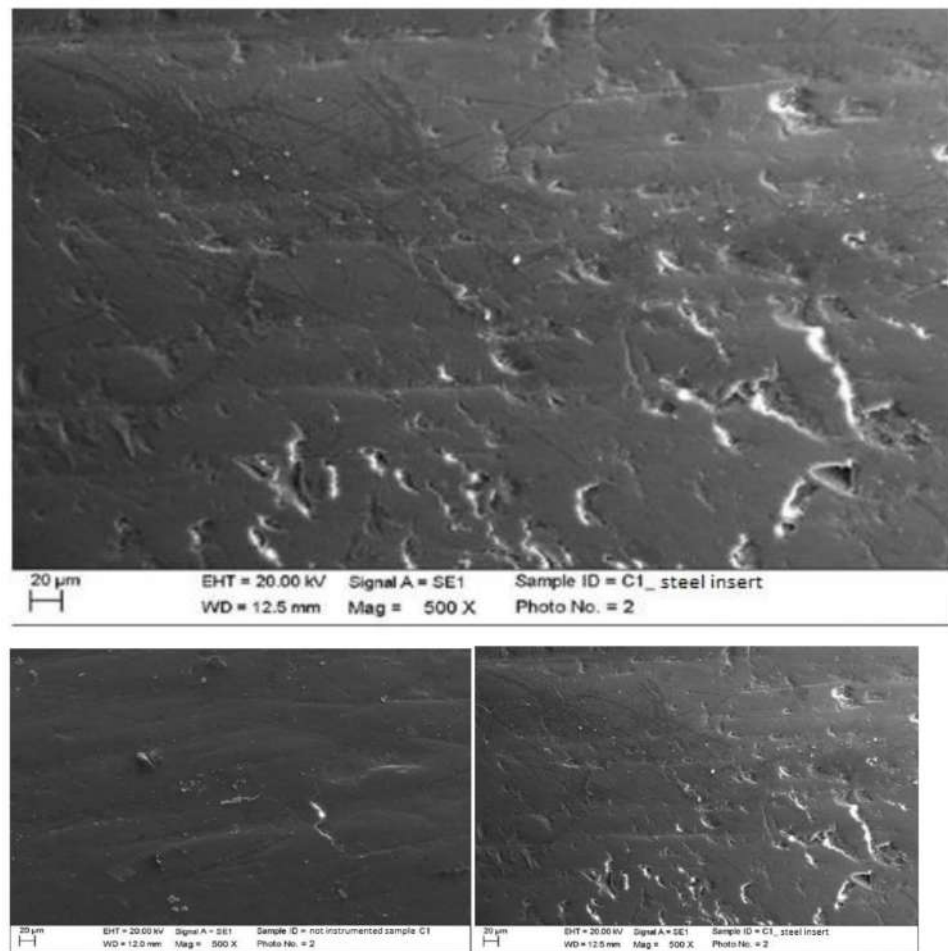
Figure 6. Instrumented composite sample C1 with steel insert (500×). Comparison before/after instrumentation.

Instrumented composite with steel insert (PS, EMS, Nyon, Switzerland) mounted on Mini Piezon ultrasonic motor (EMS, Nyon, Switzerland).

The classic insert created light linear scratches on the surface without leaving accumulations of steel. The other irregularities were not due to the instrumentation, but to the finishing treatment of the material. Surface processing residues were removed from the treatment (Figure 6).

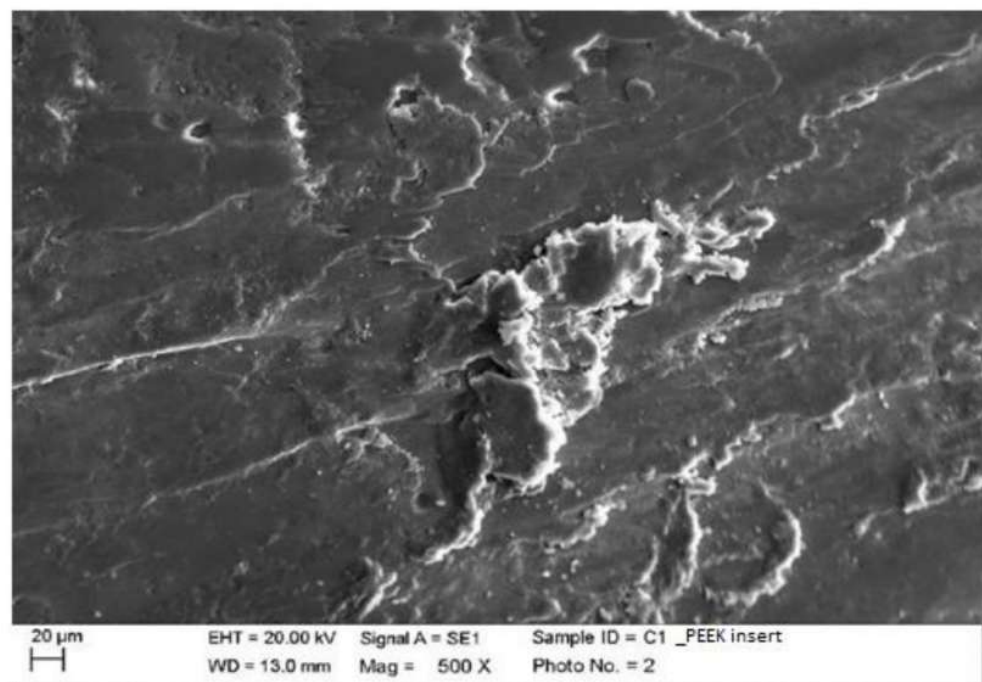
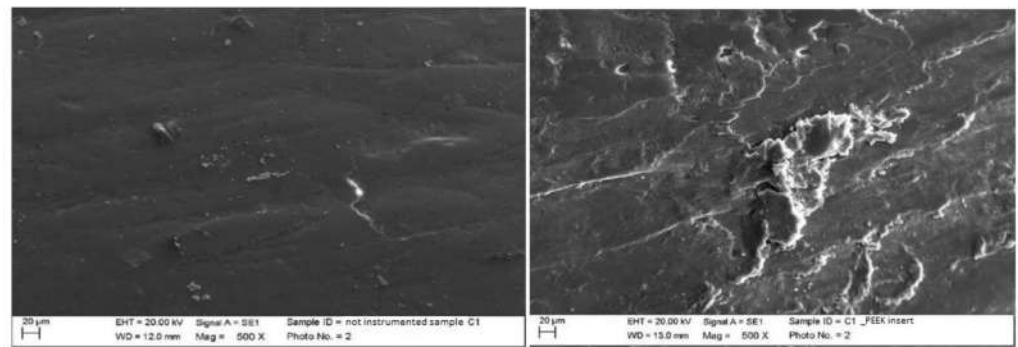
Figure 7. Instrumented composite sample C1 with peek insert (500 \times). Comparison before/after instrumentation.

Instrumented composite with peek insert (ICS-IC1, Mectron, Carasco, Italy) mounted on MultiPiezo ultrasonic motor (Mectron, Carasco, Italy).

The peek on the composite material created important alterations by partially removing processing residues. The smaller residues were completely removed, but some surface irregularities remained. However, with the simple surface analysis, we could not define whether the alterations were due to etching or the deposition of the instrumentation material (Figure 7).

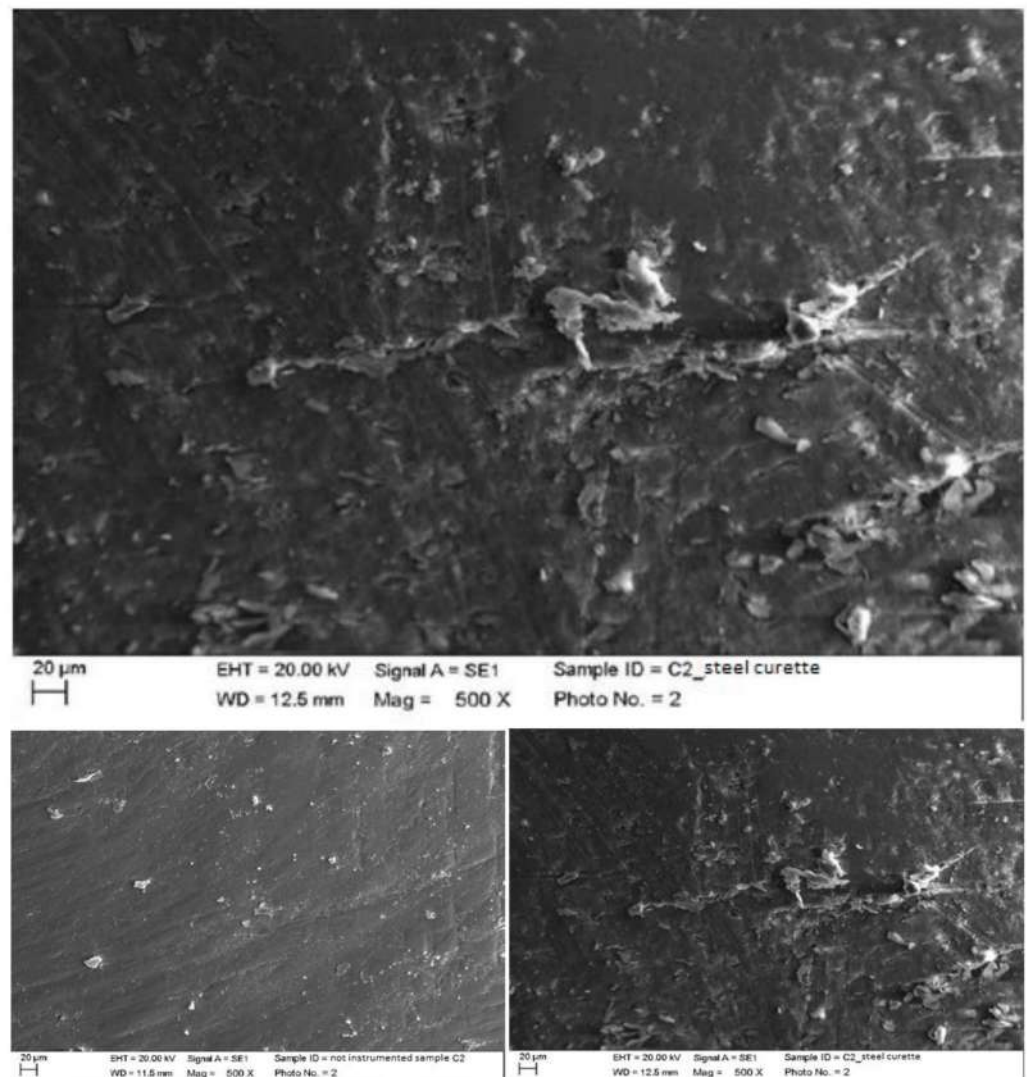
Figure 8. Instrumented composite sample C2 with steel curette (500 \times). Comparison before/after instrumentation.

Instrumented composite with steel curette (PDT, Missoula, MT, USA).

The classic curette did not create important alterations to the surface of the material; it removed some residues, but left others (Figure 8).

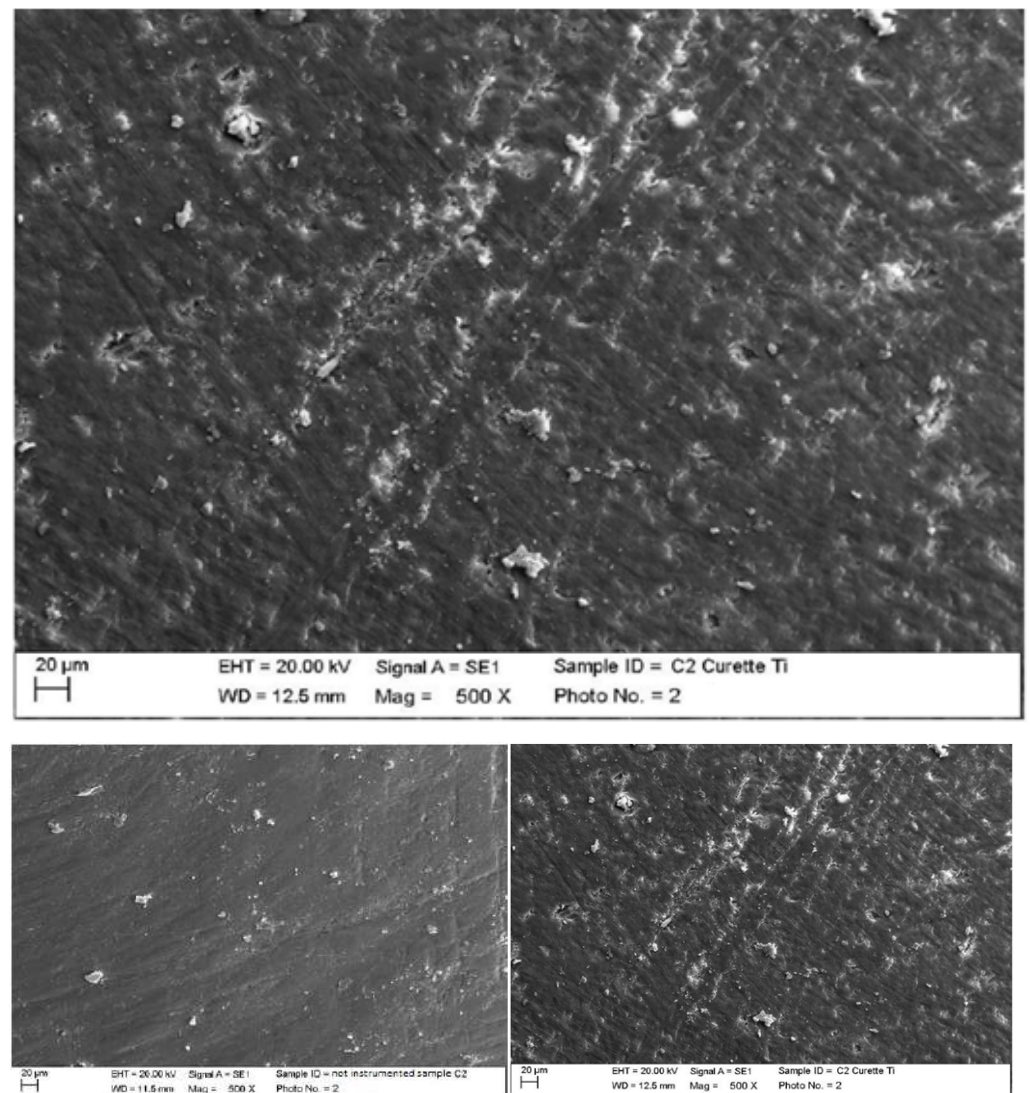
Figure 9. Instrumented composite sample C2 with titanium curette (500 \times). Comparison before/after instrumentation.

Instrumented composite with titanium curette (Wingrove 3-4, PDT, Missoula, MT, USA). The titanium curette created deeper incisions than the classic curette, completely removing finishing residues (Figure 9).

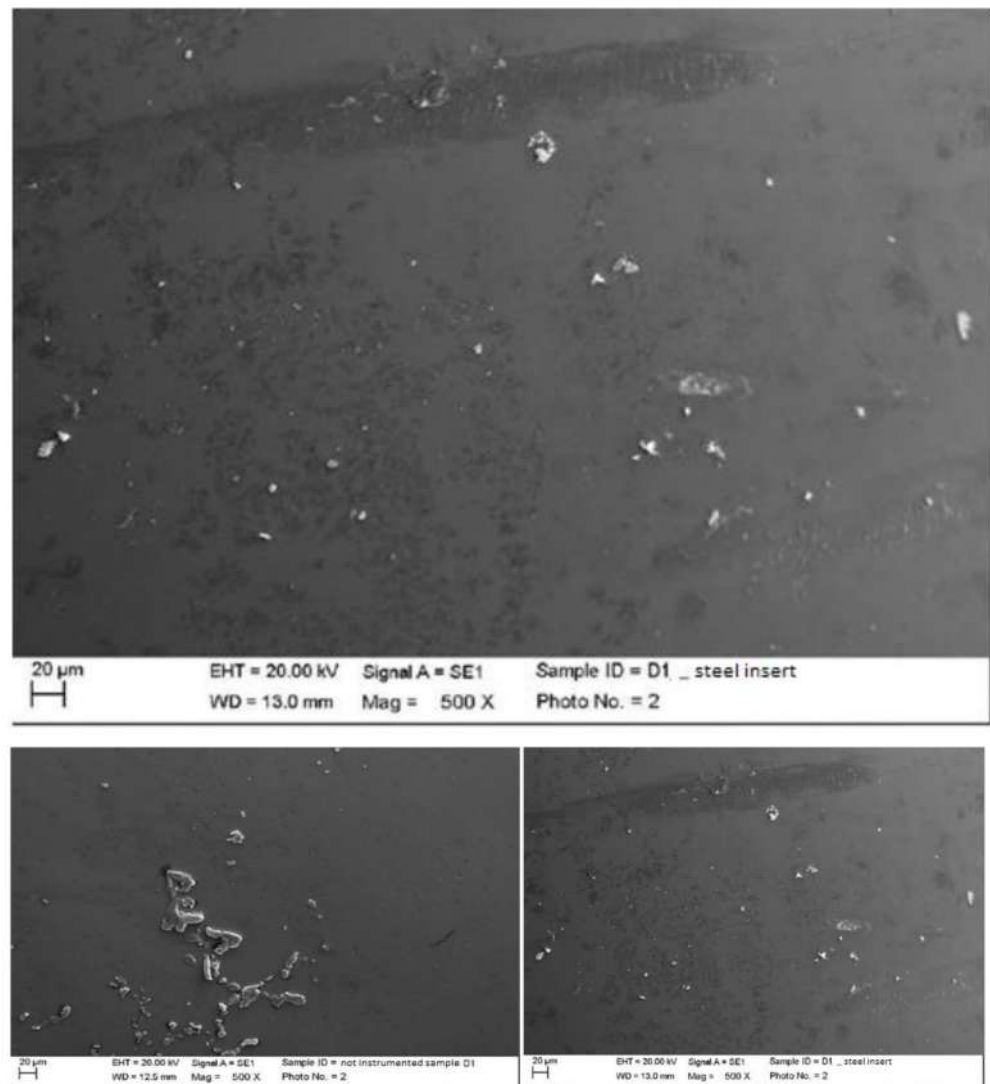
Figure 10. Instrumented disilicate sample D1 with steel insert (500×). Comparison before/after instrumentation.

Instrumented disilicate with classic steel insert (PS, EMS, Nyon, Switzerland) mounted on Mini Piezon ultrasonic motor (EMS, Nyon, Switzerland).

The classic insert did not particularly alter the disilicate, also leaving processing residues, which was probably due to the fact that the residues themselves were larger than the other materials. There were slight scratches on the surface visible only at large magnifications (Figure 10).

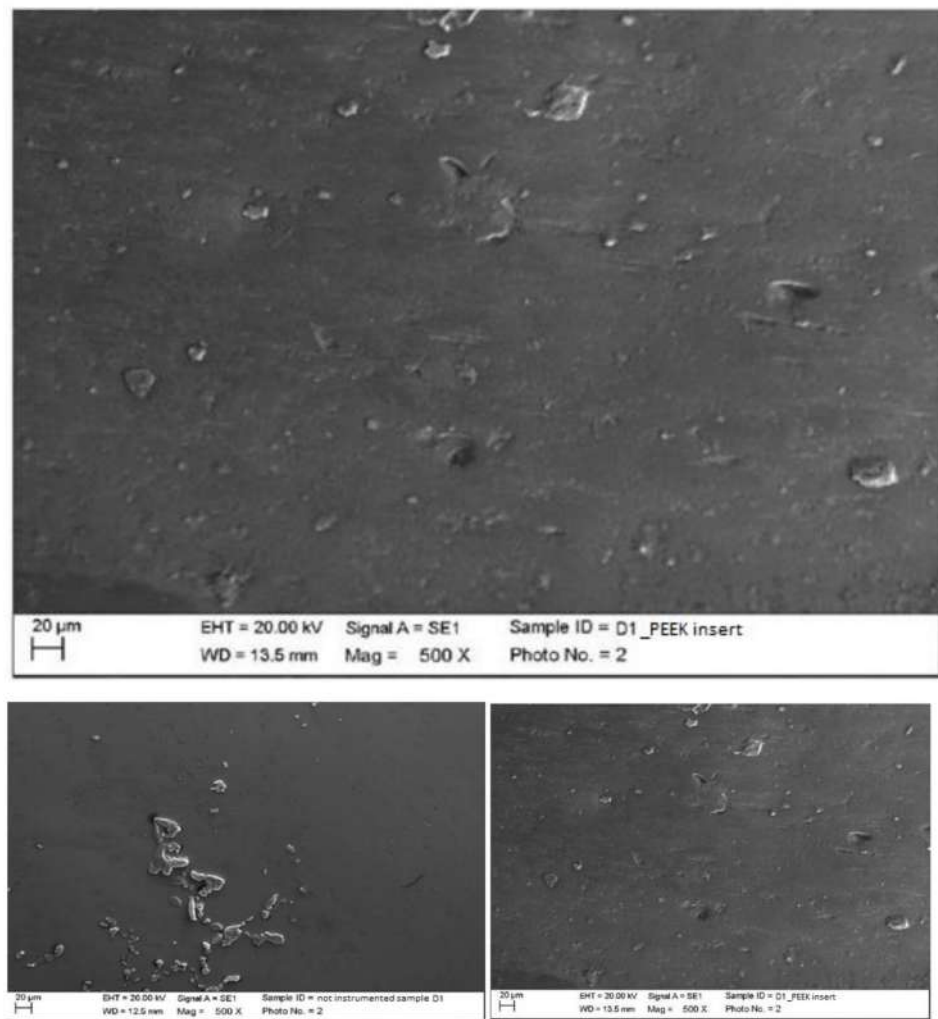
Figure 11. Instrumented disilicate sample D1 with peek insert (500×). Comparison before/after instrumentation.

The peek created major alterations on the surface of the lithium disilicate. In fact, the dendritic formations (or primary crystals) representing the origin of the material were clearly visible, exposed precisely following the instrumentation of the surface itself. However, it was not possible with surface analysis to establish whether the formations were abraded disilicate or residual peek; to verify this, chemical–physical analysis of the surface should be carried out. A photo was taken at 3800 magnification, where it is possible to see in detail the areas from which the crystals were formed (Figure 11).

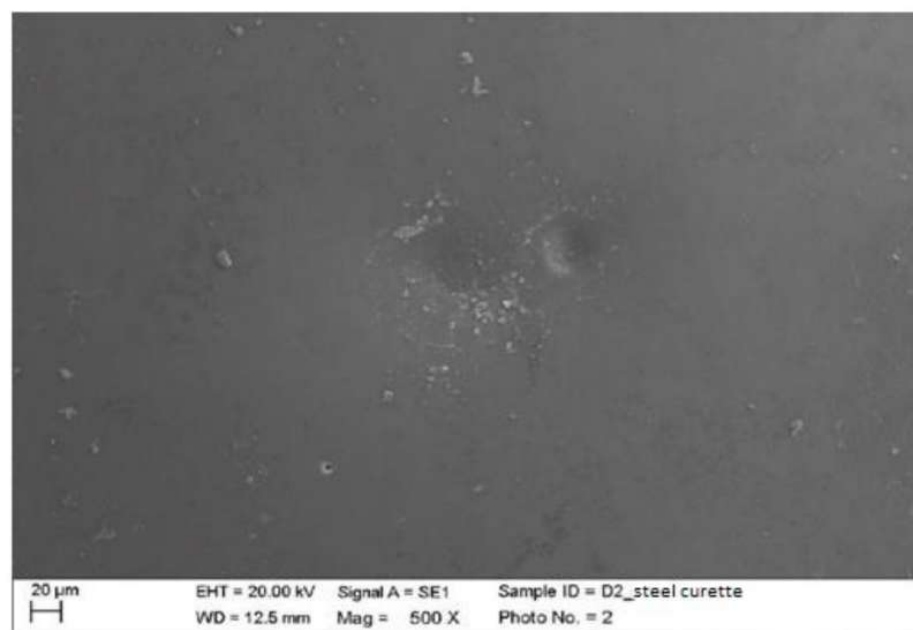
Figure 12. Instrumented disilicate sample D2 with steel curette (500×).

Instrumented disilicate with steel curette (PDT, Missoula, MT, USA).

The classic curette created almost no effect on the disilicate, other than the slight accumulation of the instrumentation materials (Figure 12).

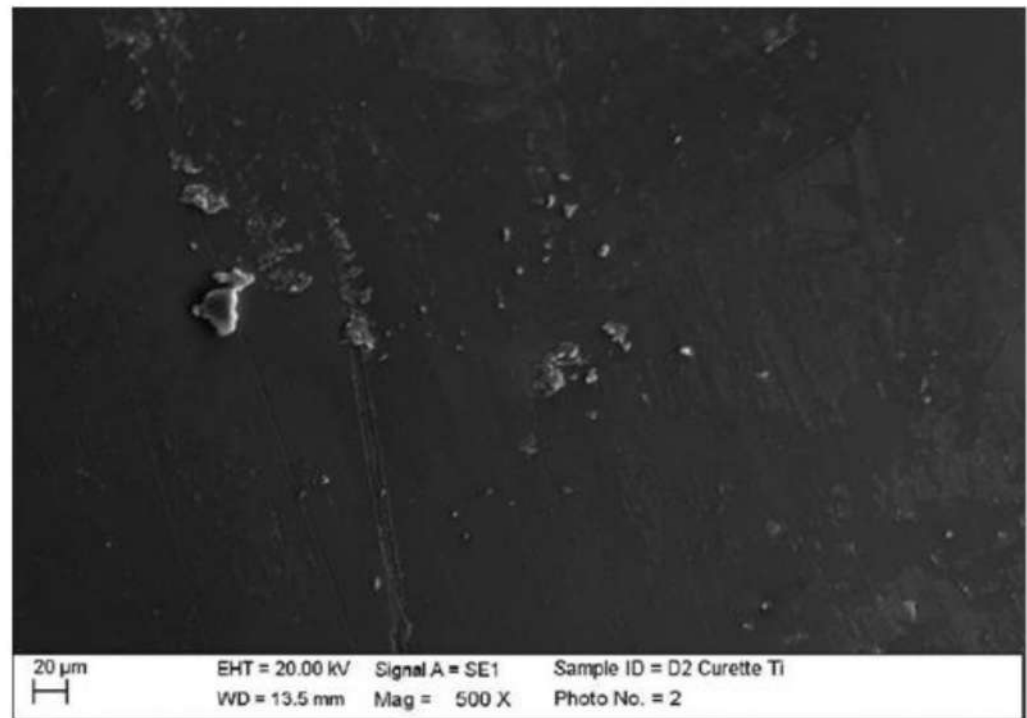
Figure 13. Instrumented disilicate sample D2 with titanium curette (500×).

Instrumented disilicate with titanium curette (Wingrove 3-4, PDT, Missoula, MT, USA).

The titanium curette created important and deep surface incisions while leaving instrumentation residues embedded within the grooves, which could be partly titanium pieces and partly pieces of silicone residues (Figure 13).

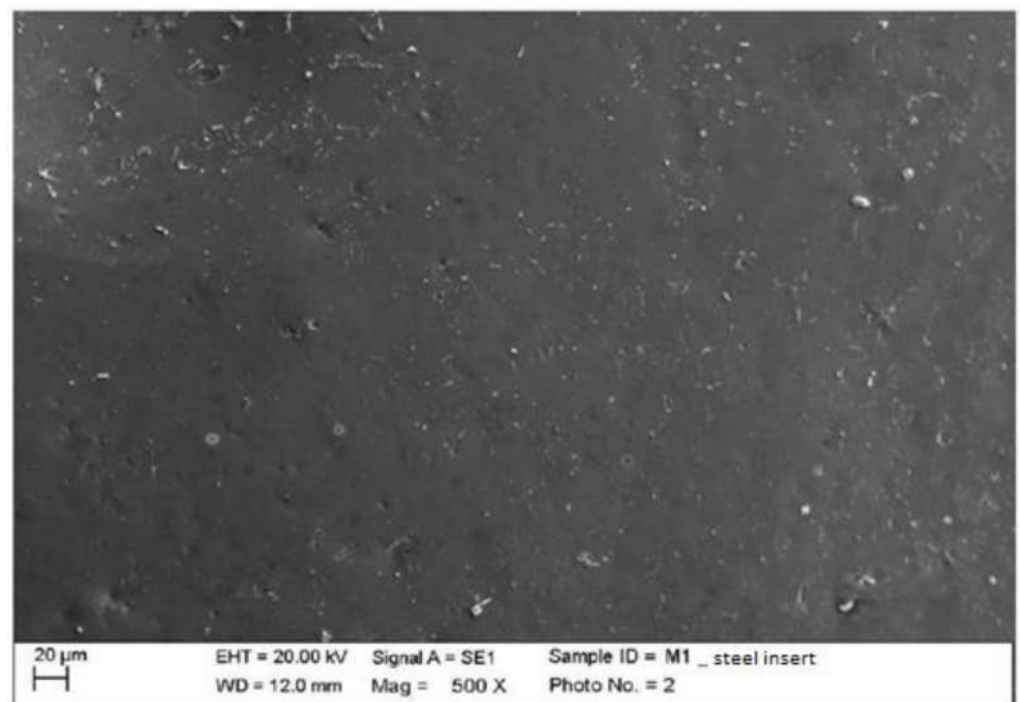
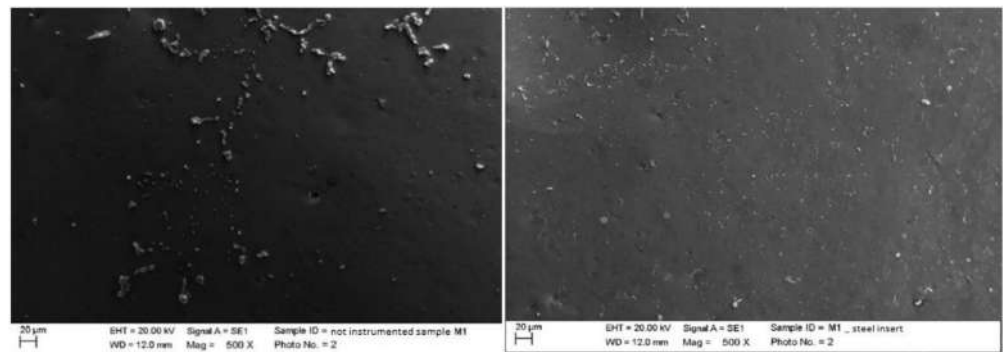
Figure 14. Instrumented ceramic sample M1 with steel insert (500 \times). Comparison before/after instrumentation.

Instrumented ceramic with steel insert (PS, EMS, Nyon, Switzerland) mounted on Mini Piezon ultrasonic motor (EMS, Nyon, Switzerland).

The classic insert eliminated finishing residues by replacing them with other instrumentation residues. The elimination of residues was clearly visible at the higher magnification, which was comparable to a thin flaking film (Figure 14).

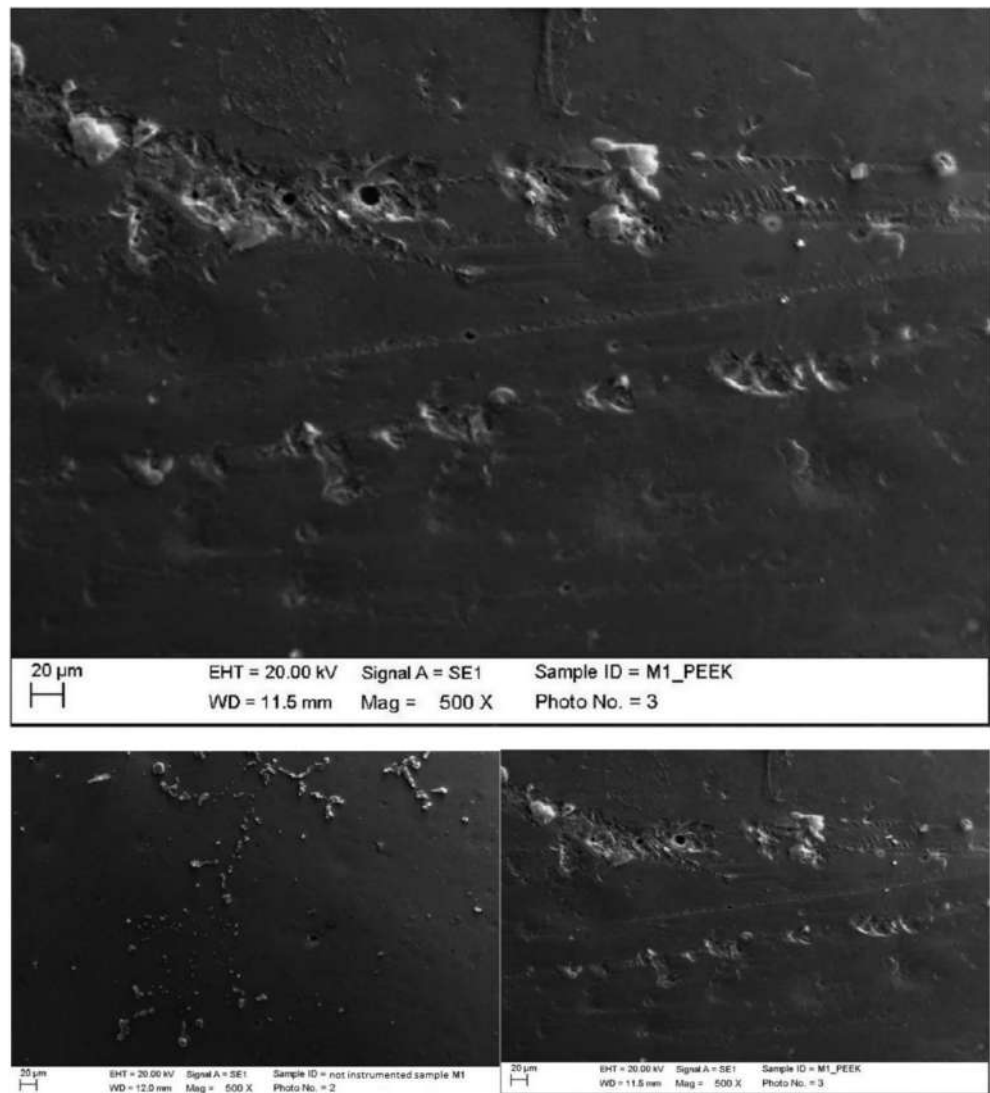
Figure 15. Instrumented ceramic sample M1 with peek insert (500 \times). Comparison before/after instrumentation.

Instrumented ceramic with peek insert (ICS-IC1, Mectron, Carasco, Italy) mounted on ultrasonic motor, MultiPiezo (Mectron, Carasco, Italy).

The peek on the ceramic created horizontal and vertical alterations, but it was again not possible to establish the origin of these changes (Figure 15).

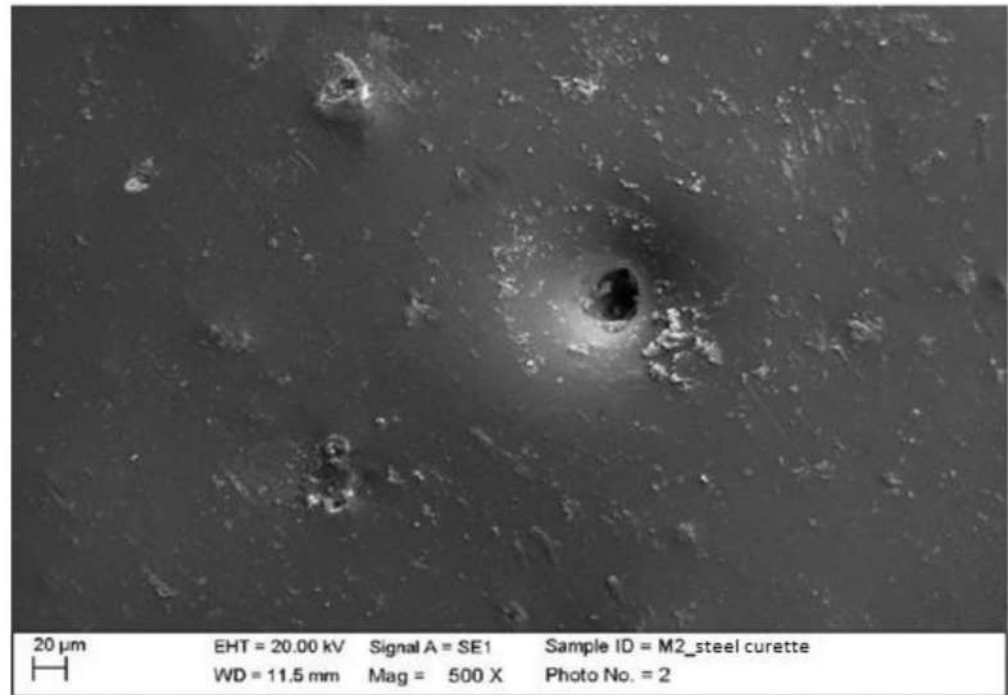
Figure 16. Instrumented ceramic sample M2 with steel curette (500×).

Instrumented ceramic with steel curette (PDT, Missoula, MT, USA).

The classic curette, being ceramic, a very hard material, hardly created any negative effects on the surface. The crater visible in photo X was due to the ceramic material itself, which was hard and brittle, but was not related to manual instrumentation (Figure 16).

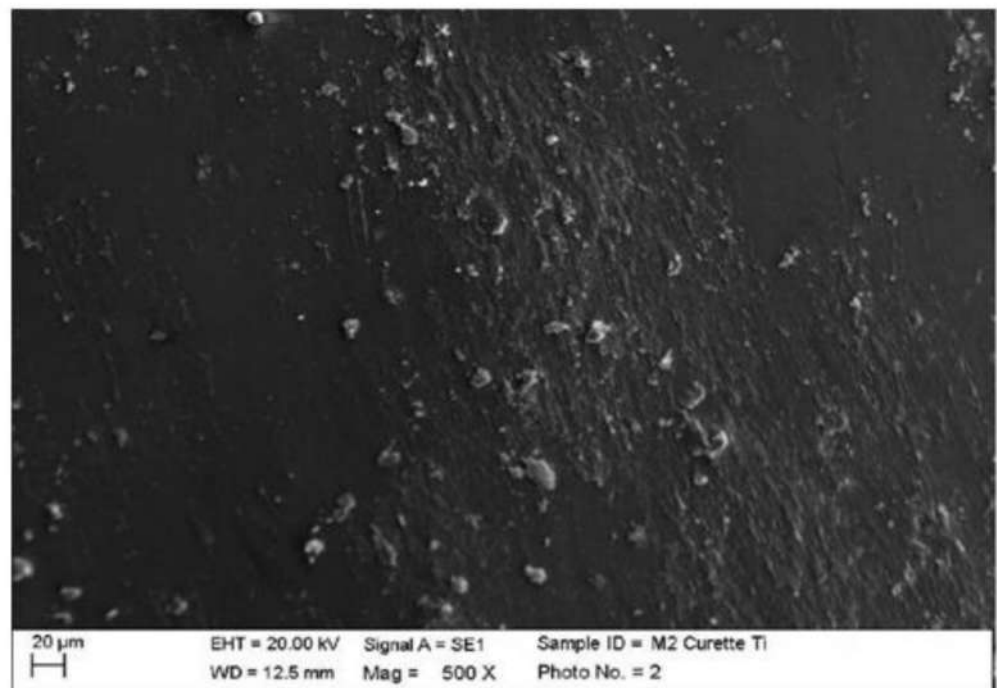
Figure 17. Instrumented ceramic sample M2 with titanium curette (500×).

Instrumented ceramic with titanium curette (Wingrove 3-4, PDT, Missoula, MT, USA).

The titanium curette did not create particular damage but left numerous large residues, both ceramic and titanium (Figure 17).

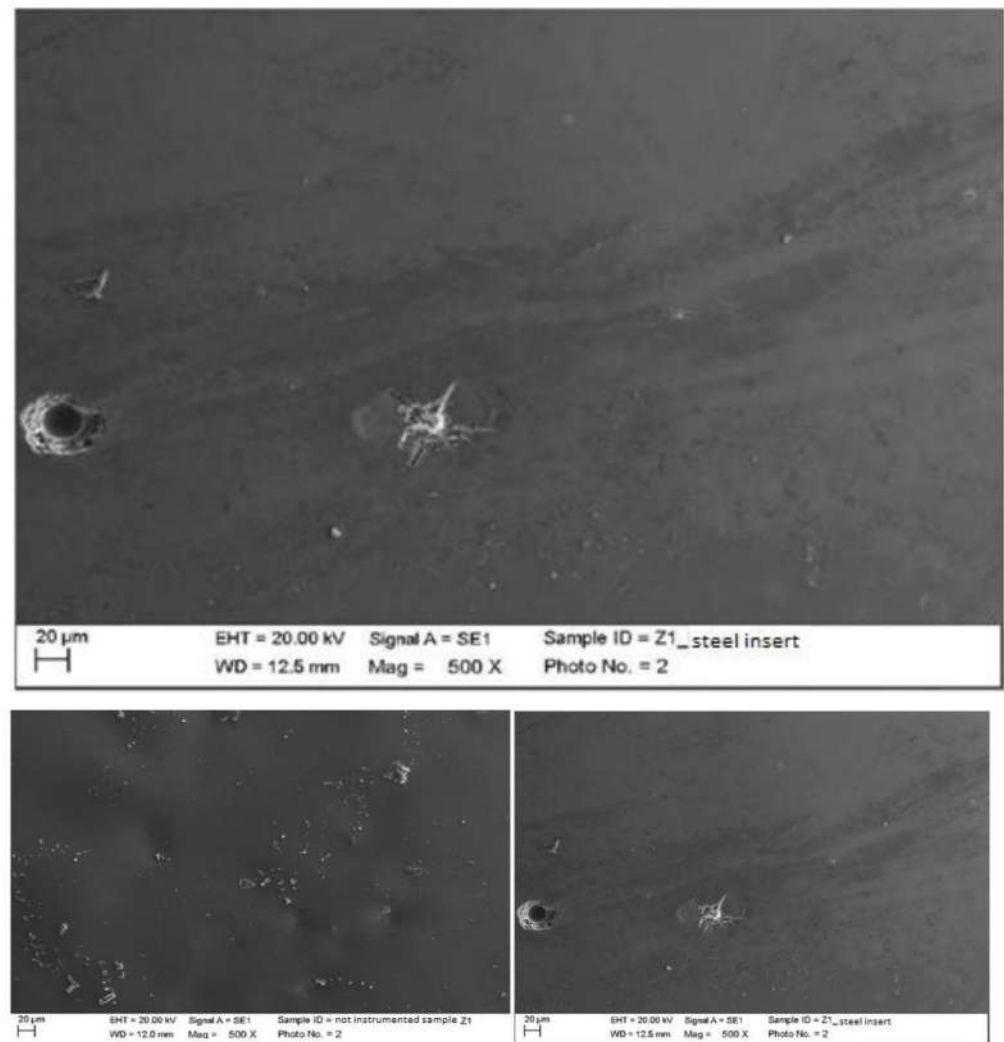
Figure 18. Instrumented zirconium sample Z1 with steel insert (500×). Comparison before/after instrumentation.

Instrumented zirconium with steel insert (PS, EMS, Nyon, Switzerland) mounted on Mini Piezon ultrasonic motor (EMS, Nyon, Switzerland).

The classic insert created a large fracture, clearly visible at 2000 magnification, in an area that was previously irregular. The crater visible in image 5.42 was not due to the instrumentation, but, as seen previously in the ceramic, to the hardness/fragility of the material (material defect). The trimming residues were removed (Figure 18).

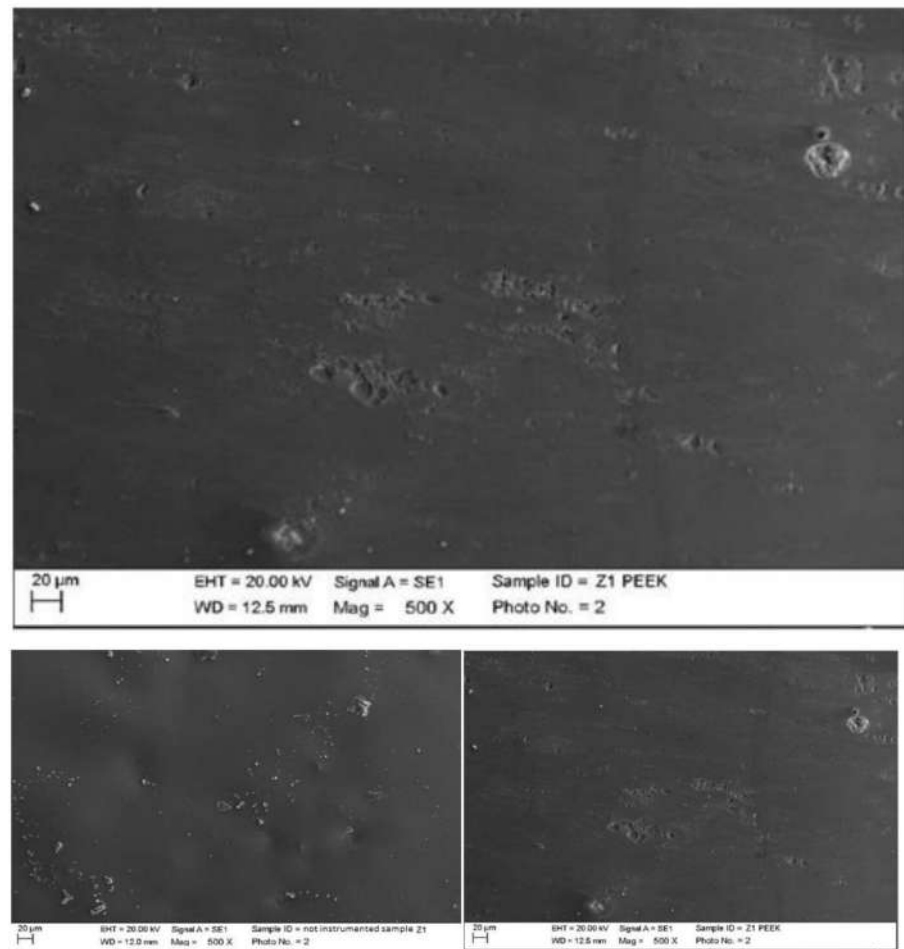
Figure 19. Instrumented zirconium sample Z1 with peek insert (500×). Comparison before/after instrumentation.

Instrumented zirconium with peek insert (ICS-IC1, Mectron, Carasco, Italy) mounted on ultrasonic motor, MultiPiezo (Mectron, Carasco, Italy).

The peek created alterations on the zirconium; however, it was not possible to establish the cause. The instrumentation areas were clearly visible (Figure 19).

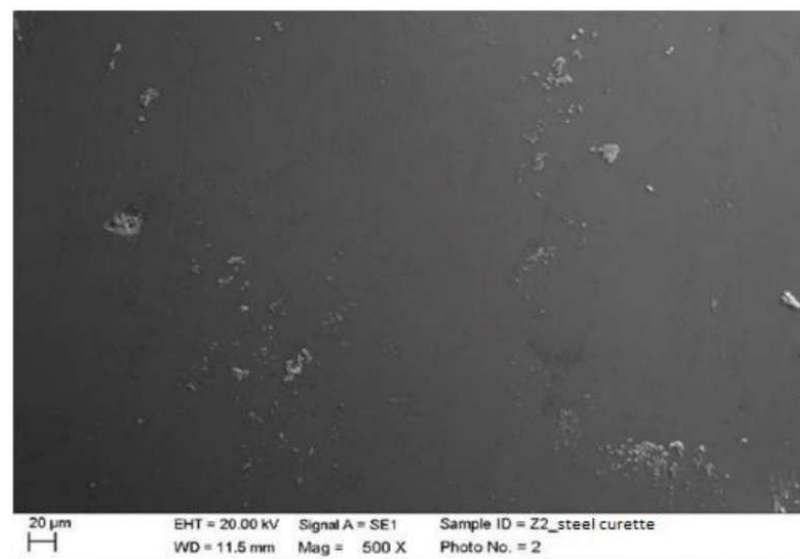
Figure 20. Instrumented zirconium sample Z2 with steel curette (500×).

Instrumented zirconium with steel curette (PDT, Missoula, MT, USA).

At maximum magnification, incisions and surface residues were visible on the zirconium part treated with a steel curette (Figure 20).

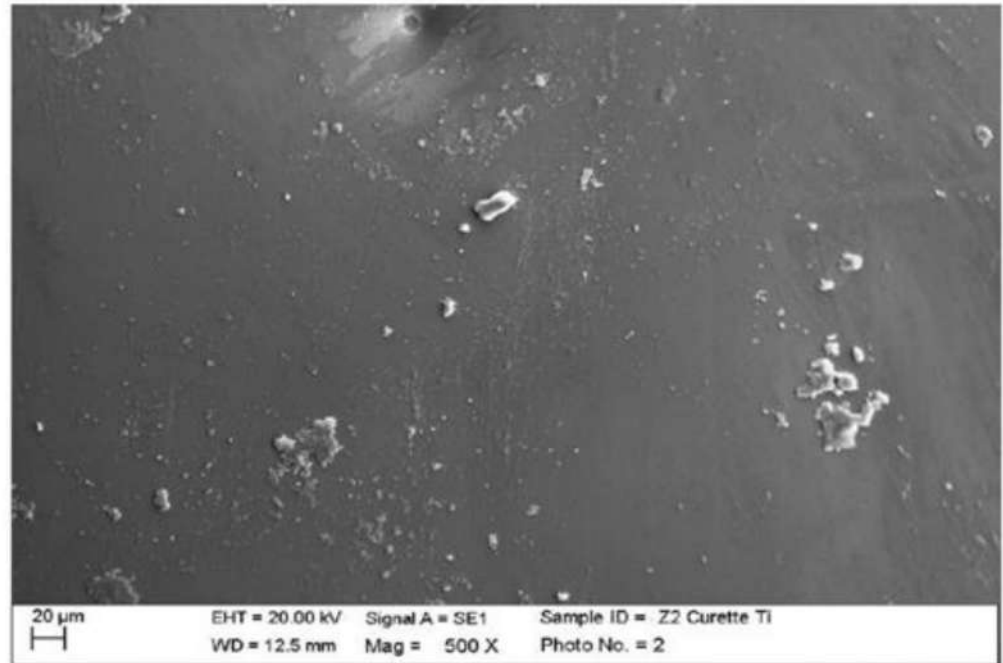
Figure 21. Instrumented zirconium sample Z2 with titanium curette (500 \times).

Instrumented zirconium with titanium curette (Wingrove 3-4, PDT, Missoula, MT, USA). The titanium curette created slight superficial incisions visible at higher magnifications, leaving few processing residues. On the left side of the enlargement, 2000 super-surface residues from finishing were still visible (Figure 21).

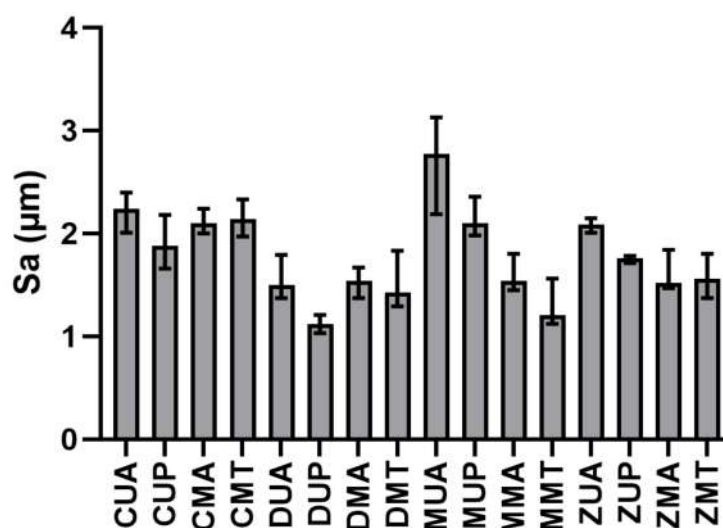
Figure 22. Median and extreme values of Sa for each combination. The material (C: composite, D: lithium disilicate, M: metal ceramic, Z: zirconium ceramic) and instrumentation (UA: ultrasonic-steel, UP: ultrasonic-peek, MA: manual-steel, MT: manual-titanium) are indicated along the abscissa axis.

Two Kruskal-Wallis tests were performed in the statistical analysis of the roughness values. In both cases, the 80 tests (five measurements \times four materials \times four instruments) were divided into four groups: composite, lithium disilicate, metal ceramic, and zirconium ceramic for material analysis, and ultrasonic-steel, ultrasonic-peek, manual-steel, and manual-titanium for instrumentation analysis. The null hypothesis, i.e., that all groups of samples came from the same distribution, was rejected in both tests, confirming the significance of the influence of both the material and the instrumentation ($p < 0.05$). The bar diagrams representing the median, maximum, and minimum values of S_a for each combination of material and instrumentation are shown in Figure 22, the legend of which is shown in Table 1.

The Kruskal-Wallis test confirmed that not all groups were from the same population, but did not provide information about which groups differed from each other. To determine between which materials and equipment there was a significant difference, a Bonferroni post hoc test was performed (Tables 2 and 3). p -values less than 0.05 corresponded to pairs of materials and instruments that had a significant difference.
