## RESTORATION OF A LANDMARK BALANCED CANTILEVER BRIDGE CONSIDERING DIFFERENT RESILIENCE AND SUSTAINABILITY STRATEGIES

Marco Domaneschi<sup>1</sup>, Stergios A. Mitoulis<sup>2</sup>, Raffaele Cucuzza<sup>1</sup>, Valentina Villa<sup>1</sup> and Roberta Di Bari<sup>3</sup>, Gopika Siva<sup>2</sup>

### Abstract

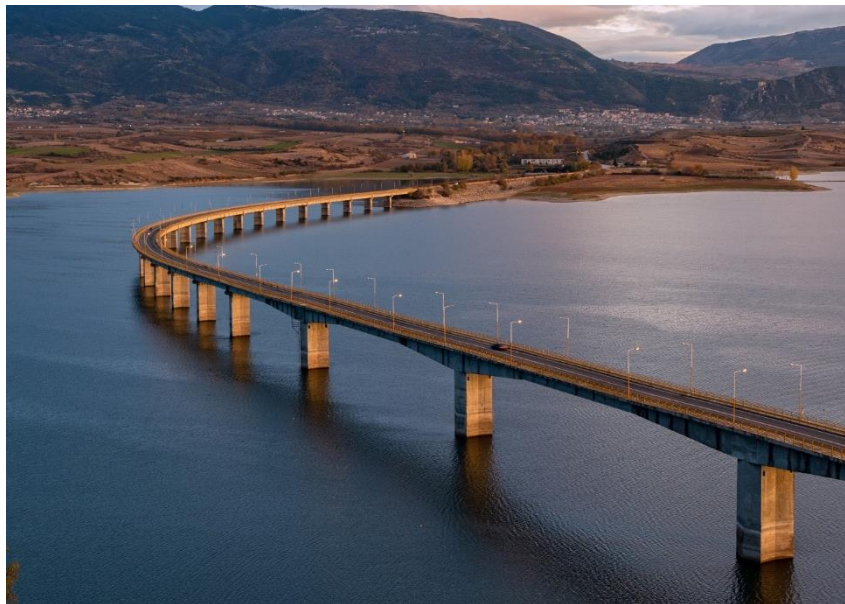
The Polyfytos bridge is an asset built in 1975 in the Municipality of Western Macedonia, Kozani, Greece and bridges the artificial homonymous lake of Polyfytos, with the local and the national road network relying entirely on its integrity. The balanced cantilever method was used to build a part of the bridge, specifically six cantilevers spanning from piers 22, 23 and 24 (Fig.1) accounting for a total of 260 meters (total length of the bridge is 1372 m).

Figure 1: Bridge layout.

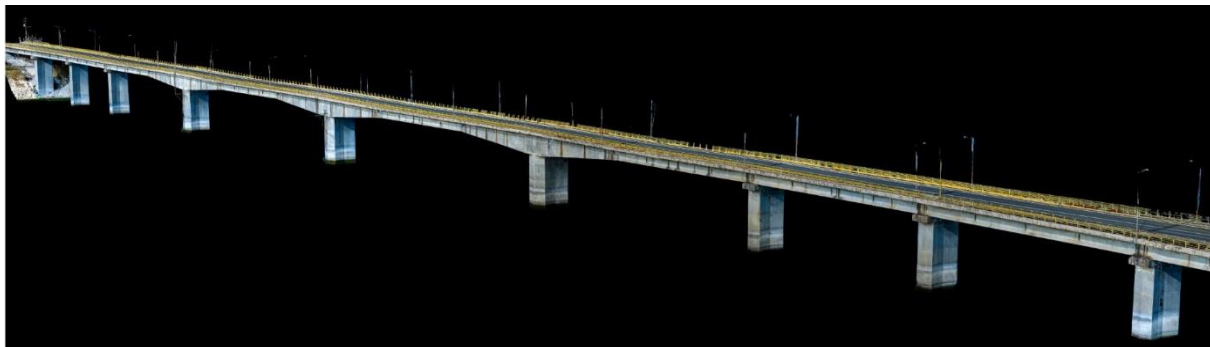
Located in the North-West part of the country, the Polyfytos bridge held the record for the largest overall length in Greece at the time of its construction, only surpassed by the Rio-Andirrio bridge almost 35 years later. The part of the bridge under interrogation consists of 3 segmentally constructed balanced cantilever sets, extending 30 meters either side of the abutments. Neighbouring cantilevers are connected by 40m long precast members forming an overall span of 100m (Fig. 1). The geometry and individual sizes of the segments were measured in the original drawings and verified on a point cloud model (Fig. 2).

Figure 1: Point cloud model.

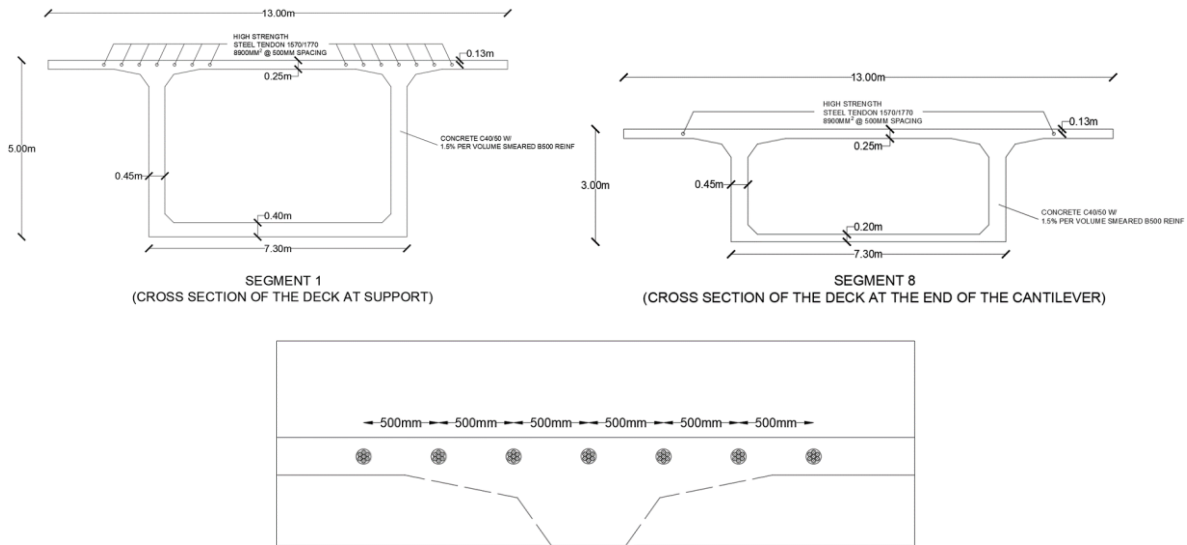
The part of the bridge under interrogation consists of 3 segmentally constructed balanced cantilever sets, extending 30 meters either side of the abutments. Neighboring cantilevers are connected by 40m long precast members forming an overall span of 100m. The geometry and individual sizes of the segments were measured in the original drawings and verified on a point cloud model. The position and trajectory of the prestressing tendons was not mentioned in the drawings so they were modelled according to standard practice of balance cantilever construction (all tendons on top flange of segment). Figure 5 depicts some critical cross sections of the cantilevers and details.

Figure 5: critical cross sections of the cantilevers and details.

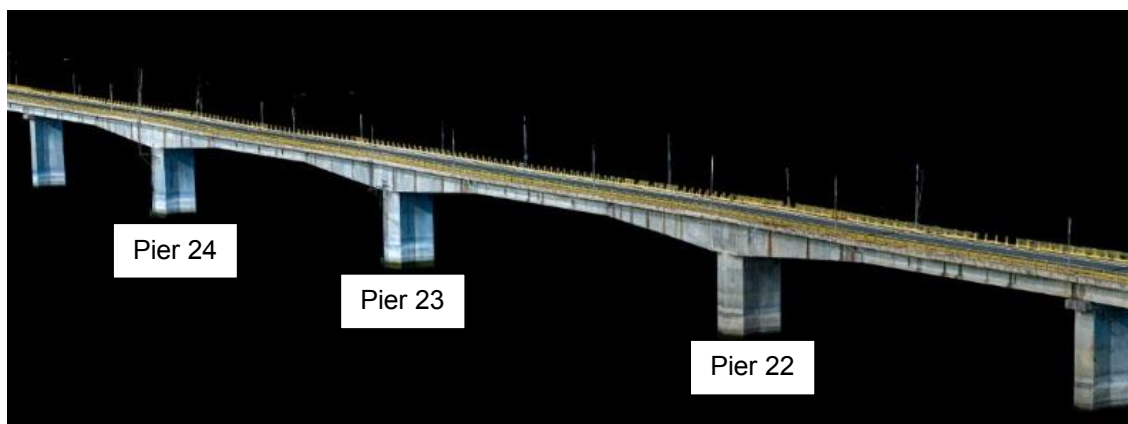
The point cloud of the bridge with some details of the cantilever and the half-joint is depicted in Figure 6. The deflection of the most critical cantilever of the bridge is reported in Figure 7, where the dashed line is the expected elevation, while the solid line is the measured position, i.e. 133mm and 207mm lower than the expected. Such deflections are the cantilever displacements downward at the tip (end) of the most critical cantilever.

Figure 6: point cloud.
