Land Planning and Extreme Snow Events: The Case of Buthier Avalanche in Aosta Valley - IT

The article reports the example of the indispensable update of hazard mapping used to reduce the snow avalanche danger with urban constraints in Cogne – Aosta Valley, in north-eastern of Italian Alps.

On 15th December 2008, an event induced by extreme weather and snow conditions occurred exceeding the known limits of the avalanche basin: the paper shows how the Avalanche Warning Service of Aosta Valley had to investigate in order to estimate the return period of the event and to update hazard maps. Due to the lack of information, the study was carried out coupling the historical and dendrochronological investigations of the woods embodied in avalanche basin and destroyed by the event.

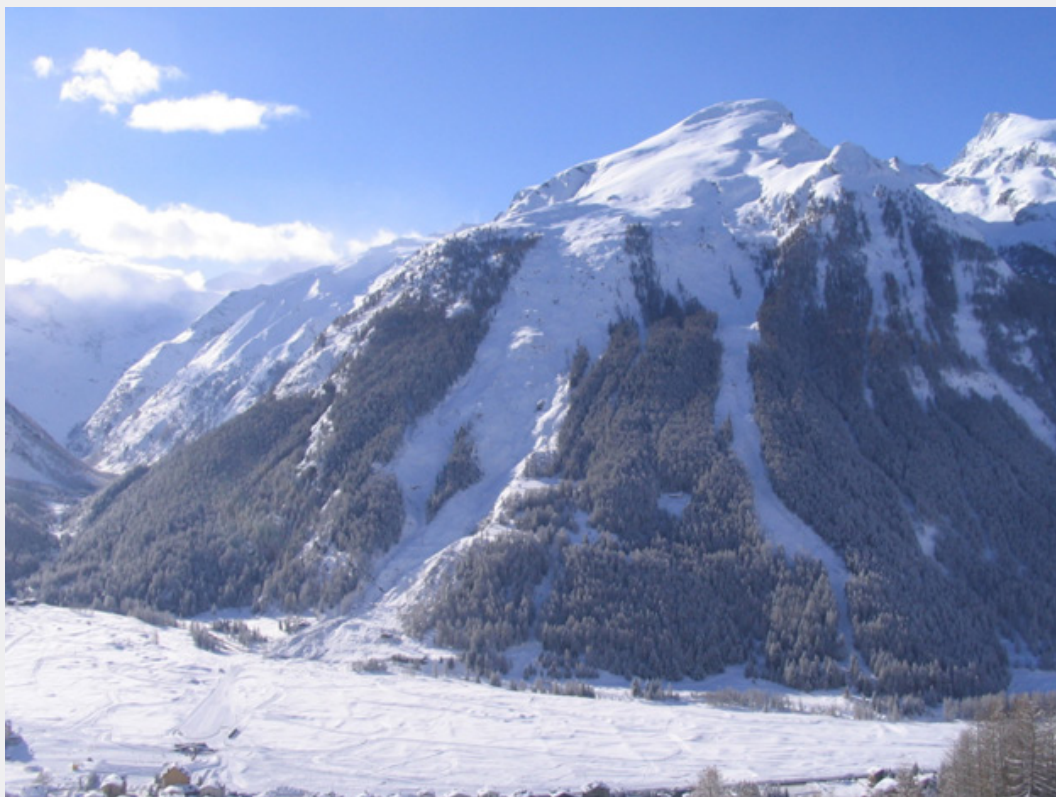
**Figure 2:** Aerial view of the Buthier avalanche released on December 15th, 2008. At the same time, the closer Pointe de l'Ouille avalanche released too (to the right in the picture): it also causes extensive damage to the forest (photo: forestry station of Aymavilles – Aosta Valley).

smell of resin filling the countryside. The cause of the sound was revealed only when the fog was cleared, uncovering the Mont Herban with a large wound of the forest at its northeastern side (Figure 2).

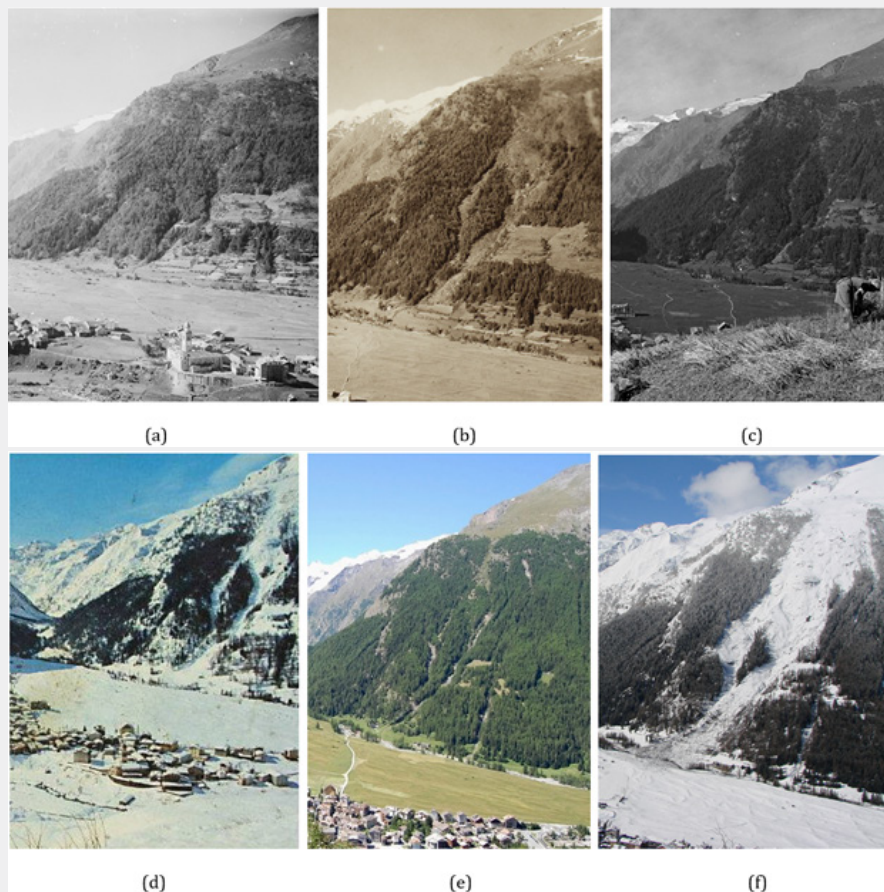
**Figure 7:** The six images to evaluate the frequency and size of the avalanche phenomenon starting from the beginning of the twentieth century analyzing the width of the forest cover.

- (a) 1915 (photo: BREL Archive - Fonds Fisanotti);
- (b) 1925-1935 (photo: BREL Archive - Fonds Domaine);
- (c) 1963 (photo: BREL Archive - Fonds Willien);
- (d) 1970-1975 (photo: private collection A. Roveyaz);
- (e) 2008 (photo: E. Borney) and
- (f) 2009 (photo: E. Borney).

Thanks to the following six images (Figure 7), the frequency and the size of the avalanche phenomenon starting from the beginning of the twentieth century has been reconstruct by analyzing the width of the forest cover.

By observing the sequence of the six photographs, we note that central strip of forest saved from the event of December 2008 appears also in historical photos of 1925-1935 (Figure 7b) and 1970-1975 (Figure 7d), but is larger than the event of December 15th, 2008 witnessing how past events were less destructive. This is also confirmed by the observation of the lateral limits of the forest affected by the historic avalanches which appear to be less extensive than those achieved by the last 2008 event. Focusing on the images where the forest is damaged (Figure 7b, 7d & 7f)

and on the left edge of the intact forest, it is easy to conclude that the event of December 15th, 2008 was clearly larger than the previous ones. In order to verify this conjecture, during the spring, an extensive dendrometric survey [11-13] was carried by using the Pressler auger, sampling various plants survived in the small core of larch (LC51E) and in staked ones at in the damaged forest (Figure 8). The samples were suitably processed to make the growth rings more visible and thus facilitate age counting on each plant.

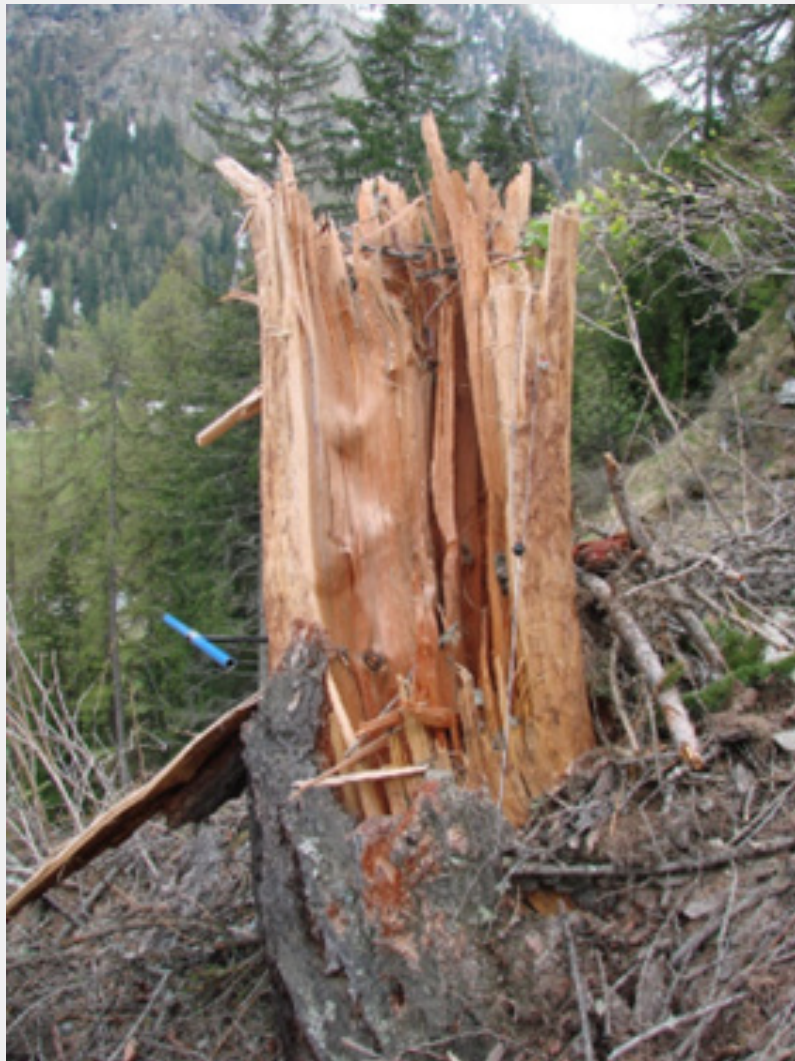
**Figure 8:** The larch (*Larix decidua* Miller) crushed by the avalanche on December 15th, 2008 (sample n. 5). It was located closed to the Buthier village. The age of the plant is about 140 years old.
