Land Planning and Extreme Snow Events: The Case of Buthier Avalanche in Aosta Valley - IT

The article reports the example of the indispensable update of hazard mapping used to reduce the snow avalanche danger with urban constraints in Cogne – Aosta Valley, in north-eastern of Italian Alps.

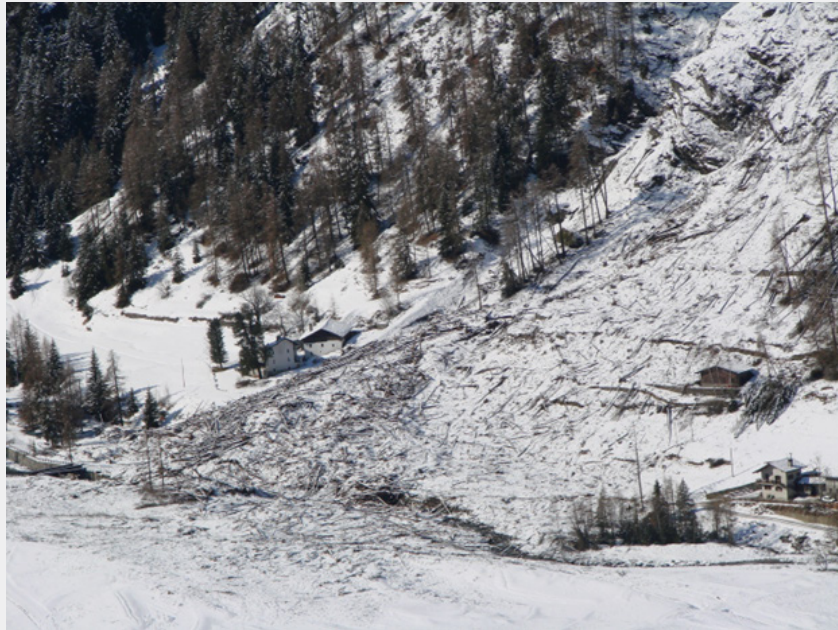
**Figure 3:** At the end of the slope, the snow flow hit two buildings in Buthier village on the south of deposition zone (on the left of picture). However, the snow flow was partially deflected by a little deflecting dam built to protect the buildings from the debris flows from the slopes of Mont-Herban. At 1554m a.s.l. (on the right of the picture), the chalet was hit by the avalanche damaging the roof, the chimney and the western side. Fortunately, the main stream of avalanche passed south of the deposition zone where most of larger size wood debris were deposited.

The powder part of avalanche continued until the first houses of Laydetré (1560m) where a thin layer of snow mixed with spruce needles and twigs of conifers was deposited. Globally, the snow avalanche broke more than 5,000 specimens of spruce and larch, dragging them to the end of the slope. A specific survey of the debris position showed that the dragged material differs according to the size during the deposition: the larger trunks of uprooted trees stopped at the end of the slope, just beyond the Valnontey creek (Figure 3), while branches and needles were deposited farther, near the meadows of Sant'Orso.
