3D slope stability analysis of a limestone quarry expansion in Northern Italy

D Martinelli^{1,2}, G Pasqualone¹, M Cardu^{1,2}, M Linares Gonzalez³

Abstract. Slope stability is a crucial aspect in case in quarrying, both in term of legal and technical restrictions. The availability of data regarding the rock mass characterization is not sufficient to guarantee a satisfactory stability analysis, which must be assessed by means of more accurate procedures. Limit equilibrium analyses have been used since many decades, as they can give satisfactory results for simple cases, such as planar or wedge blocks. Nevertheless, when dealing with more complex cases, such as opencast quarries and mines, where the slope geometry consists on several benches plunging in different directions, this simplified approach cannot give a satisfactory answer. In this scenario, numerical models can return a much more complete and accurate assessment of the overall stability. The paper describes a possible approach to evaluate the stability of the slopes of a limestone opencast quarry in Northern Italy. The country is experiencing a growing demand of limestone for the production of cement for the constructio

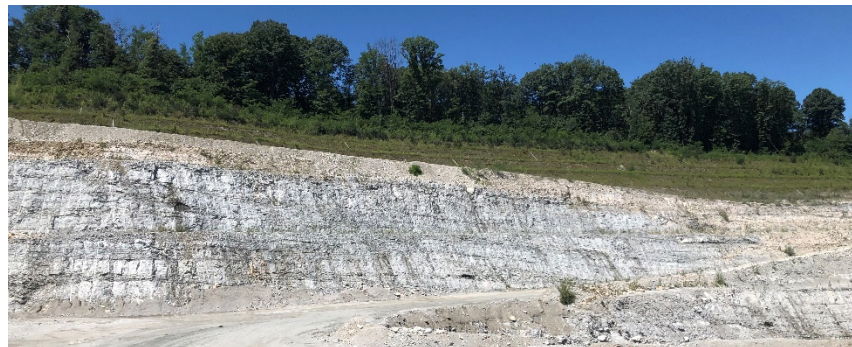
Figure 1. Condition of the exploited face with rock and soil strata visible.

The exploited material is a limestone which belongs to the Eocene Epoch, called “Ternate formation”. It is mainly characterized by the deposition of resettled marine sediments. This formation consists of a succession of organogenic limestone with granular support, interspersed with a grey-green marl [2]. The strata in Figure 1 confirm an evolution of the environment due to erosion and subsequent fluvial resettlement. Above and in contact with the carbonate formation, a Quaternary formation is noticed, made of detrital material, with different grain size and composition, and a variable thickness. The carbonate formation is slightly fractured, with discontinuities mostly perpendicular to the layers. The formation has a layering with a variable dip (10-25°) in the North-West-North direction, as also described by Mancin [3]. The orientation of the layers cannot not be verified on the West side of the quarry, due to the presence of an important overburden. Due to the intersection of systems of fractures, the erosive action of the meteoric waters is favoured, with the formation of voids, filled by fine material (clay).
