3D slope stability analysis of a limestone quarry expansion in Northern Italy

To cite this article: D Martinelli *et al* 2023 *IOP Conf. Ser.: Earth Environ. Sci.* **1124** 012131

D Martinelli^{1,2}, G Pasqualone¹, M Cardu^{1,2}, M Linares Gonzalez³

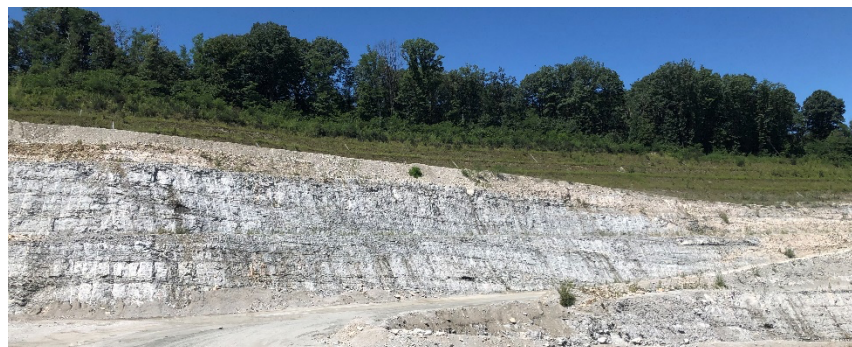
Figure 1. Condition of the exploited face with rock and soil strata visible.

The exploited material is a limestone which belongs to the Eocene Epoch, called “Ternate formation”. It is mainly characterized by the deposition of resettled marine sediments. This formation consists of a succession of organogenic limestone with granular support, interspersed with a grey-green marl [2]. The strata in Figure 1 confirm an evolution of the environment due to erosion and subsequent fluvial resettlement. Above and in contact with the carbonate formation, a Quaternary formation is noticed, made of detrital material, with different grain size and composition, and a variable thickness. The carbonate formation is slightly fractured, with discontinuities mostly perpendicular to the layers. The formation has a layering with a variable dip (10-25°) in the North-West-North direction, as also described by Mancin [3]. The orientation of the layers cannot not be verified on the West side of the quarry, due to the presence of an important overburden. Due to the intersection of systems of fractures, the erosive action of the meteoric waters is favoured, with the formation of voids, filled by fine material (clay).
