Point clouds and surface analyses to detect anomalies

Point clouds and surface analyses to detect anomalies / Sammartano, Giulia; Patrucco, Giacomo; Perri, Stefano; Spano',
Antonia - In: The Halls of Turin Exhibition Center by Pier Luigi Nervi: a multi-disciplinary approach for diagnosis and
preservationELETTRONICO. - Los Angeles : Getty foundation, 2023. - pp. 154-167

3c Point clouds and surface analyses to detect anomalies

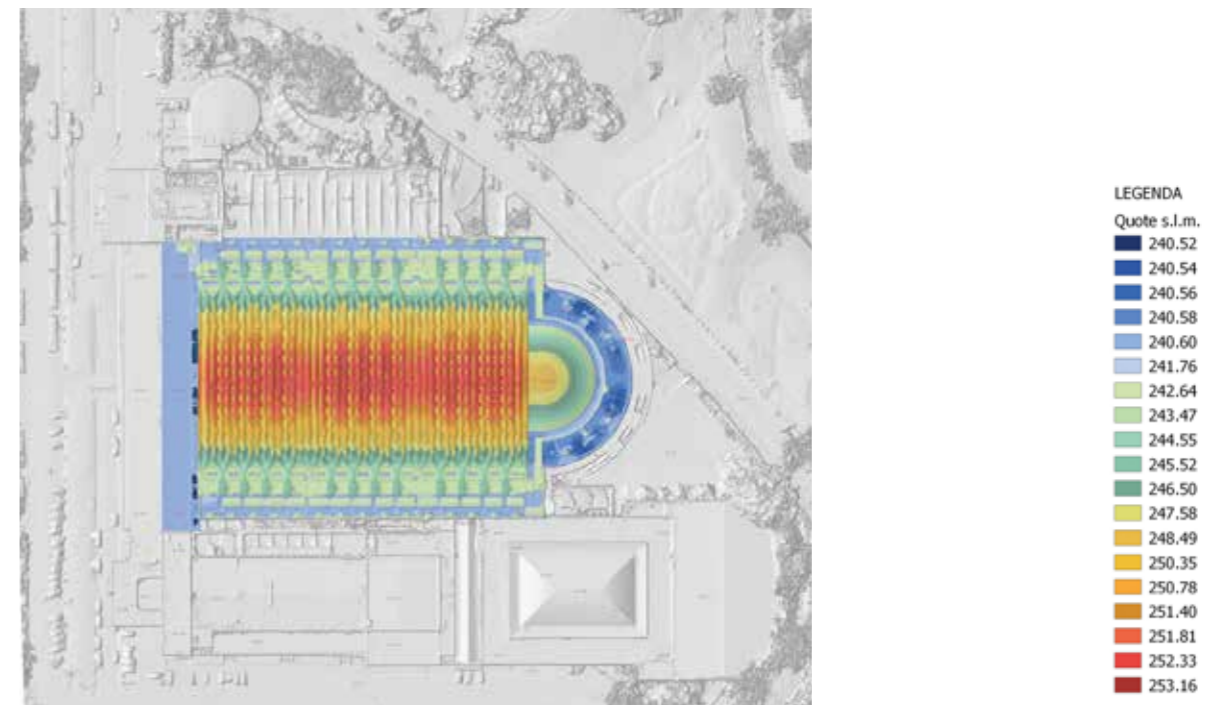
3c 1.1 (above): the DSM thematic view using range colors concerning the roof of Hall B, and (below) an extract.

The UAV photogrammetric survey made it possible to calculate the DSM of the roofs and of the surroundings of the building complex. The visualization of the altimetric information according to color scales enabled each pixel to be checked both visually and analytically for any differences in level. Figures 3c 1.1 and 3c 1.2, respectively, show both the complete DSM panels of each roof of Halls B and C, and an enlarged extract enabled us to estimate the extent of the troughs in the roof slab, which create puddles of rainwater after rainfall.

The difference in height was approximately up to 13 cm for the coverage of Hall C and approximately up to 8 cm for the flat roof portion of the exedra of Hall B.

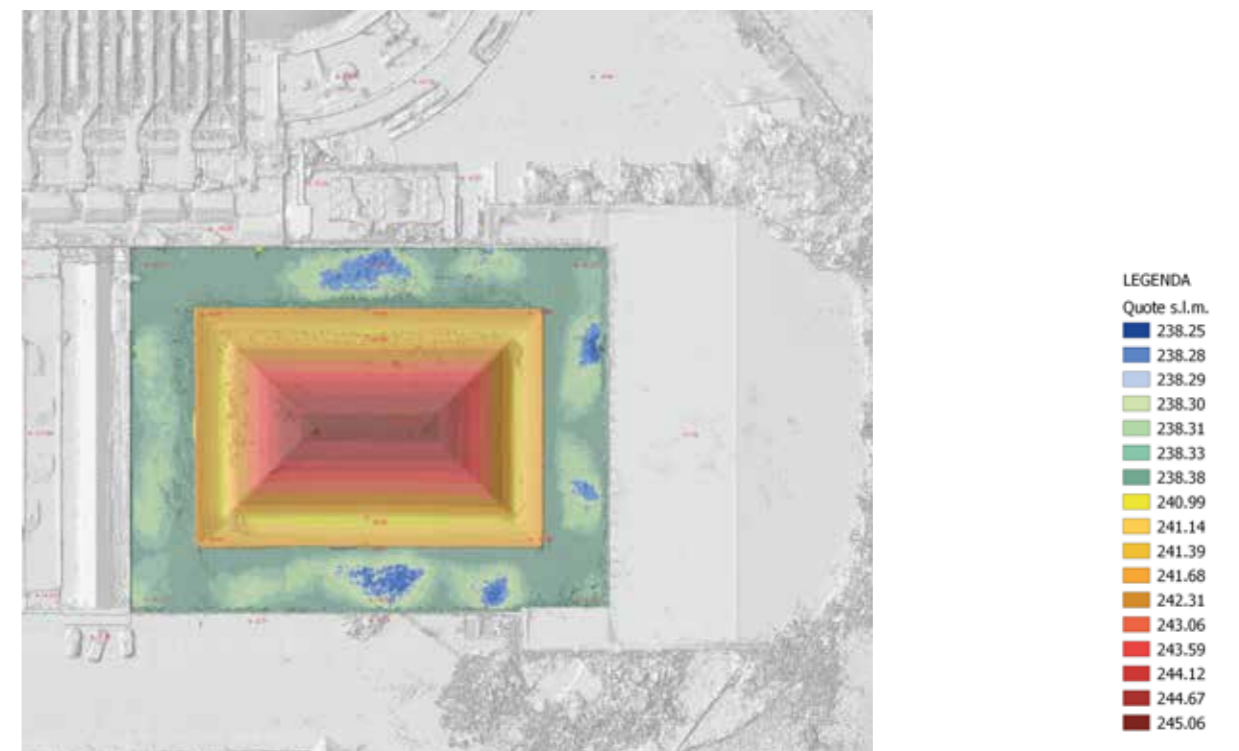
3c 1.2 (above): the DSM thematic view using a range of colors for the roof of Hall C, and (below) an extract.

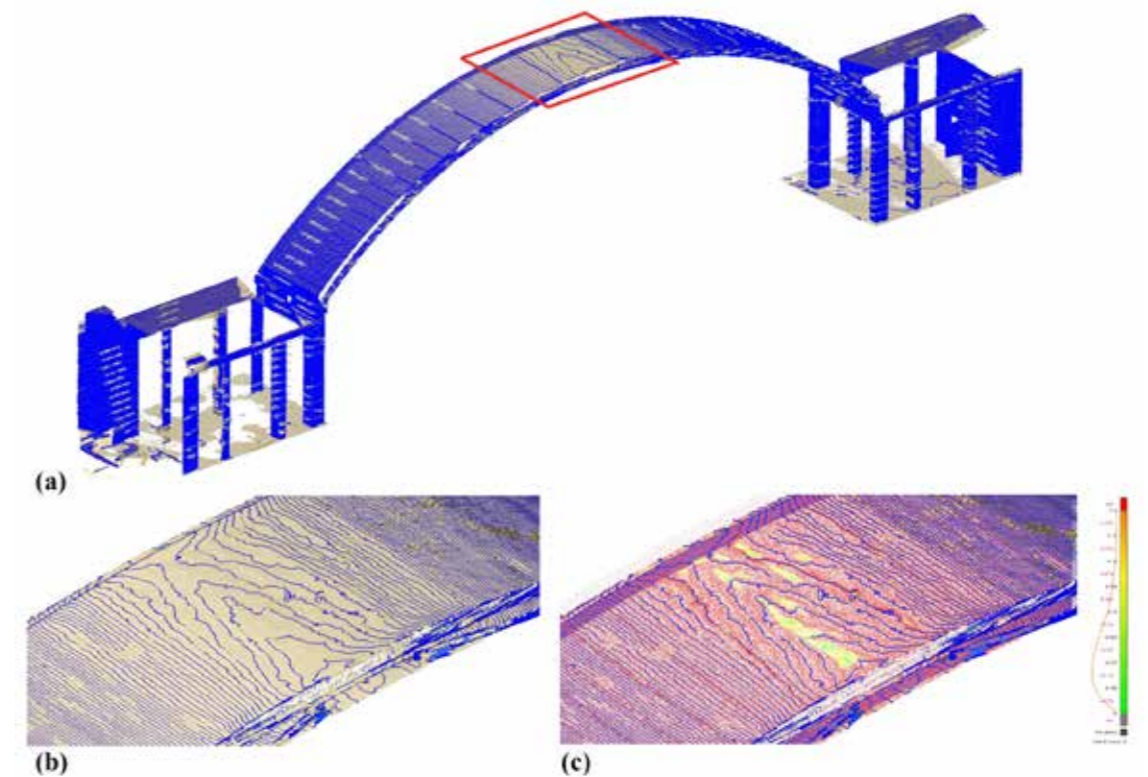
3c 4.1: Extraction of isohypses from the point cloud of the so-called SAP vault (above and below left), together with a pixel-to-pixel difference of surfaces showing a lowering of the arc in the direction of the dome.

The first two images (3D and nadiral view) of Figure 3c 4.1 show the point cloud transformed into a continuous surface (mesh) and the extraction of isohypses (contour lines referring to the land) at a distance of very few centimeters (10 cm). The altered shape of such lines can demonstrate the specified design geometry and the possible anomalies of shape. These can also be in the form of asymmetries of spatial configuration which, when compared with other structural investigations, can provide important clues to formulate the presence of deformations, which have occurred after construction.

The final image in Figure 3c 4.1. shows we can investigate the problem further by comparing the measured point cloud and the ideal cylinder, which confirms a maximum deviation of 3.5 cm in the direction of the apse dome.

We are quite convinced that if everything in the previous reasoning is correct, the lowering is not to be ascribed to a slight subsidence or deformation after construction but rather to a more credible, skillful adaptation during construction, which took place using the accentuated principles of on-site prefabrication., Pier Luigi Nervi had to connect the cross-section of a cylinder with a parabolic cross-section with the cross-section of a sphere. (circular).

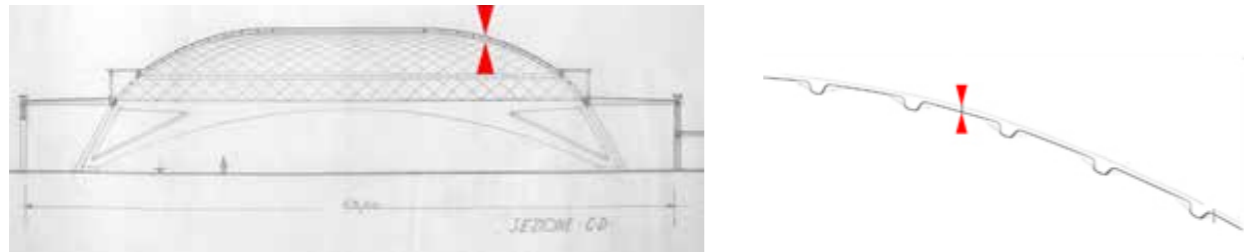
3c 5.1: Project drawing of the section of the vault of Hall C (CSAC, Università di Parma, courtesy Fondation PLN Project), and the corresponding intrados-extrados section on the integrated point model.

Starting from Hall C, particular interest was dedicated to the possibility of verifying the correspondence of the ferrocement elements of the design phase with the actual construction, thanks to a reality-based model. To do this, the archive drawings relating to Hall C were analyzed and a correspondence was created with the real sections [figure 3c.5.3]. The expected thickness of the latter was 5cm, with the addition of a 2cm

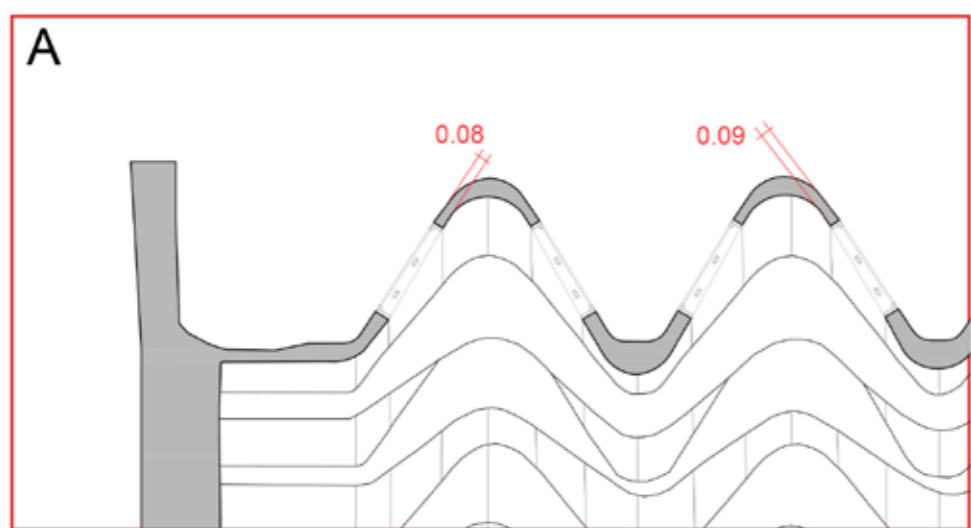
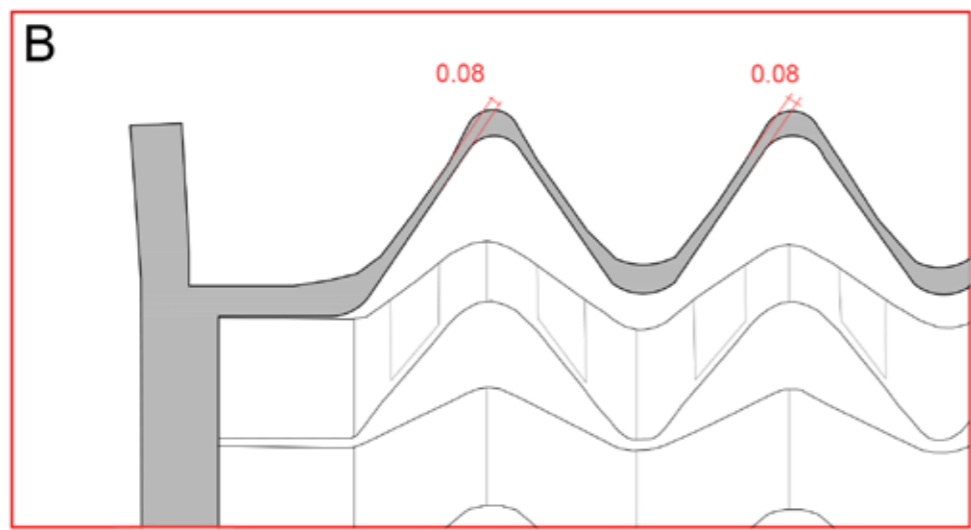
3c 5.10: Studies to calculate the thicknesses of the envelope of the vault of Hall B, and related architectural drawings in cross-section.

In essence, the strategy adopted to determine the envelope of the undulated thin-shell vault of Hall B was as follows: a targeted photogrammetric process of the aerial block of images was re-performed, using only the images pertaining to the coverage of Hall B and an attempt was made to optimize the results in relation to noise and residual errors on the control points. In the light of this result, careful extraction of the average surface was carried out along the entire extension of the extrados of the undulated vault.

Subsequently, the portion detected by close-range photogrammetry using images acquired from close range through the elevator was selected as the sample surface (Figure 3c 5.9). This careful combination of medium surfaces led to the vectorization of the sections of the large, vaulted structure shown in the panels of the architectural drawings (Figures 3c 5.10)
