A Preliminary Study for the Knowledge Process: Pier Luigi Nervi's Taormina Stadium

Federico Vecchio^{1*}, Giuliana Di Mari¹, Alessandra Renzulli¹.

1 - Dipartimento di Ingegneria Strutturale, Edile e Geotecnica (DISEG), Politecnico di Torino, Italy.

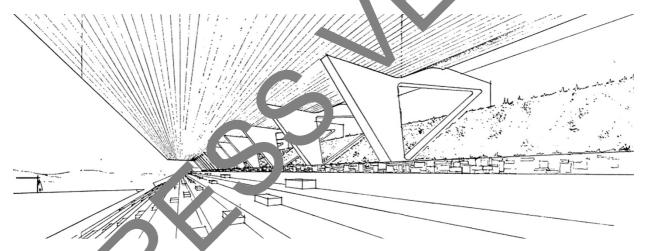
Fi Sketch of the Taormina Stadium - © 1958, Architectural Record 12

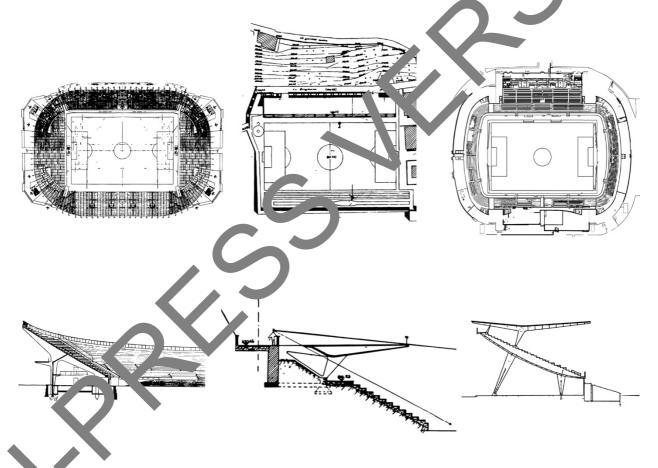
Figure 2 – Sketch of plans and sections of the three Nervi stadiums in Rome (left), Taormina (center), and Novara (right) - © 2024, drawing by the Authors

The analysis was conducted starting from the protection and preservation systems inherent in the designs of a see stadiums signed by Nervi (Fig. 2): the sports center stadium in Taormina (1955- 1960), the Flaminio stadium in Ron (1956-1959) and the municipal stadium in Novara (1964- 1976). After the famous Berta municipal stadium in Flore ce, these stadiums resulted from the collaboration with his son Antonio, with whom he founded the "Studio Vervi" in 19-4 to join the "Nervi & Bartolini" design studio. These are typologically innovative sports facilities when a significe at role is taken by technical and structural achievement and with particular attention to aesthetic express. [77] The Florence Stadium, even if it was mentioned at the starting point for the discussion, is not included in the study as it is: chronologically earlier, designed by Pier Luigi Nervi without the collaboration of Antonio, and attensively covered with the discussions on the dangers of demolition.

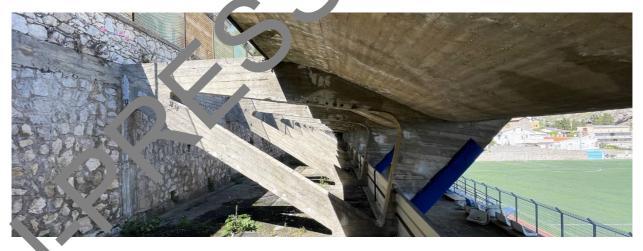
Figure 3 – The Nervi's skills emerges between fragility and degradation - © 2021, Authors

In the case of Taormina, there are further specific vulnerabilities (Fig. 3) characteristic of football stadiums, in addition to the criticalities typical of the Modern heritage. Several reasons lead to assimilating the stadium into a minor work [16]. The first is that, compared to the stadiums in Rome and Novara, it is smaller in size, designed to hold up to a maximum of 3900 spectators (Tab. 1). The second is that this stadium has been little studied and, at times, excluded from the scientific literature, being the subject of interest only of authors Antonino Marino and Laura Marino [14]. A third reason is the lack of interest in heritage protection from organizations and associations.

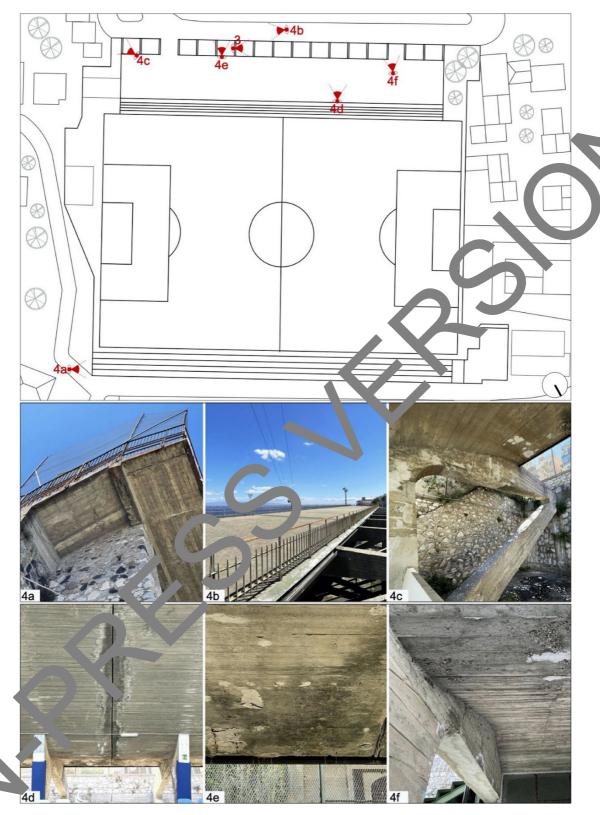
Figure 4 – Details of the degradation and location in the floor plan: (a) the north stand in structural decay, (b) the abandoned terrace, (c) aesthetic degradation from incorrect patching and vegetation, (d) degradation at the structural joint, (e) lack of concrete and spalling, (f) construction defects such as honeycombs - © 2021, Authors

The north stand is cantilevered and has reduced thickness (Fig. 4a), which shows damage due to pull-out phenomena that expose the reinforcement bars and have caused cracks and localized corrosion decay. In addition, it shows significant degradation due to increased exposure to weathering. The south grandstand presents problems that also impact the functional aspect: the terrace above the roof cannot be used for the heavily degraded flooring and the corroded metal parapets (Fig. 4b). Other problems are related to poor or inadequate maintenance, such as weed vegetation and inconsistent patching with cement mortars (Fig. 4c). Problems related to water exposure have caused efflorescence, discoloration, delamination, and cracking, particularly at the three structural joints of the south stand roof (Fig. 4d). In several places, material *lacunae* and small localized spalling phenomena are also evident where the ceiling reinforcement cover is thinner (Fig. 4e). Finally, sporadic honeycombs are evident (Fig. 4f). All of the several places, material degradation process that, over time, could alter the very stability of the structure. The sports facility generally does not meet regulatory requirements regarding fire prevention and removing architectural barriers.
