The Garisenda Tower in Bologna: Damage Assessment Results from Principal Component Analysis, Acoustic Emission, and Nonlinear Finite Element Analyses Involving Creep and

# The Garisenda Tower in Bologna: Damage Assessment Results from Principal Component Analysis, Acoustic Emission, and Nonlinear Finite Element Analyses Involving Creep and Smeared Cracking

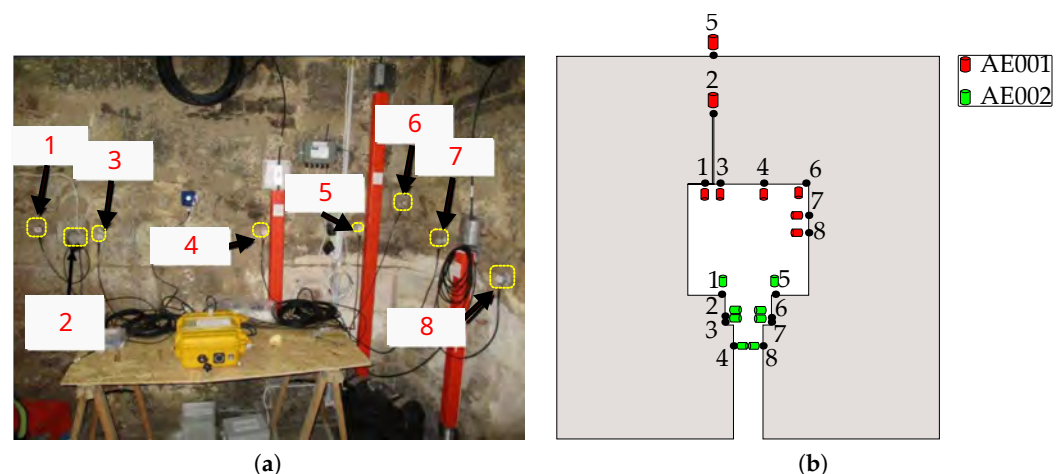
**Figure 2.** The AE sensors of device AE001 in the base of the tower. The numbers in the figure correspond to the channel (sensor) identifier, e.g., 1 corresponds to channel (CH) number 1 (CH1), 2 to CH2, and so on. Note: Sensor CH5 was later moved to the outside wall of the base (a). Schematic representation of the position of the AE sensors in the base (b).

A custom-designed monitoring system capable of detecting acoustic emissions (AEs) was installed at the base of the Garisenda Tower. The system is comprised of two devices, AE001 and AE002, each featuring eight channels connected to piezoelectric sensors. The system was installed in order to investigate micro-cracking and thus to allow for structural assessment of the base of the tower. The first device, AE001, was put in place on 31 May 2019. Its sensors are installed in the eastern (leaning) side of the tower, with sensor CH2 being located inside the base casing, and CH5 being close to the outside wall (it was previously also located in the inner wall but was relocated). The second device, AE002, was added on 14 March 2023. Its sensors are located on the western side of the tower, close to the entrance. The sensors (Lunitek AEmission LT18-003-PRD00-R0) have a frequency range of 15–625 kHz. They are securely fastened to the tower's inner wall using high-strength adhesive. Based on the ongoing AE field monitoring on the Garisenda Tower, only AE signals within a frequency range of 50–400 kHz, with an amplitude  $\geq 0.7$  mV, and a number of oscillations (ring-down count)  $\geq 3$  were considered, with signals that did not fall into these specifications discarded as noise. Figure 2 shows the installation of the piezoelectric sensors at the tower's base, as well as a schematic diagram of their arrangement, providing a visual representation of the setup.

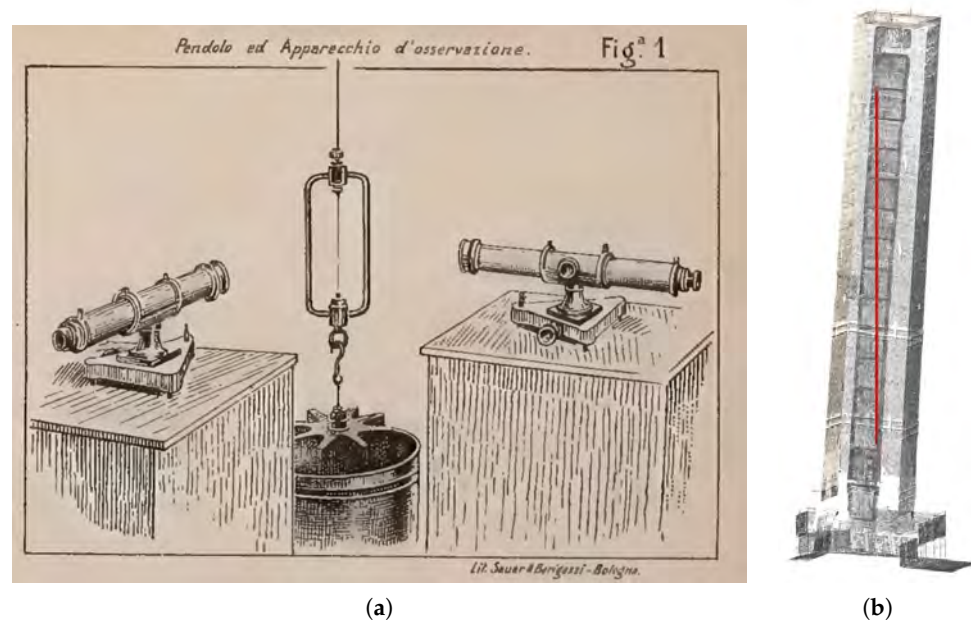
**Figure 3.** Schematic of the pendulum used by Prof. Cavani at the beginning of the 1900s [1] (a); laser scan of the pendulum inside the tower (b). Credit for the latter attributed to R.teknos srl.

In February 2021, a 30 m pendulum was installed inside the tower by the company RTeknos s.r.l (<https://www.rteknos.it/>, accessed 27 October 2025) to measure the planar movement of its top in comparison with the base. This modern monitoring system finds inspiration in a mechanical pendulum installed inside the Garisenda as early as the beginning of the 20th century by Prof. Cavani with the same scope (Figure 3). The pendulum consists of a steel wire attached to a 15 kg mass submerged in a viscous fluid, which serves to provide damping. The position of the wire is monitored by a telecoordinometer, comprising a unit equipped with photocells arranged in transmitter–receiver pairs, actuated by an electric motor and supplied with power through a cable fitted with connectors. It can detect displacements of up to 100 mm in the south-east direction (X-axis) and up to 50 mm in the north-east direction (Y-axis). The pendulum's margin of error is 0.075% of the maximum reading. This translates to an error range of 0.075 mm in the X direction and 0.0375 mm in the Y direction. The system also records the internal temperature at the base of the tower.

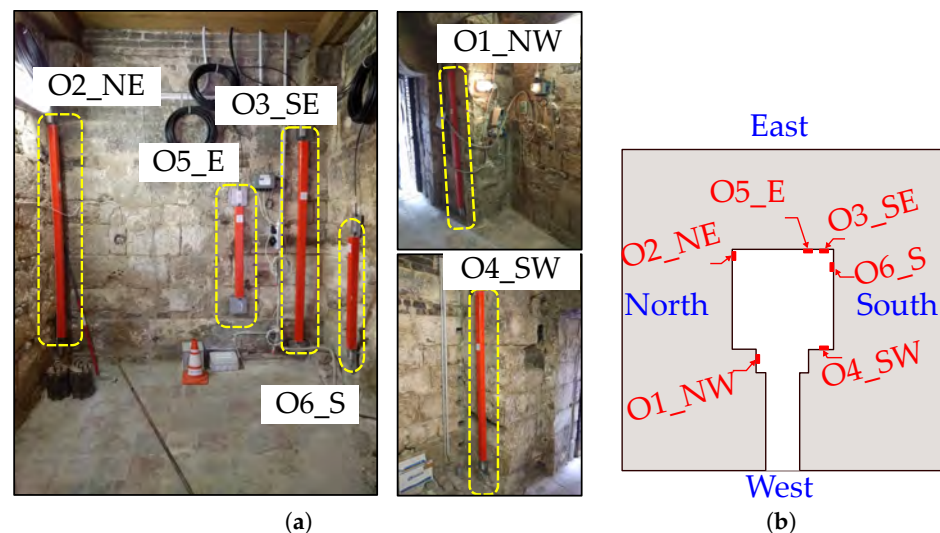
**Figure 4.** FOSs on the inner walls of the tower base (a). Credit is attributed to OSMOS Group. Schematic representation of the position of the FOSs in the tower base (b).

Eight FOS sensors were placed vertically on the inner walls of the base of the tower by OSMOS Group (<https://www.osmos-group.com/en>, accessed 27 October 2025). Six of them are shown in Figure 4; the other two were installed at the end of 2023 but were not considered for the present analysis. The FOSs were installed to measure strains in the base—the four 2 m long strings were installed to measure global strains in the base, while the two 1 m long strings were installed to measure local strains in the south-east corner, where the inner selenite presented signs of degradation. String O4\_SW was removed shortly after installation, due to interference with other works, and its readings were also discarded. The system records strain and temperature in the vicinity of the FOSs. Sampling frequency is up to 100 Hz for dynamic events (such as earthquakes). Of the eight FOSs, six of them are 2 m long and two of them are 1 m long (strings O5\_E and O6\_S in Figure 4).

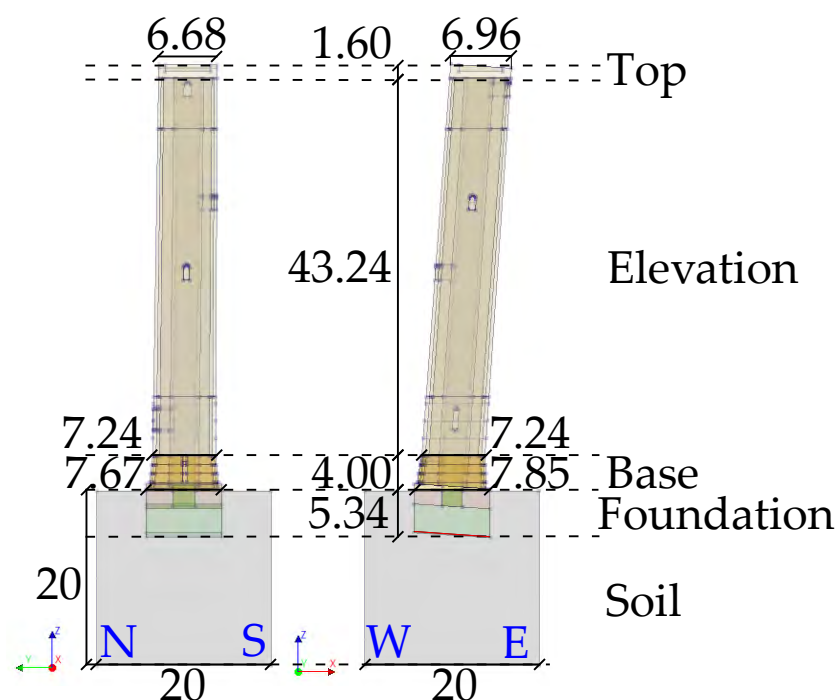
**Figure 5.** West (on the left) and south (on the right) views of the FE model geometry, with dimensions indicated in meters.

A 3D finite element model was developed utilizing the DIANA commercial package (<https://dianafea.com/>, accessed 27 October 2025). The computational mesh consists predominantly of quadratic brick and wedge elements, for a total of around 200,000 elements and 600,000 nodes. Mesh refinement strategies varied across different structural regions. In the elevation, an element size of 1 m was adopted (with the exception of the region close to the base, where the element size was set to 0.5 m). In both in the base and foundation, element size was set to 0.2 m, while in the soil a coarser discretization of 2 m was used. The base of the tower was modeled with four layers: two outer selenite layers, an intermediate infill ("sacco"), and an inner selenite layer. The outermost layer of selenite was discretized with one element, while the second exterior layer of selenite was modeled with two brick elements, for a total of three elements and seven nodes through the thickness. For the internal selenite layer, two elements were used through the thickness. West and south views of the geometry of the model in DIANA, with its dimensions, can be seen in Figure 5, while the geometry of the model, with the inner layers, is shown in Figure 6.

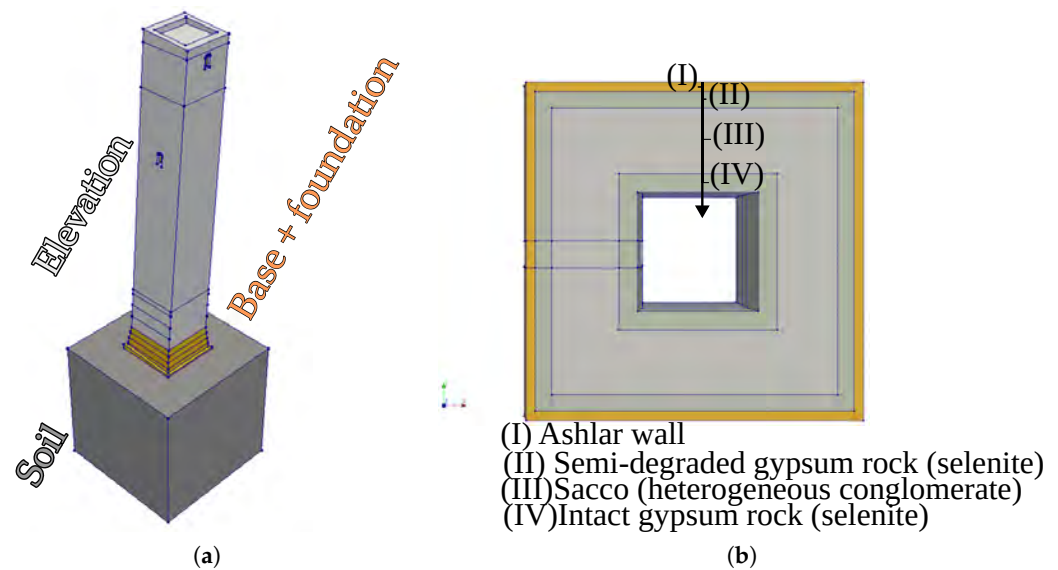
**Figure 6.** Isometric view of the FE model geometry. (a). Top view of the base section of the FE model, highlighting the different layers. (b).

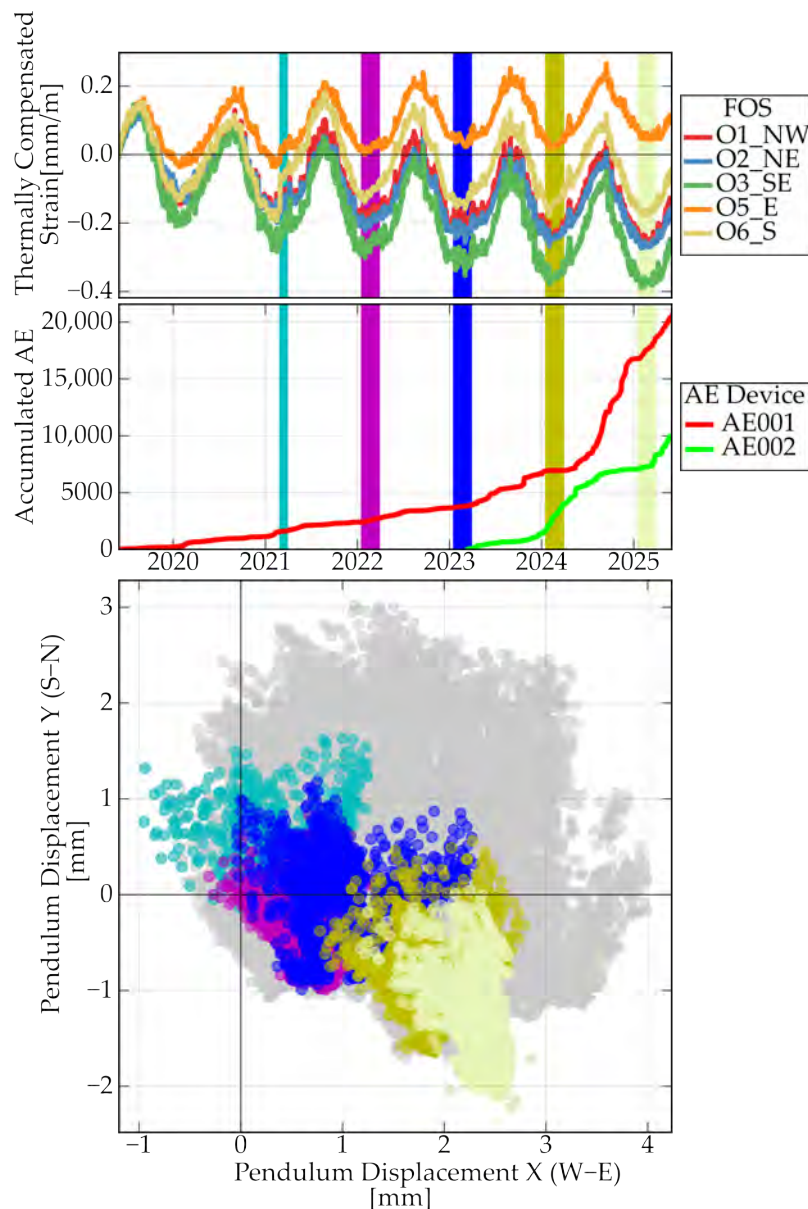
**Figure 7.** FOS strains (top graph), accumulated AE rate (center graph), and pendulum position (bottom graph) from 31 May 2019 to 6 September 2025.

To better understand the need of using PCA in the context of the SHM of the Garisenda Tower, Figure 7 depicts the behavior of the FOS strains, the accumulated number of AE signals, and the pendulum displacements together.

The periods were chosen to be roughly from mid-winter to mid-autumn, to highlight the behavior of the system in winter periods. As can be seen, the global behavior of the pendulum seems to be movement towards the south-east (SE) which is the direction of the leaning. This coincides with surges in AE rate and with global and local minima of FOS strains.

These interpretations of the principal components are supported by the observation of specific time windows highlighted in Figure 7, where coherent variations in pendulum displacement, acoustic emission activity, and temperature are observed. During these periods, the projection of the variables in the PC1–PC2 space confirms the link between structural movements and damage-related acoustic activity. Possible time-lag effects between temperature variations, pendulum movements, and acoustic emission activity will be investigated in future work.

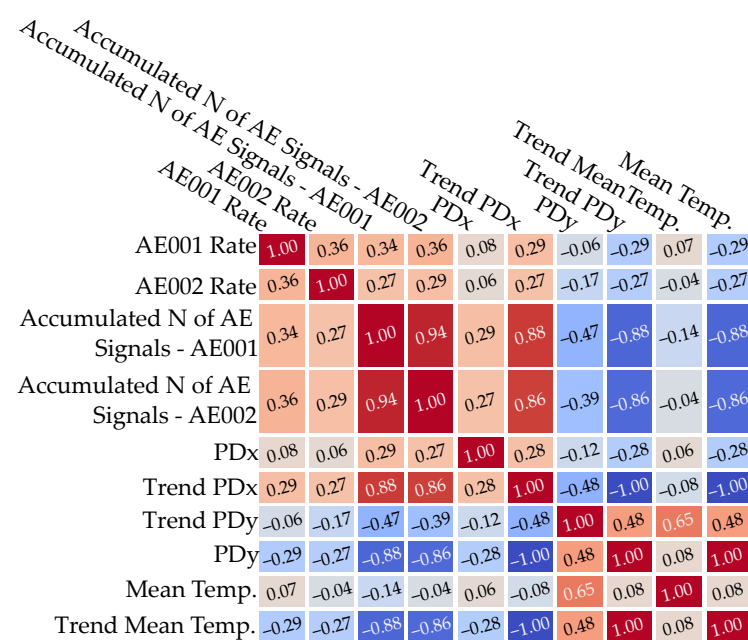
**Figure 8.** Correlation matrix of the variables analyzed. Red values indicate positive correlation and blue values indicate negative correlation.

Values were taken from 31 March 2019 to 31 May 2025. As per Equation (1), the variables were standardized and the correlation matrix was built (Figure 8).

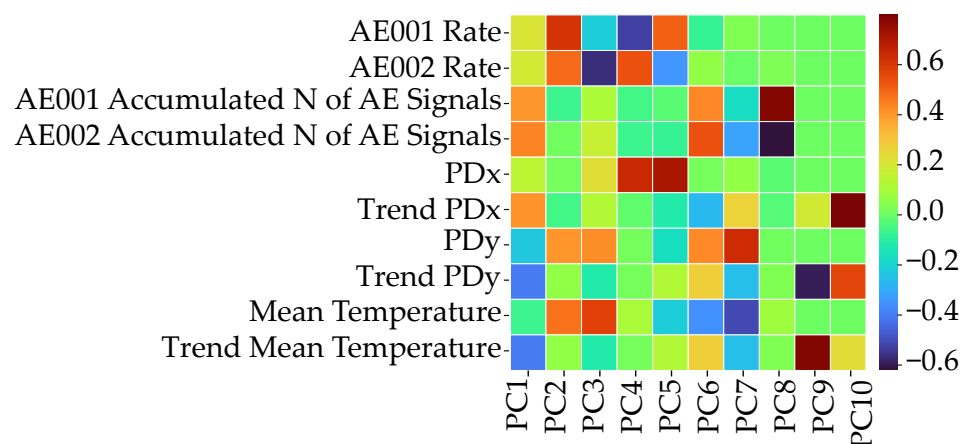
**Figure 9.** Heatmap representing the contribution of each original variable to each principal component.

From the correlation matrix, the principal components were determined. Since there are ten variables in the problem, ten principal components were calculated. The principal components, i.e., the impact of each original variable on each PC, are presented in the heatmap shown in Figure 9.

- The first PC aggregates accumulated AE, pendulum displacements, and the mean temperature. It is viewed as an indicator of damage caused by the increase in the inclination of the tower (which can also be seen by the pendulum movement).
- The second and third PCs aggregate AE rate (strong correlation for PC2, and strong anti-correlation for PC3), pendulum movement PDy (N-S motion), and mean temperature. They are viewed as changes in damage in the N-S direction due to thermal effects.
- The fourth PC, as with the second and the third, also aggregates AE rate and the pendulum movement (PDx), but this time without the temperature. It is viewed as pure damage caused in the W-E direction.

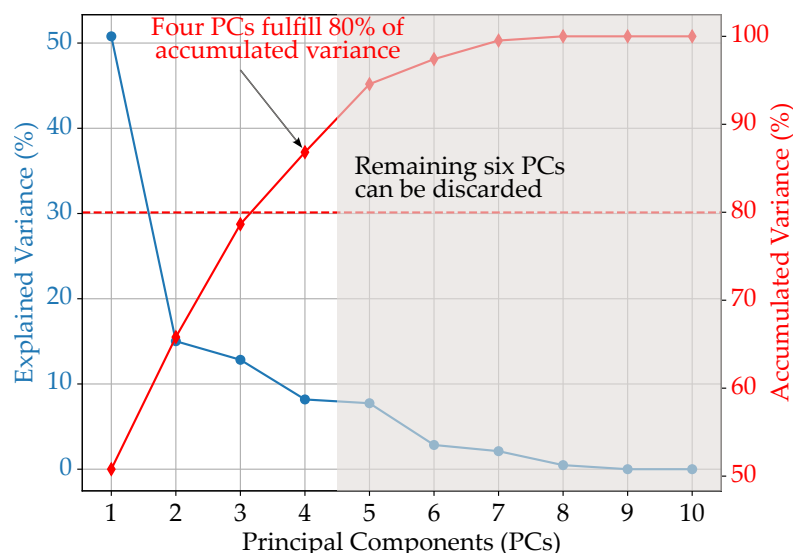
**Figure 10.** Scree plot used to determine the number of PCs to be kept in the analysis.

To understand how many principal components were sufficient for the analysis, the cumulative explained variance was calculated, shown in Figure 10. It was seen that the cumulative explained variance of the first four principal components was already higher than 80%, so the last six variables were discarded. In this study, however, attention is focused on the first two PCs. The higher-order components (PC3 and PC4), while not negligible, are associated with more localized effects and are therefore not discussed in detail in this work.

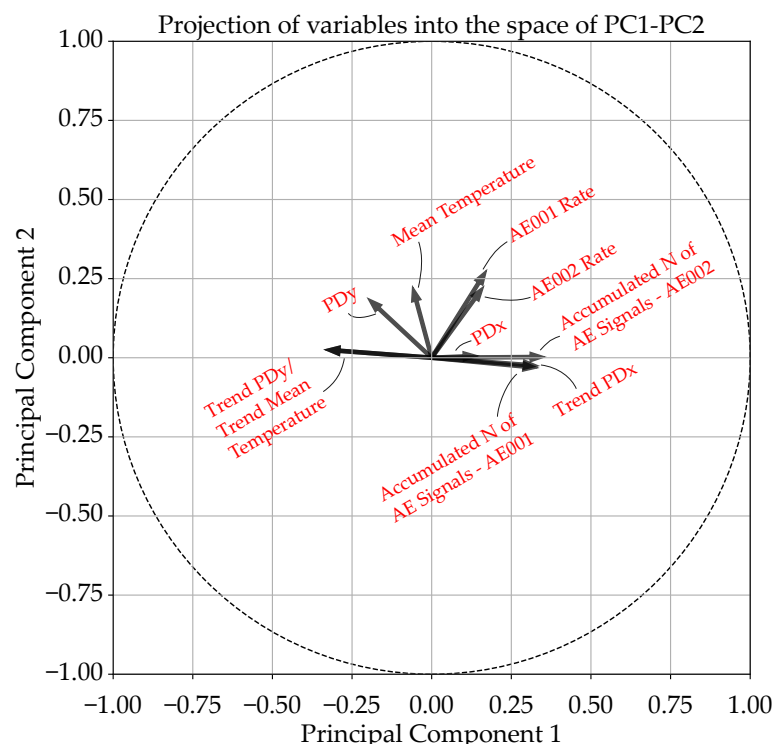
**Figure 11.** Circle of correlation: Projection of each original variable into the space of PC1-PC2.

To aid with the interpretation of the results, all variables were projected in the space of PC1-PC2, as can be seen in Figure 11.

- The variables PDx, Trend PDx, and both of the accumulated numbers of AE signals point strongly in the direction of PC1, but they point weakly in the direction of PC2. This could mean that they are correlated to damage caused by the pendulum movement in the S-E direction. This is the opposite behavior of the variables Trend PDy and trend mean temperature, which point strongly (and negatively) in the direction of PC1. An interpretation of this fact would be that, when temperatures and PDy increase, the damage related to the movement of the pendulum decreases.

- The AE rates point in the direction both of PC1 and PC2, which suggests that they are correlated to damage due to pendulum motion, specifically in the N-S direction. Interestingly, the AE rates seem to be more sensitive to the damage due to the pendulum movement in the N-S direction, as they point more in the direction of PC2 than in the direction of PC1. The variables PDy and mean temperature point in the direction of PC2, but point in the negative direction of PC1. This reflects that they are correlated to damage in the N-S direction (PC2), but anti-correlated to the damage considering the overall pendulum movement. An interpretation of this fact would be that, when temperatures and PDy increase, the overall effect of damage decreases, while increasing in the N-S direction, as if the damage shifted from W-E to N-S movement.

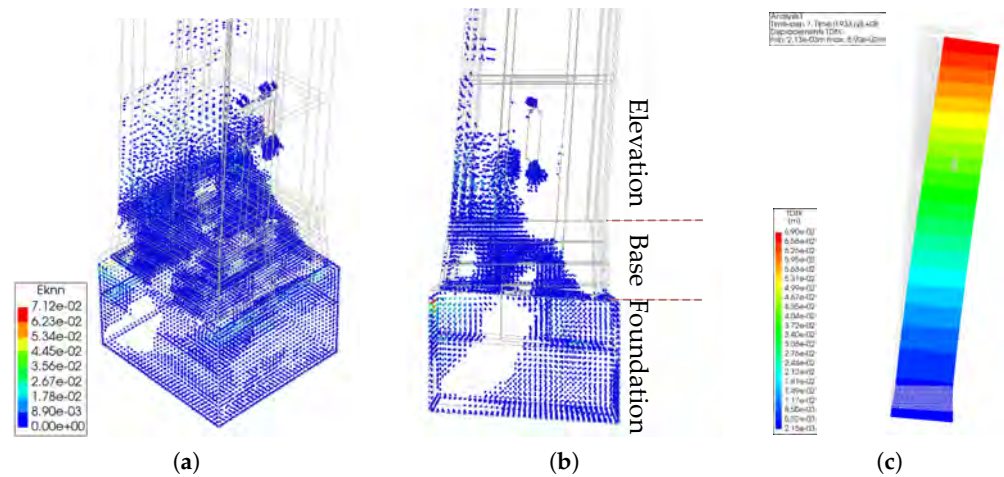
**Figure 12.** Cracks in the tower after 2.5° of tilt, where it can be seen that cracking mostly occurs in the region under tension, closer to the entrance (a,b). Eastwards displacement of the tower after 3.5 years, as a result of viscoelastic creep (c).

The numerical analysis converged up to an additional base rotation of approximately  $2.6^\circ$ . Beyond this value, convergence could not be achieved due to the development of diffuse cracking and strain localization, which can be interpreted as a physically meaningful indication of structural instability rather than a purely numerical issue. Figure 12a shows the diffused cracking pattern in the lower region of the tower, with the region under tension (closer to the entrance) being apparently the most affected.

In relation to the viscoelastic creep model, the displacement in the east direction is shown in Figure 12b. Additional tilting clearly occurs in the presence of viscous deformation. A comparison between experimental and numerical results is presented in Figure 13.

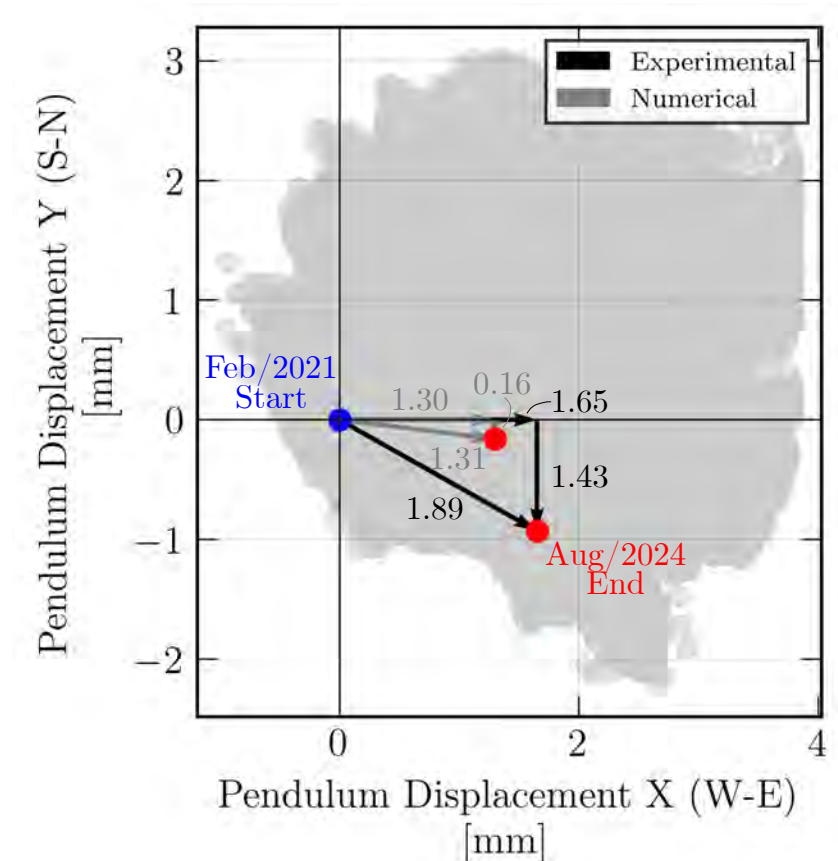
**Figure 13.** Experimental and numerical (due to creep) inelastic pendulum displacement after 3.5 years. The north–south displacements are not as well represented as the east–west displacements in the numerical model.

The creep model built in DIANA reflects well the long-term behavior observed experimentally in the tower, at least considering the displacement in the east direction. The behavior still has room for improvement in the north–south direction.
