# Performance of historical ferrocement specimens subjected to corrosive environments

Department of Structural, Geotechnical and Building Engineering (DISEG), Politecnico di Torino, Torino, Italy

## Abstract

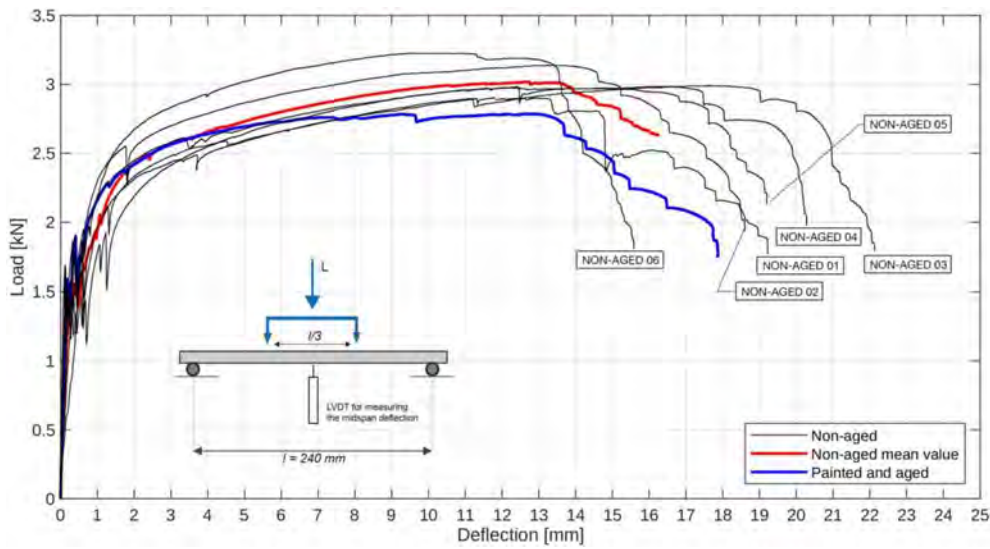
FIGURE 14 Four-point bending test load-deflection pattern, non-aged samples + painted and aged.

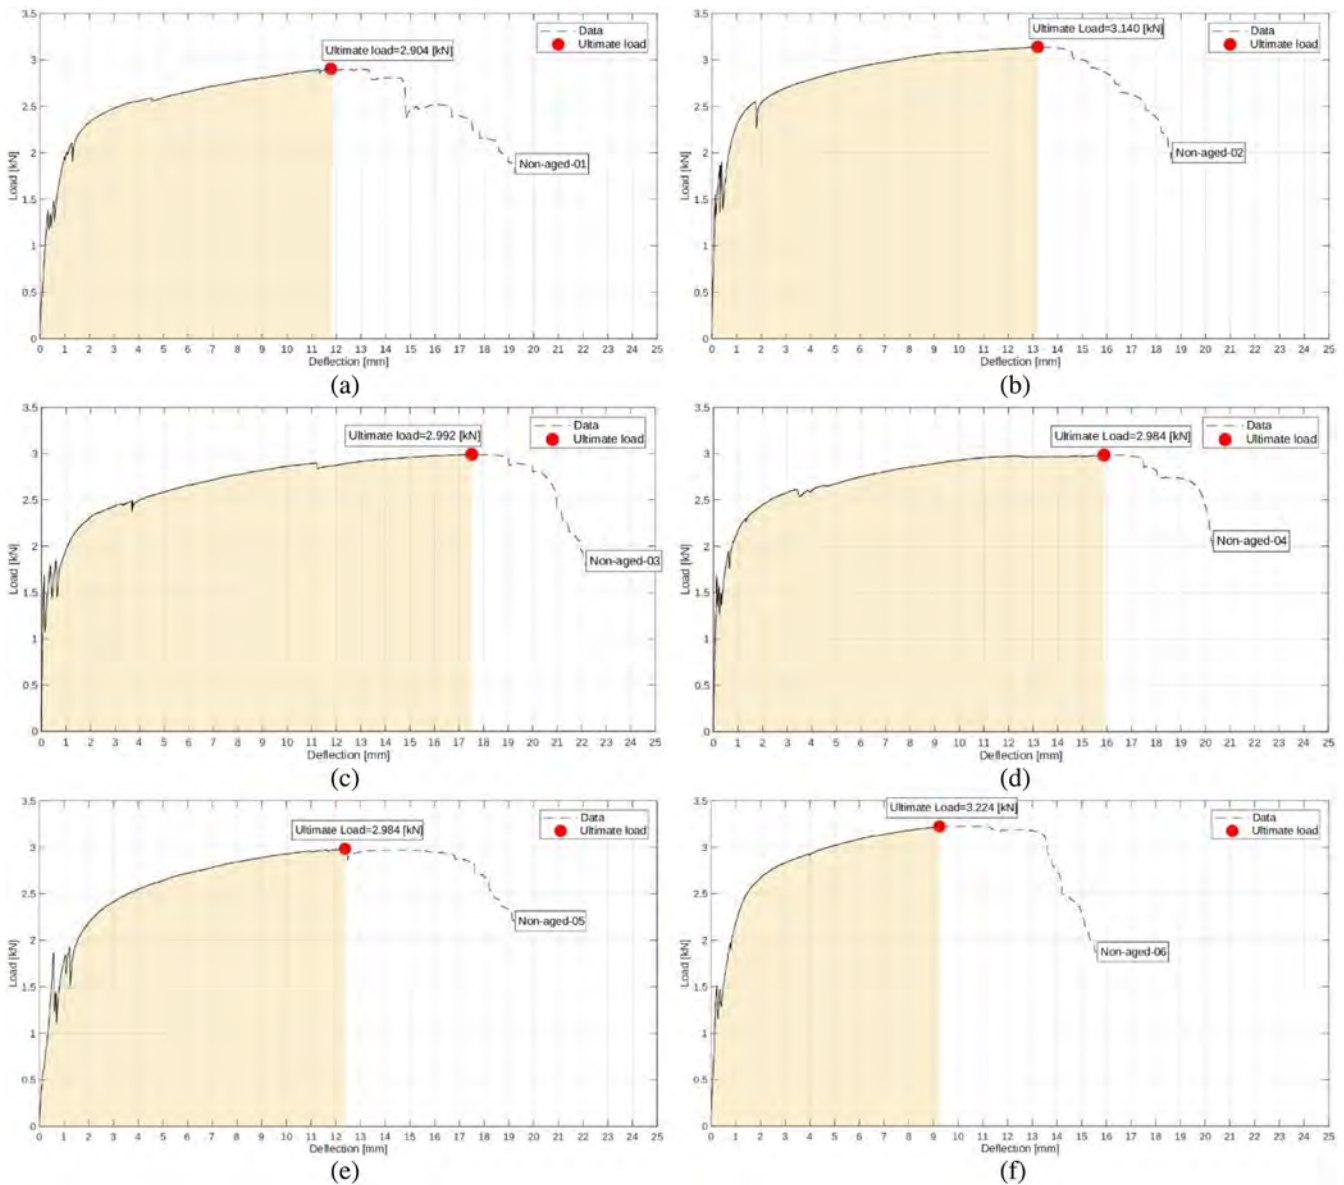
FIGURE 15 Four-point bending test, load-deflection pattern with ultimate load point and work highlighted, non-aged samples from (a) to (f).

Table 9 reports the results of the flexural tests of aggregated samples in terms of ultimate load and  $\delta_u$  (defined as the deflection at the ultimate load). Results are used to evaluate the mechanical properties of the ferrocement samples by comparing the performance of the aged and non-aged ones. Table 10 reports the results in terms of mean values and their standard deviation for each parameter (ultimate load, work, and  $\delta_u$ ). The comparison is done in terms of percentage loss compared to the non-aged samples; moreover, an additional parameter useful to evaluate the ductility of the material is by comparing the loss of work, which is represented by the underlying area of the load-deflection (Figures 13 and 15).

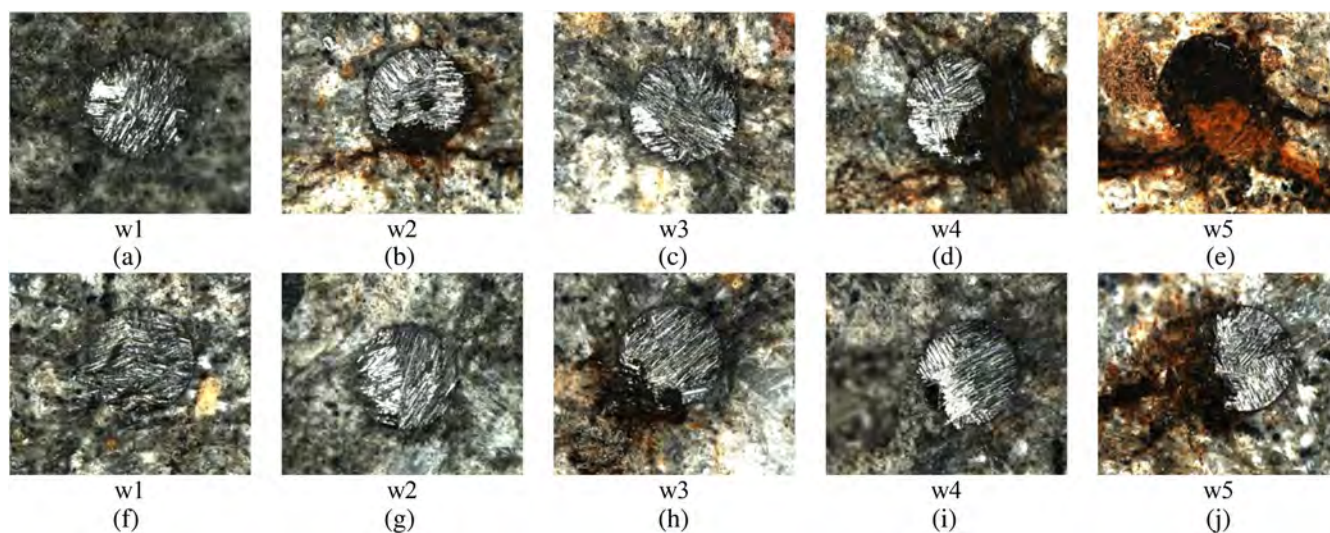
FIGURE 17 Photographic acquisitions of the corrosion state of wires of sample Aged\_02 (a–e) and the painted and aged sample (f–j), by means of the optical microscope (magnification 5×).

The corrosion was then measured for each wire of the first layer of mesh (highlighted in red in Figure 16c), which was the one closest to the surface exposed to the aging action of the chlorides. Figure 17 shows the photographic acquisition of the corrosion state of the wires of sample Aged\_02 and the sample Aged and painted. Corrosion was detected in all samples, besides the different levels of seriousness in the different wires, ranging from no corrosion (e.g., Figure 17a,c, f,g,h) to the total corrosion of the area (Figure 17e). Results of the measurements of the cross-sectional corrosion-loss of the wires of each sample are reported in Table 8, while Figure 18 shows a detail of the measuring on a wire.
