Doctoral Dissertation
Doctoral Program in Civil and Environmental Engineering (36th Cycle)

Collapse Analysis and Selective Retrofitting

using the Applied Element Method, AEM

Cosimo Pellecchia

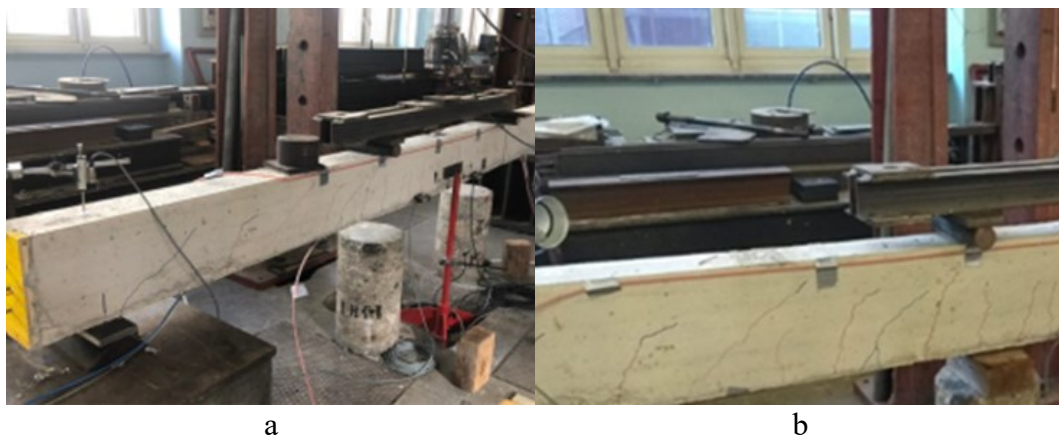
Figure 4. Test setup (a) and crack pattern at failure (b)

At the end of the test, two types of cracks were detected, due to bending moment and shear (Figure 4, b). Bending vertical cracks were concentrated between the two loading points while shear diagonal cracks developed between the support and the loading point.

Before approaching the analysis of a full-scale collapse case, the research focused on a component-level test case. A reinforced concrete, RC, beam was assembled and tested in the Polytechnic laboratories using a four-point bending test. The test was performed in displacement control using a beam designed for ductile behavior (Figure 4, a).

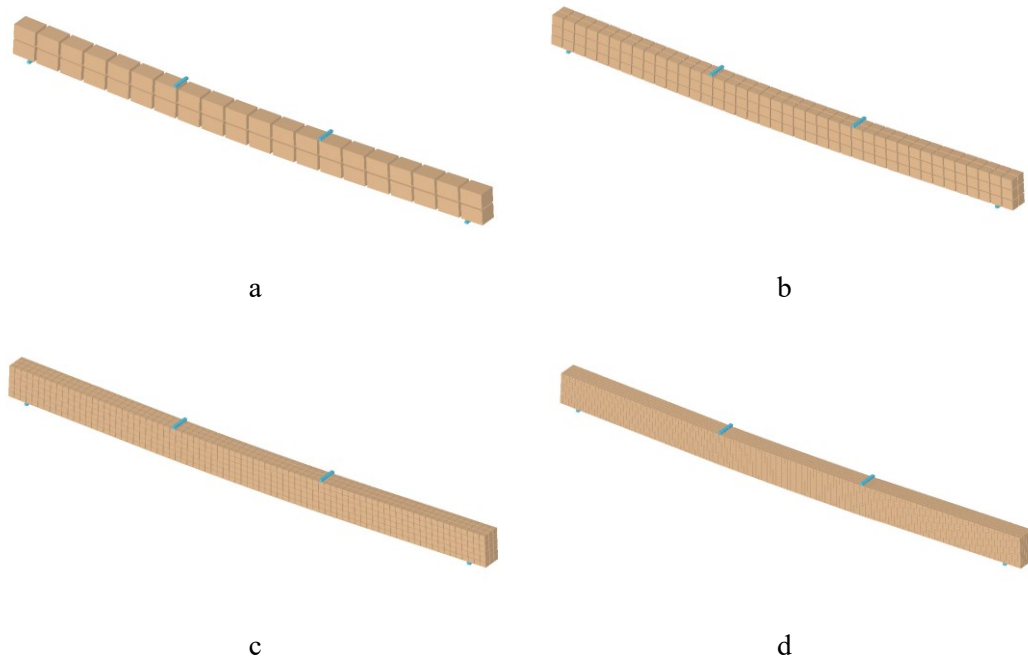
Figure 5. Sensitivity analysis considering a mesh length equal to 20 (a), 10 (b), 5 (c) and 2.5 cm (d).

Different AEM mesh ratios were considered in the analysis (Figure 5).

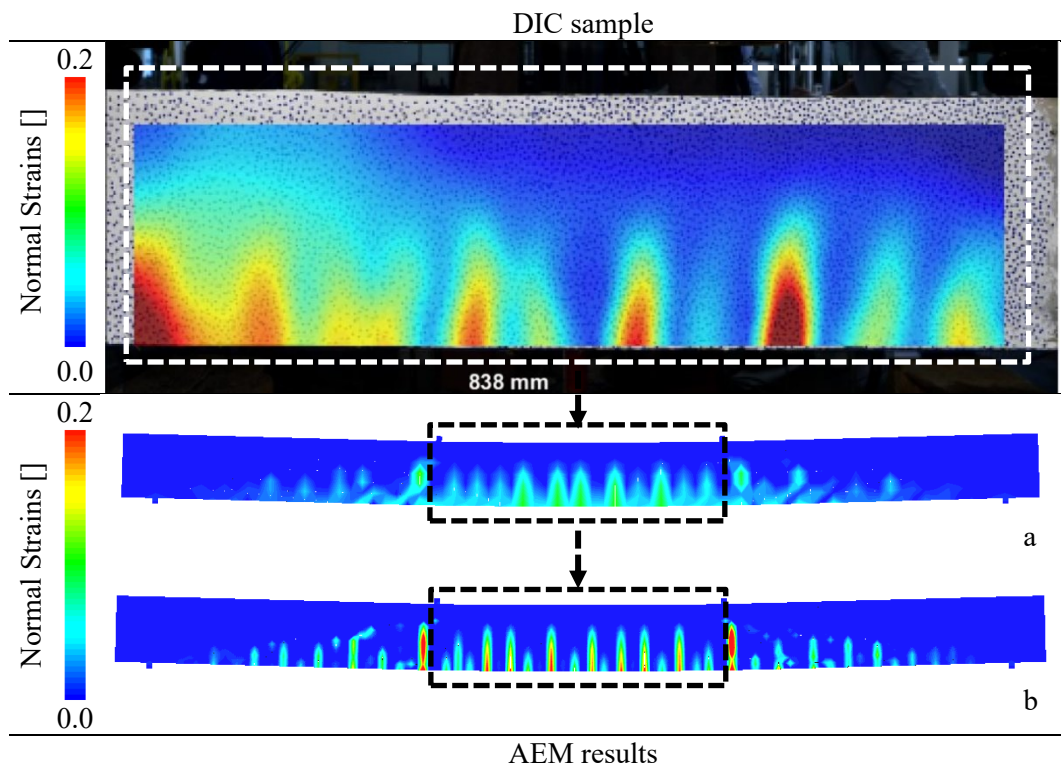
Figure 6. Comparison between DIC and AEM results considering a mesh length of 20 (a) and 2.5cm (b).

It was observed how the reduction of the mesh length from 20 to 2.5cm, passing through the 10 and 5cm length steps, provided an increasing refined representation of the cracks and strain values. For the sake of picture clarity, only the results obtained with the roughest (20cm) and refined (2.5cm) mesh dimensions are included in Figure 6.

The comparison between the actual test and the numerical simulation was carried out through the Digital Image Correlation technique, DIC. The DIC technique uses the recorded displacement of a given point pattern to derive the strain distribution of a given surface. A high-resolution camera captures the displacement of the different points, and the images are post-processed using a detection algorithm to compare the position of the different markers and calculate the displacement and strain fields. By using the contour plot technique, the resultant strains valued derived from the experimental test are visually compared with the numerical results at the different loading steps. The accuracy of the DIC technique is generally depending on image acquisition, analysis and image subject (Bomarito et al. 2017). Previous research proved that the deviation between values acquired using DIC and conventional techniques such as strain gauge is less than 5% (Lakshmish Kumar, H B, and Hossiney 2019). The experimental test was carried out considering different loading steps. The numerical results at different loading steps shown a good accordance with the actual strain detected through DIC technique (Figure 6).

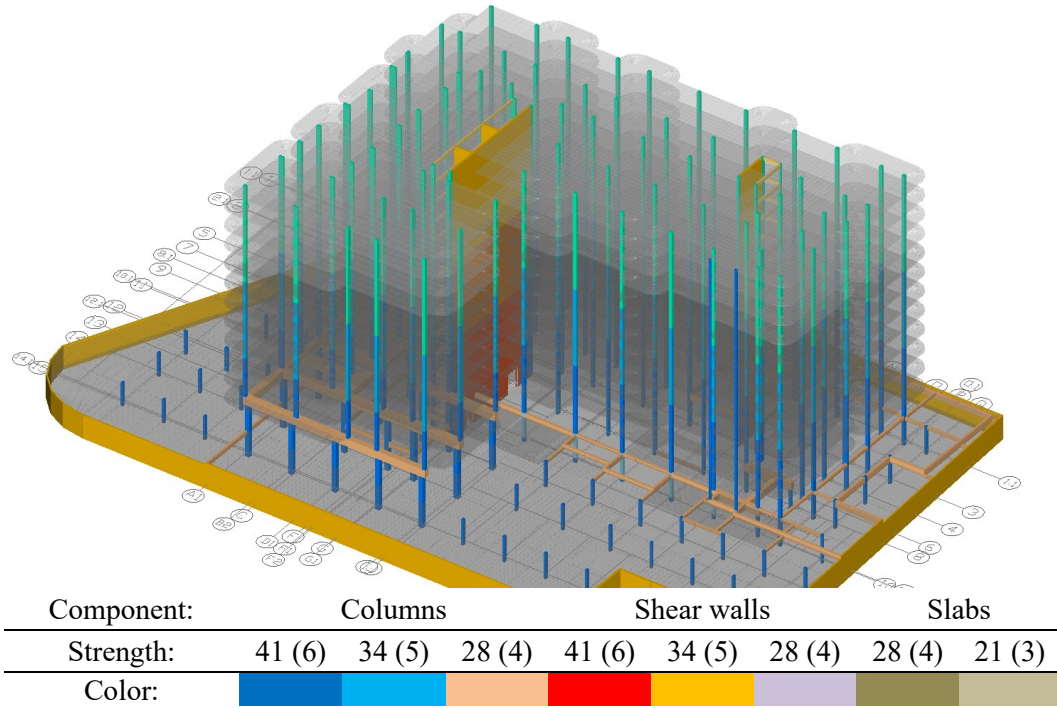
Figure 8. Color map of concrete strength in columns, shear walls, and slabs (a) [MPa (ksi)]

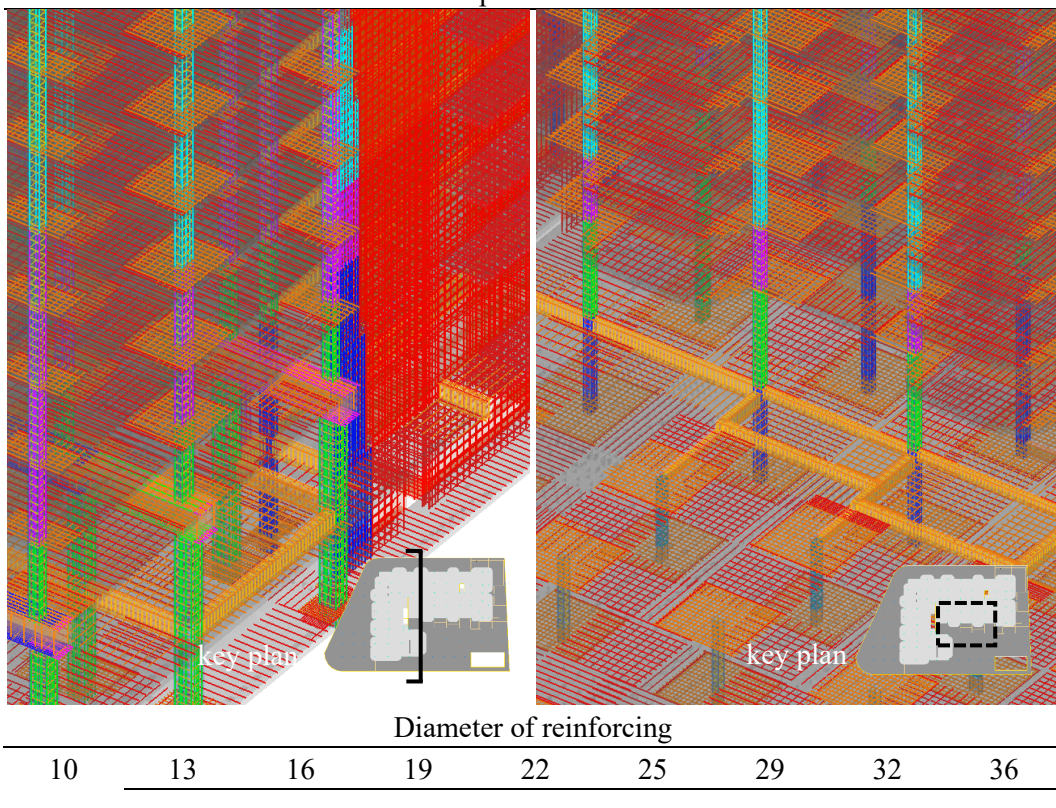
Figure 9. Diameter of reinforcement bars implemented in the numerical model [mm]

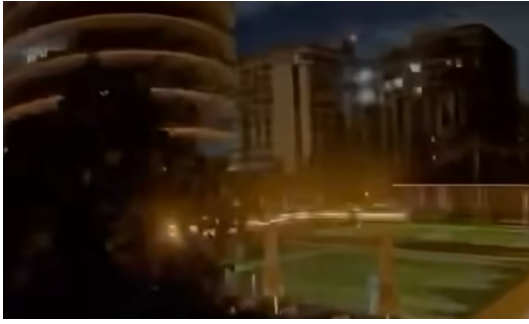
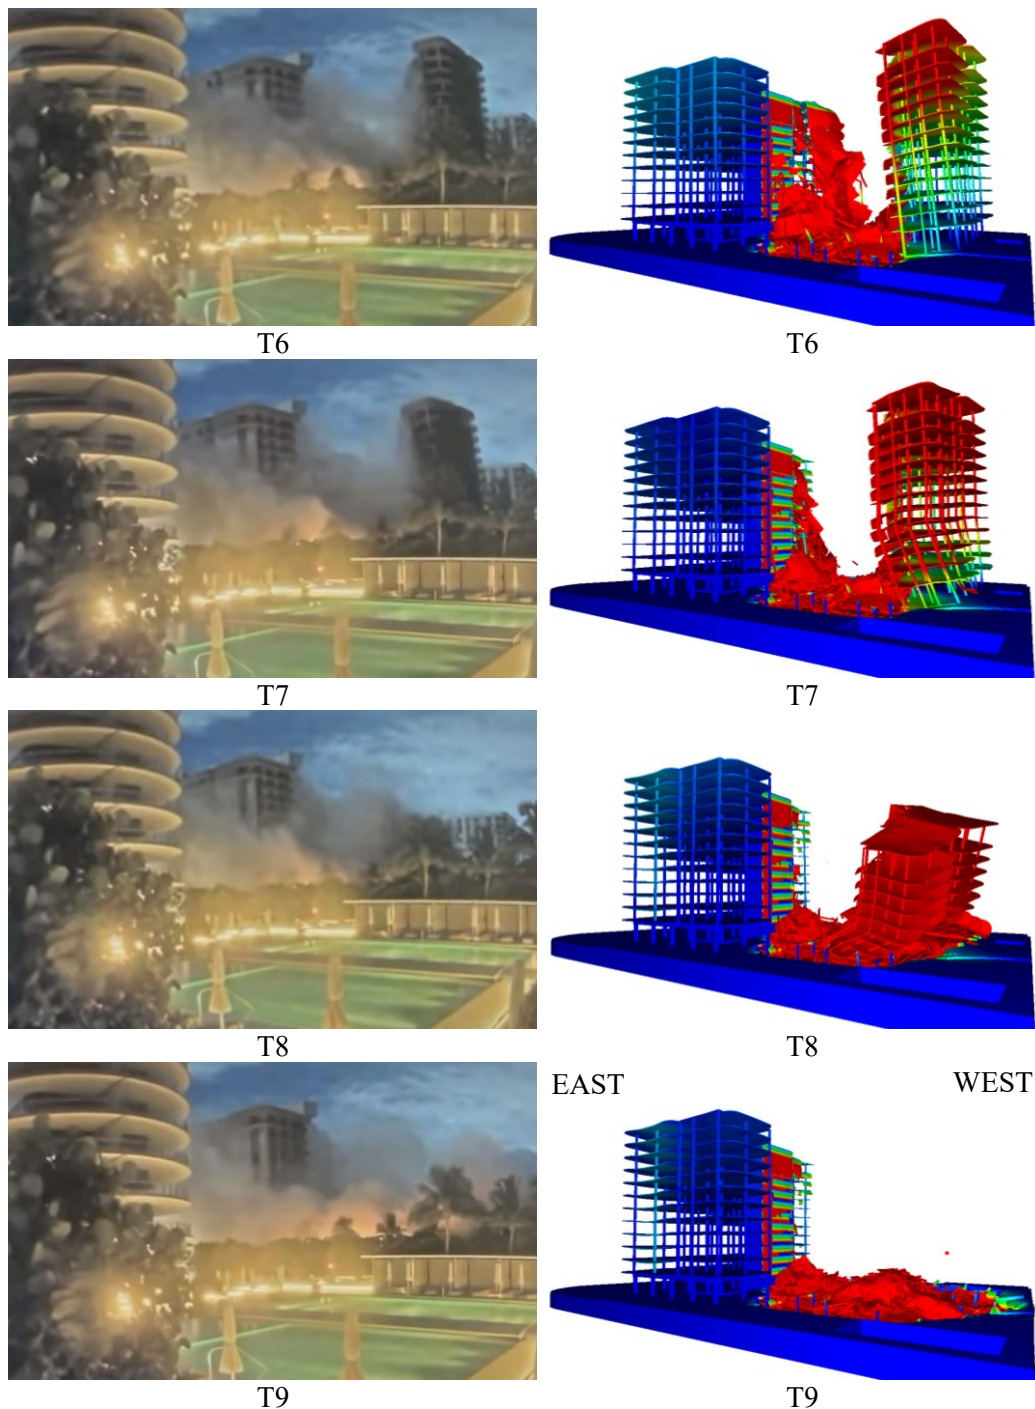
Fig. 11 shows a side-by-side comparison between the simulation and the footage of the collapse (Slater 2021). The comparison shows a good agreement between the simulations and the actual collapse, both during the initial failure of the central portion of the building, and the initial torsion of the remaining eastern portion of the building, a few instants later. However, a flexural failure at mid-height of the eastern wing of the structure can be observed only in the numerical analysis, occurring when the remaining portion of the structure starts hitting the ground (frame T7 in Figure 17).

Figure 17. Side-by-side comparison between the collapse footage and the numerical analysis in nine different timestamps; Image courtesy of Slater (2021).

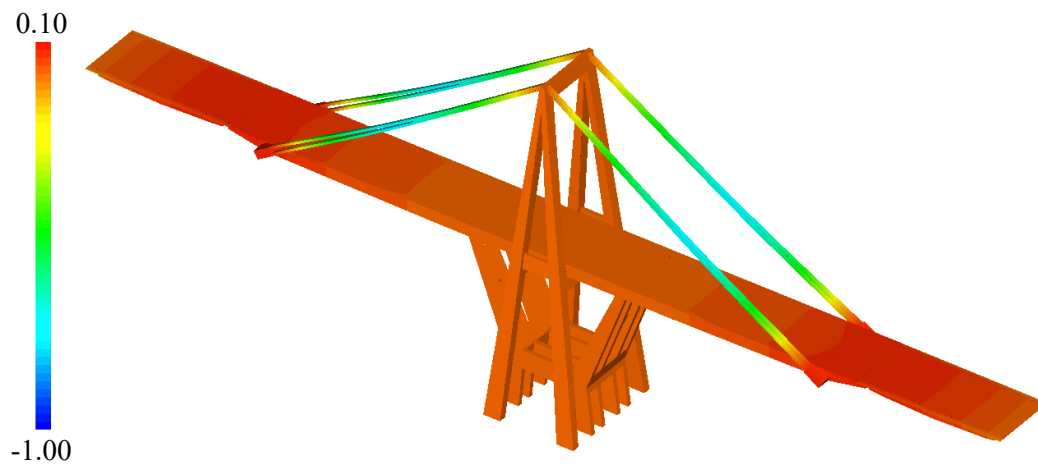
phenomena, such as concrete cover decompression of the bridge stays. Time-dependent phenomena, as well as construction defects were not considered in the analysis scheme described herein. The vertical displacements based on the above-mentioned analysis schemes are shown in Figure 27.

Figure 27. AEM model: vertical displacements due to the dead load after post-tensioning of prestressing cables [cm]

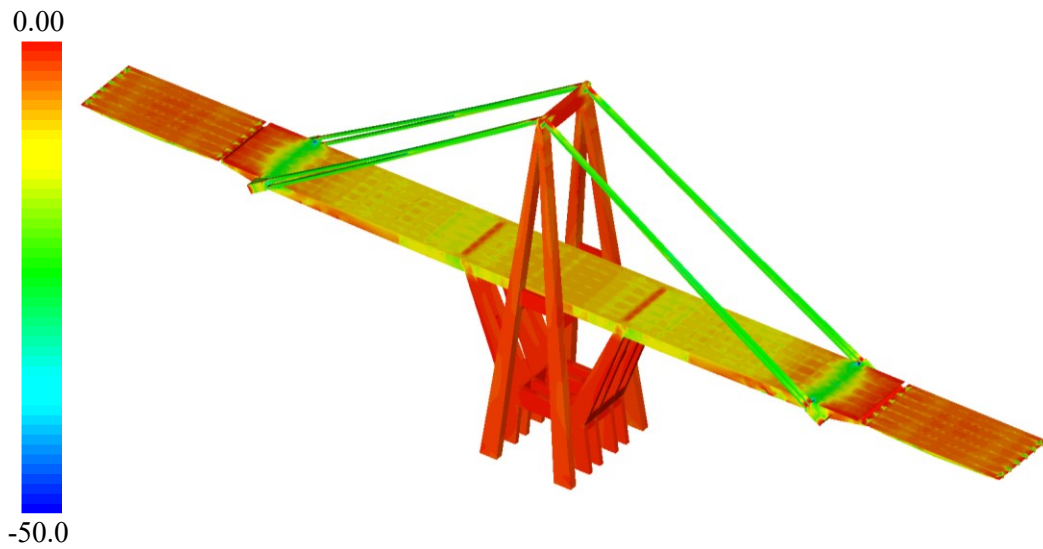
The first outcome of the sensitivity analysis on the progressive collapse of the bridge highlighted the robustness of the A-shaped tower, of the trestle and of the deck. This result was justified in view of the redundancy that characterize these structural elements and their compression state in in-service condition. Indeed, both the A-shaped tower and the trestle elements were predominantly in compression. Similarly, the main girder was subjected to high compressive forces because of the horizontal components of the internal forces in the stays. In essence, all the deck sections were in a prevalent compression state under the working loads (Figure 28).

Figure 28. Compressive stresses along the deck in the static analysis [MPa]

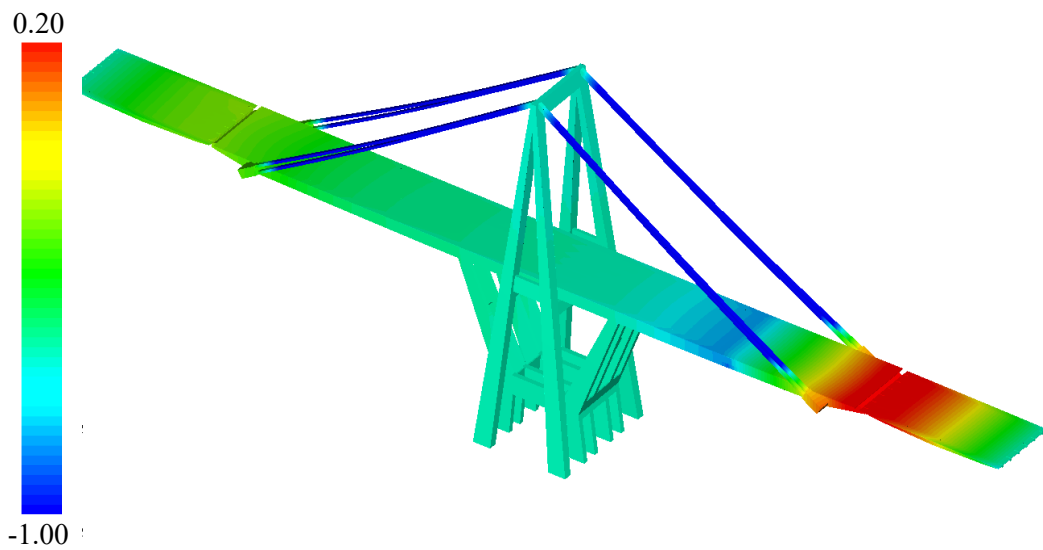
Figure 29. Vertical displacement with degradation to four deck's ribs [m]

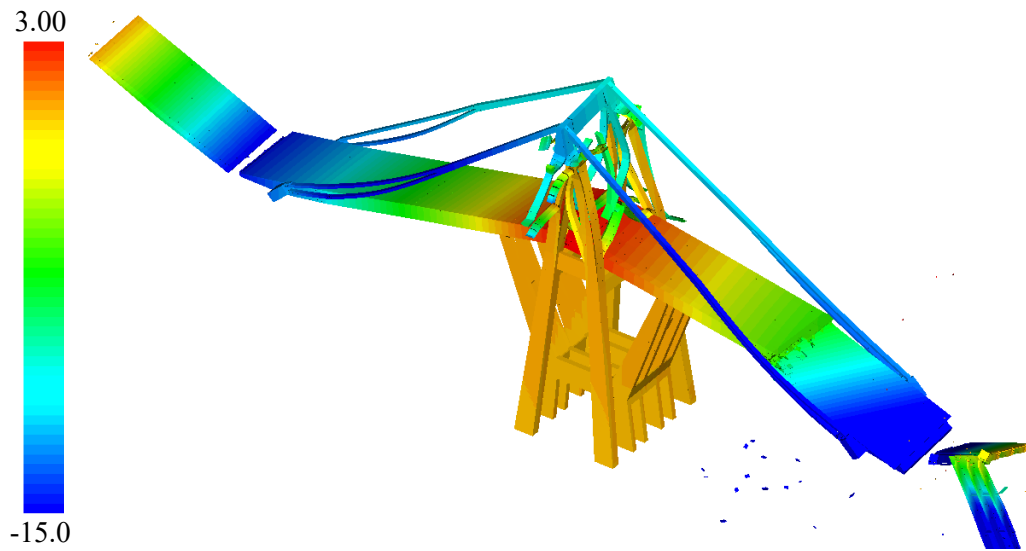
Figure 30. Vertical displacement with degradation to four deck's ribs [m]

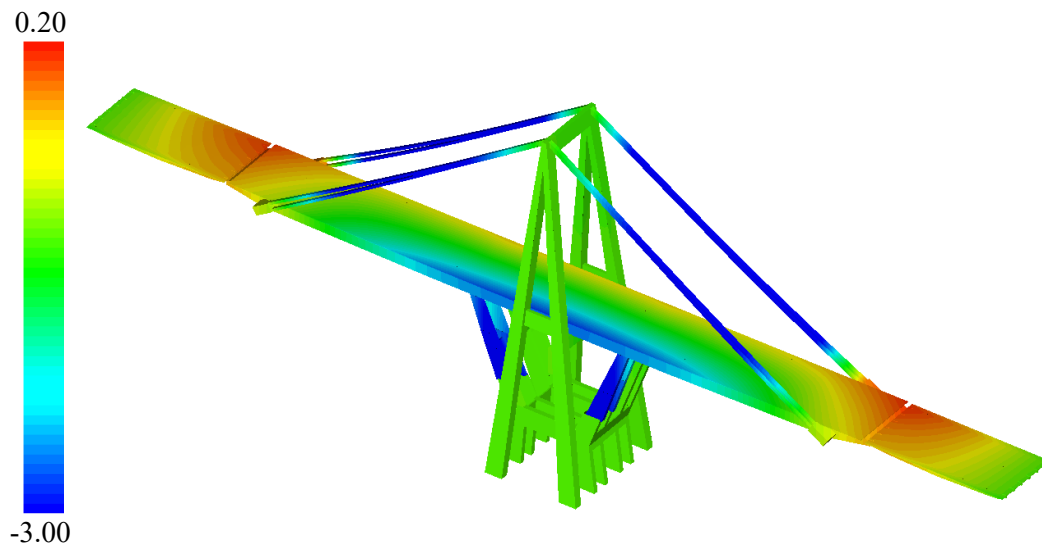
Figure 31. Vertical displacement with degradation to four trestle's sections [m]

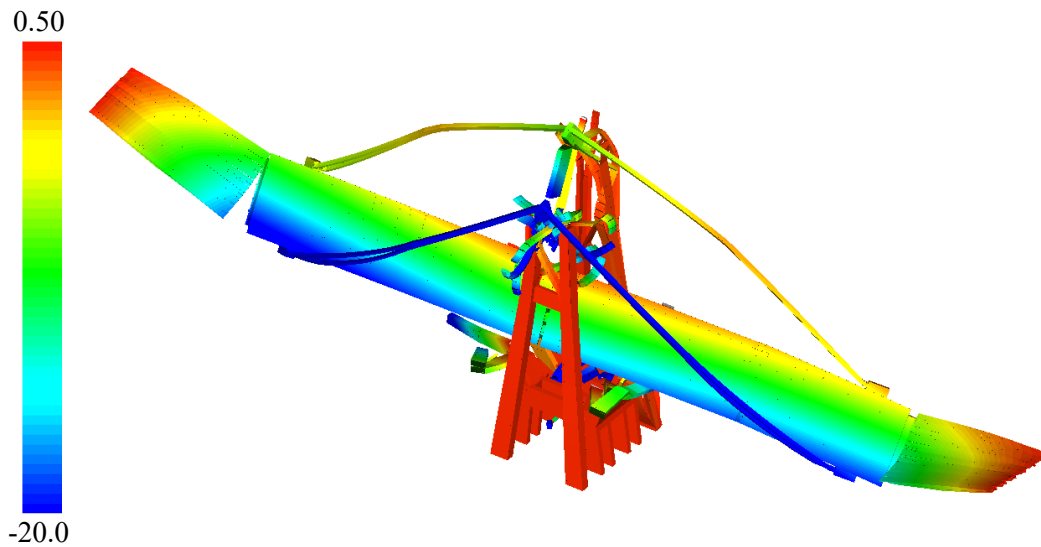
Figure 32. Vertical displacement with degradation to five trestle's sections [m]

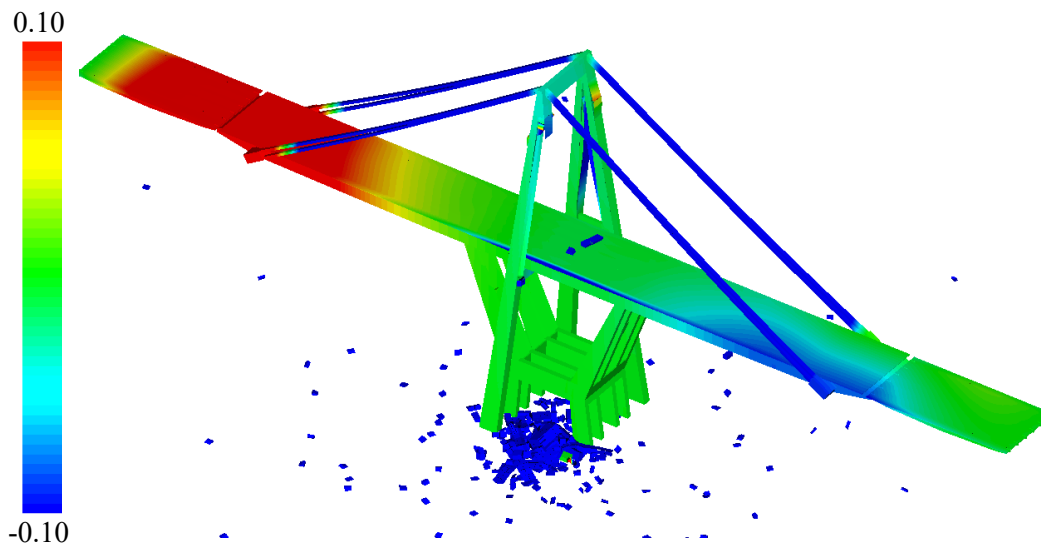
Figure 33. Vertical displacement with applied degradation to one tower's section [m]

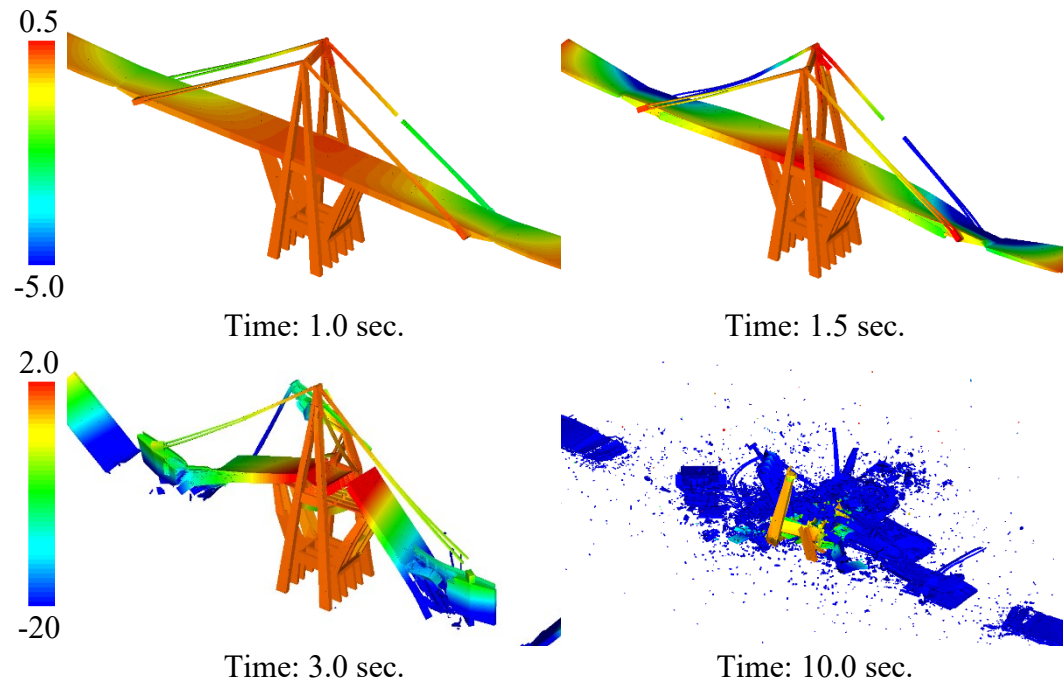
Figure 34. Vertical displacement with applied degradation to one cable's section [m]

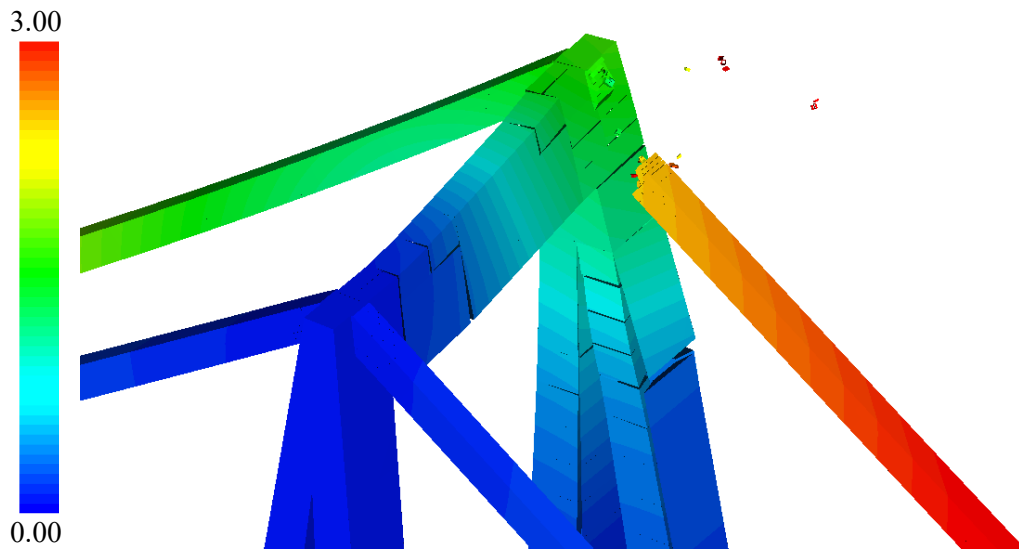
Figure 35. Vertical displacement with applied degradation along the entire length of the stay [m]

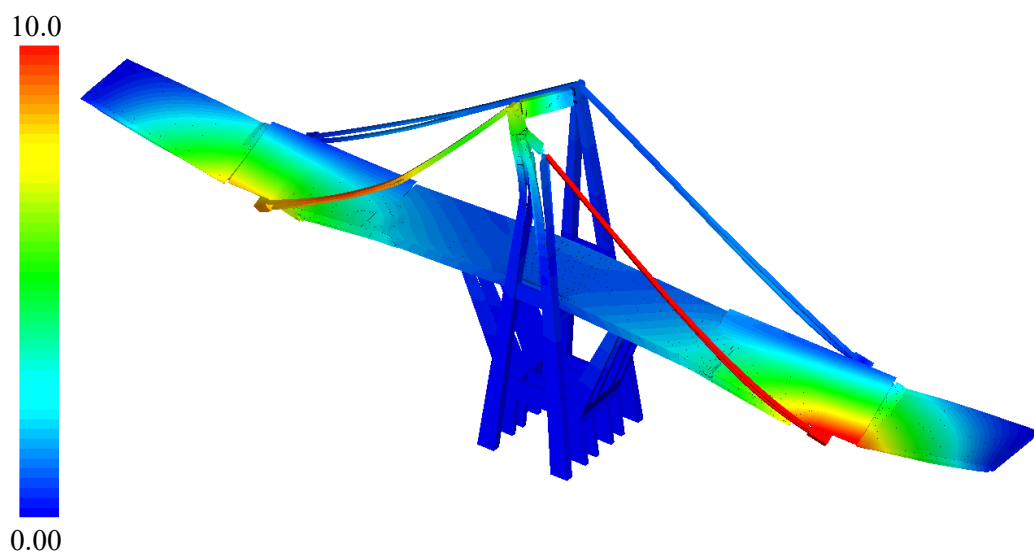
Figure 36. Vertical displacement with applied degradation to the South-East stay [m].

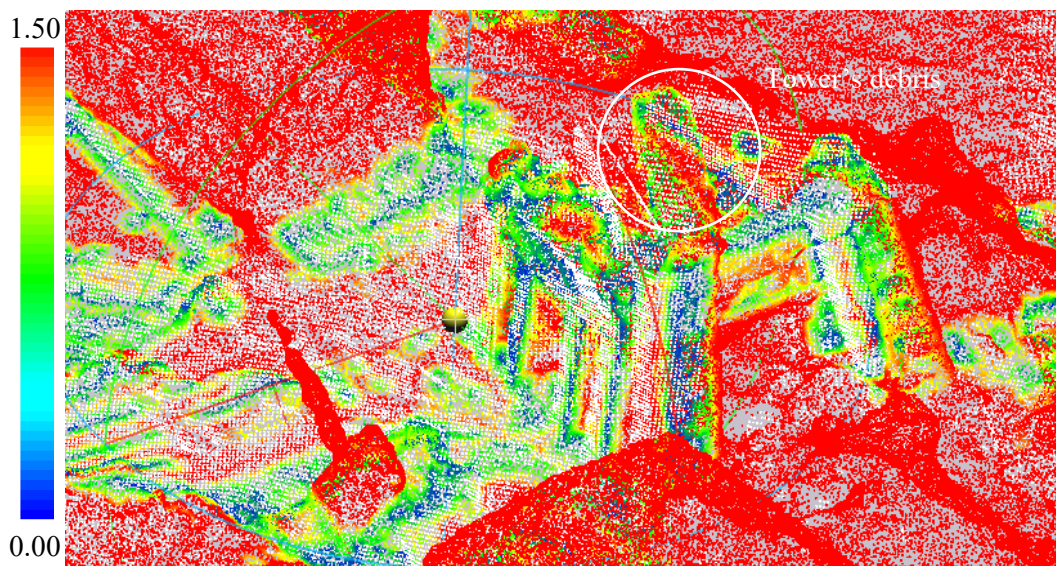
Figure 40. Absolute distance between point cloud based on satellite images and point cloud based on AEM analysis [m]

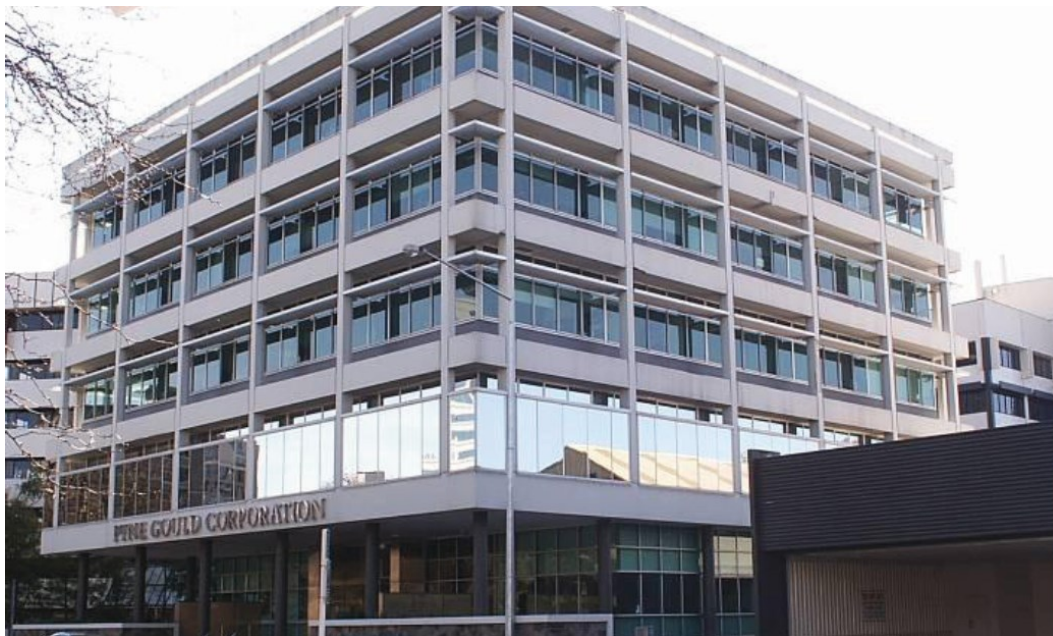
Figure 41. Pyne Gould Building photographed from the South-East elevation after the 4 September 2011 earthquake.

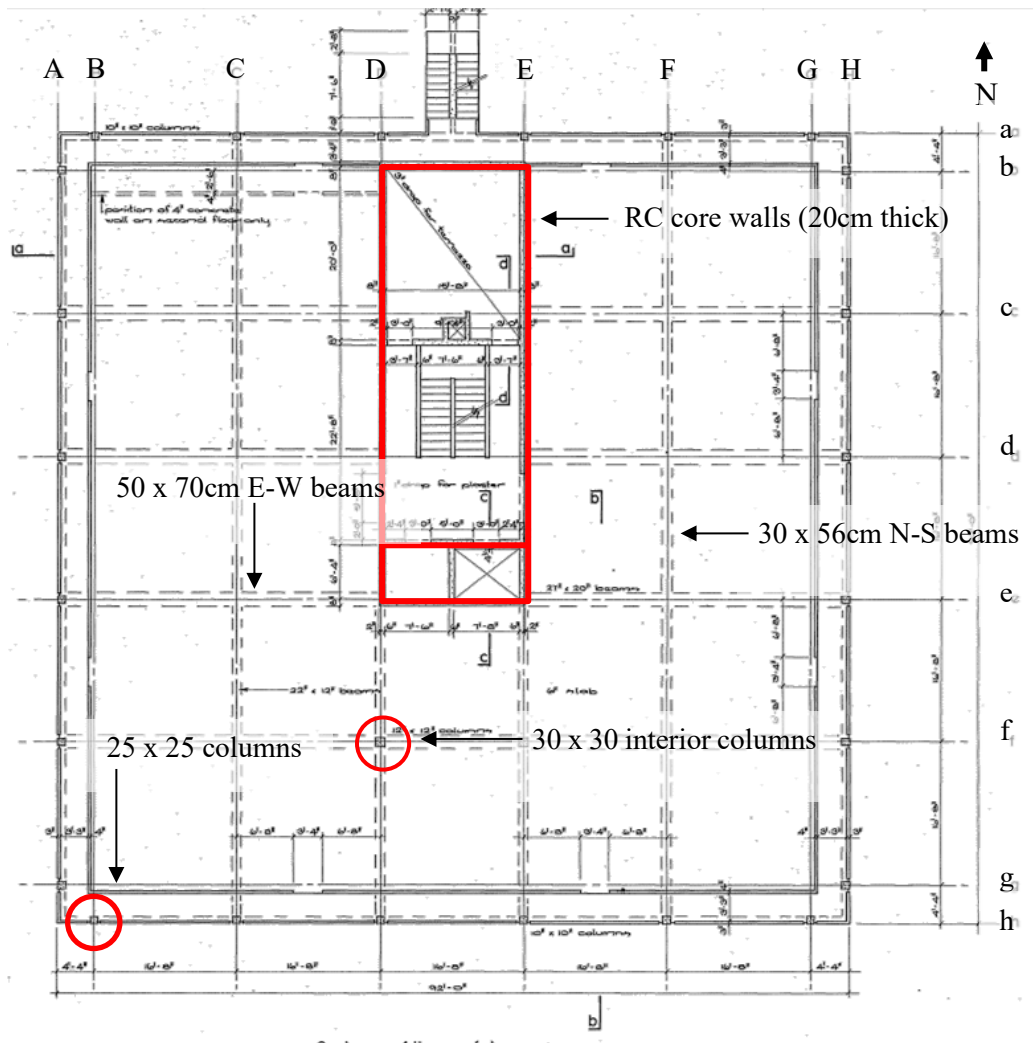
Figure 42. Typical floors (2nd to 4th Floors)

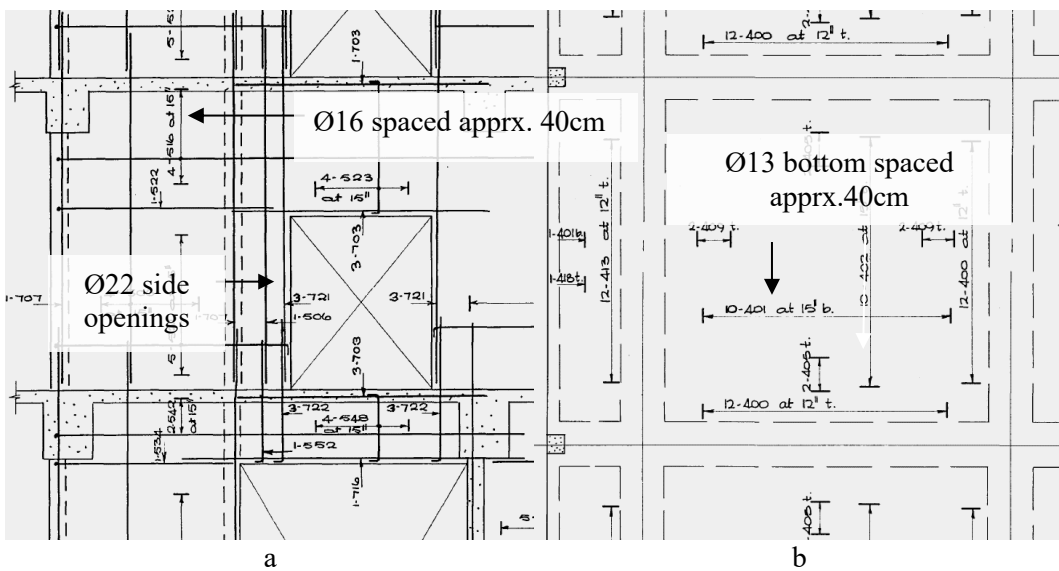
Figure 45. Shear wall (a) and Sabs (b) reinforcement details.

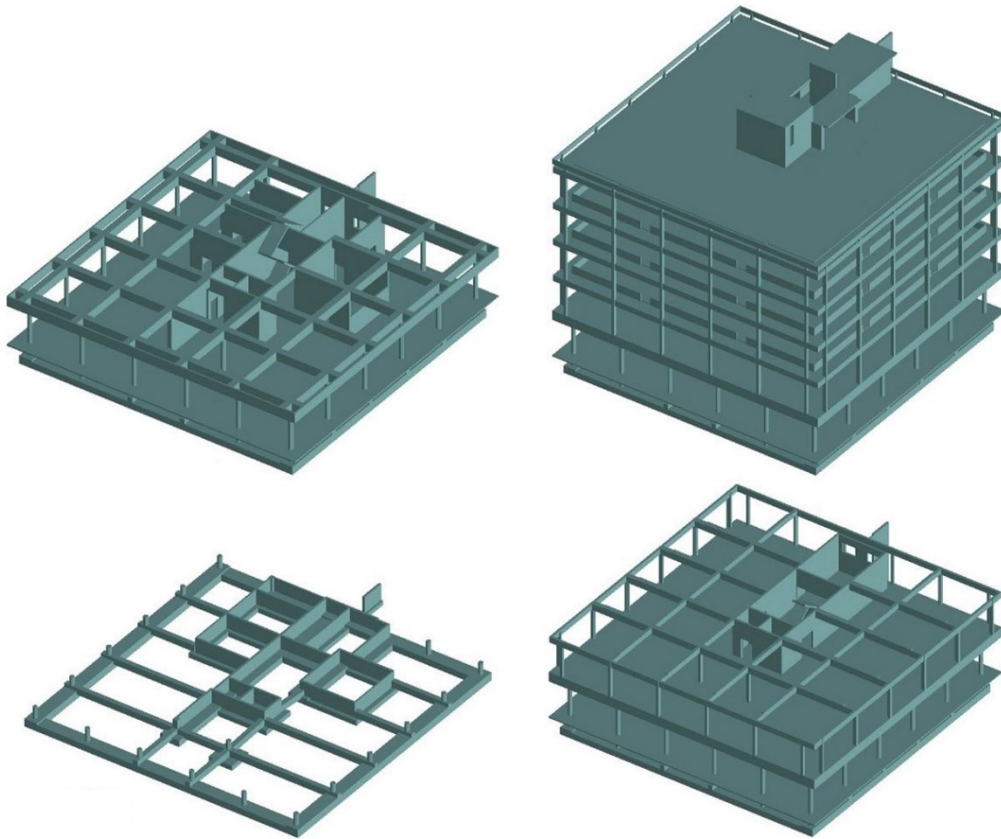
Figure 47. AEM numerical model

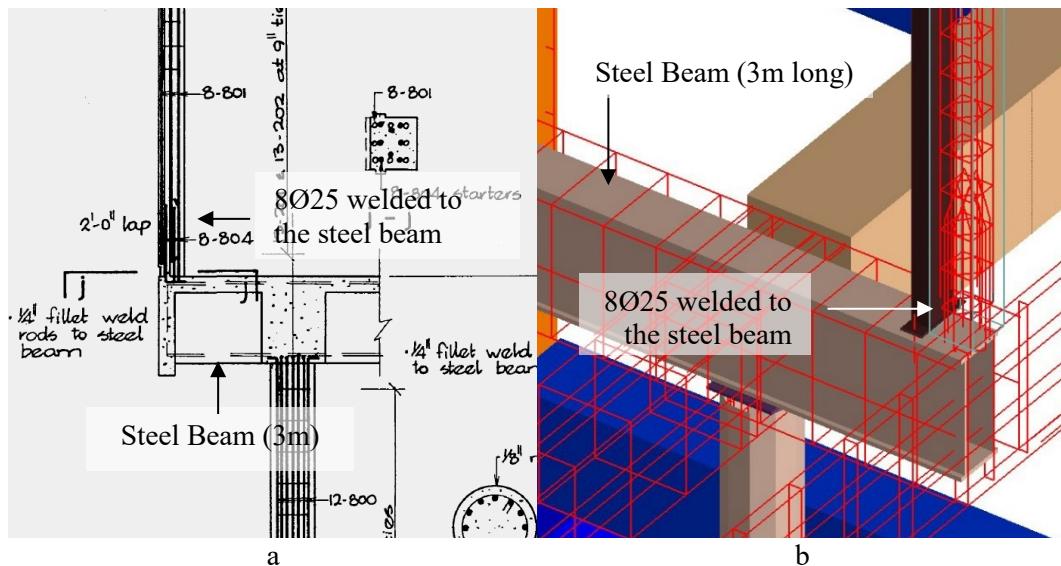
Figure 49. Steel beams enclosed in the concrete girder, original drawings (a) and numerical model (b).

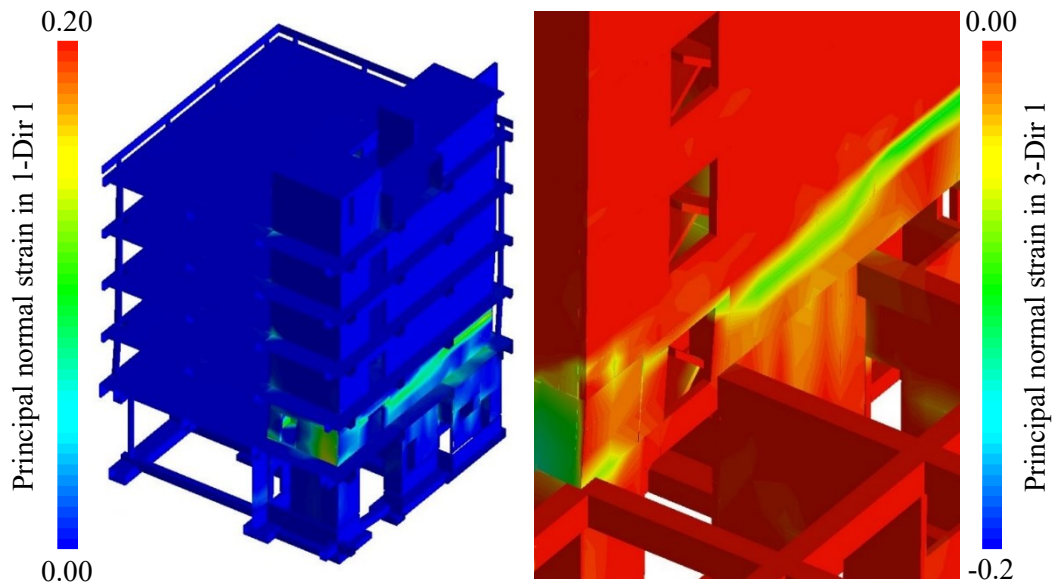
Figure 52. Buckling failure in the shear core of the building at approximately 7.00sec.

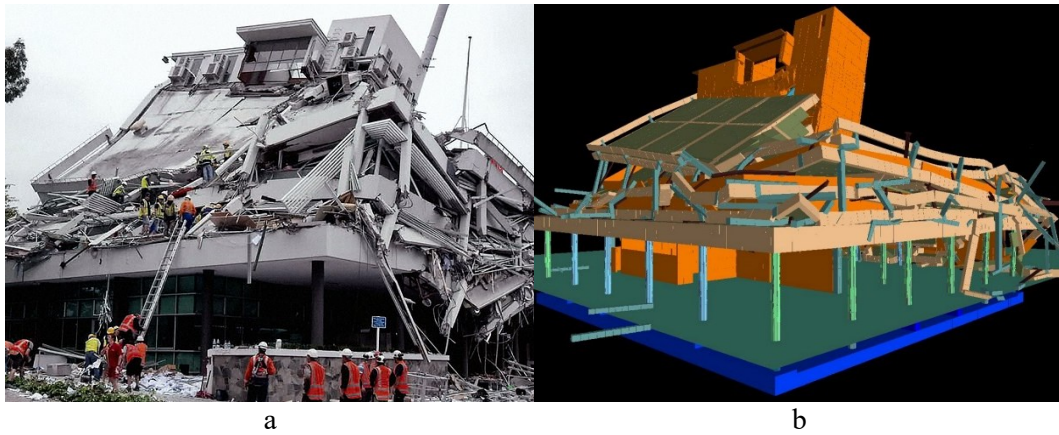
Figure 54. South-west picture of the Pyne Gould Building after the collapse, (a) and analysis results (b).

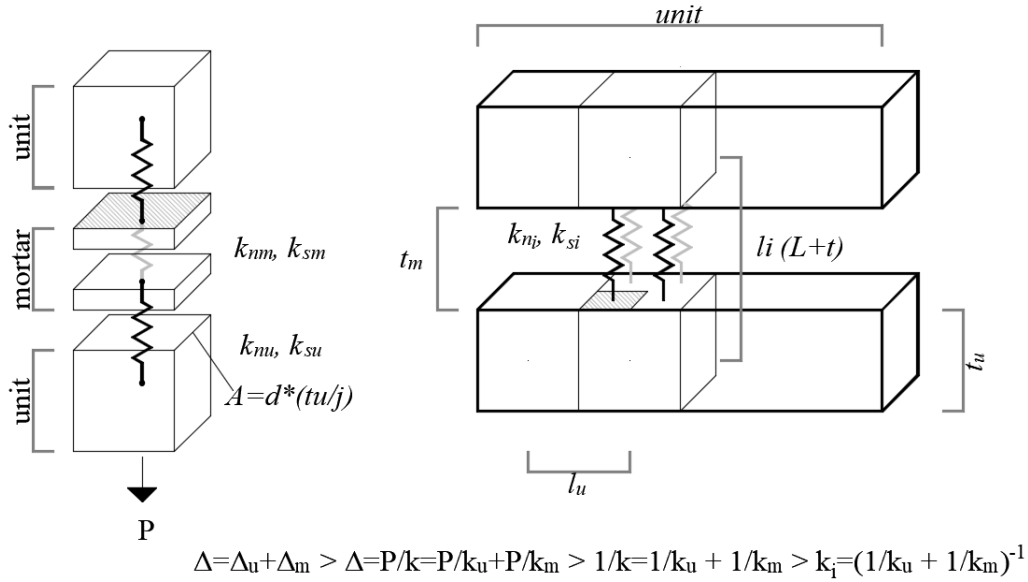
Figure 56. Equivalent springs representing unit-mortar interaction.

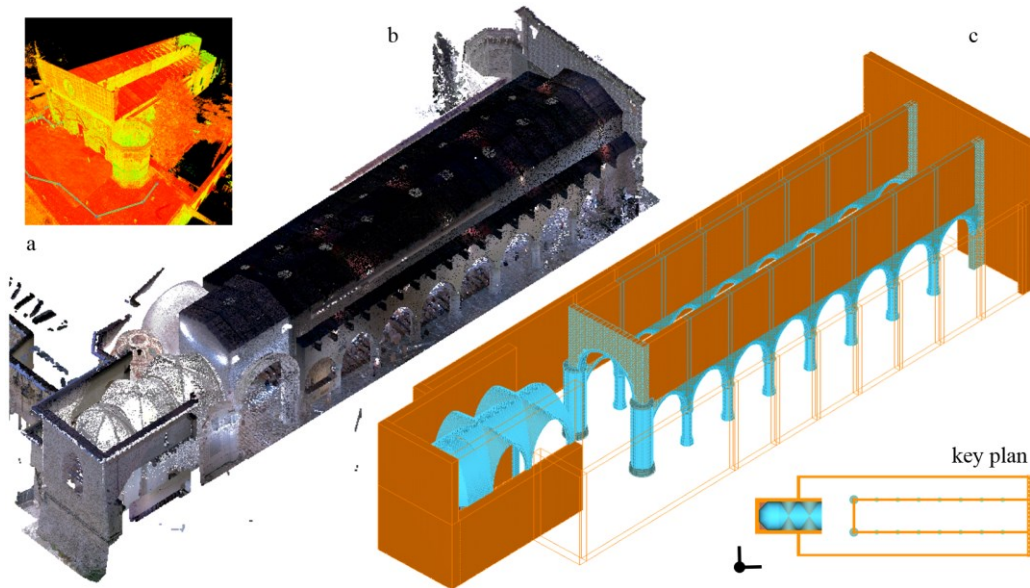
Figure 57. Laser scanner survey of the Basilica (a), processed point cloud (b), and developed numerical model (c).

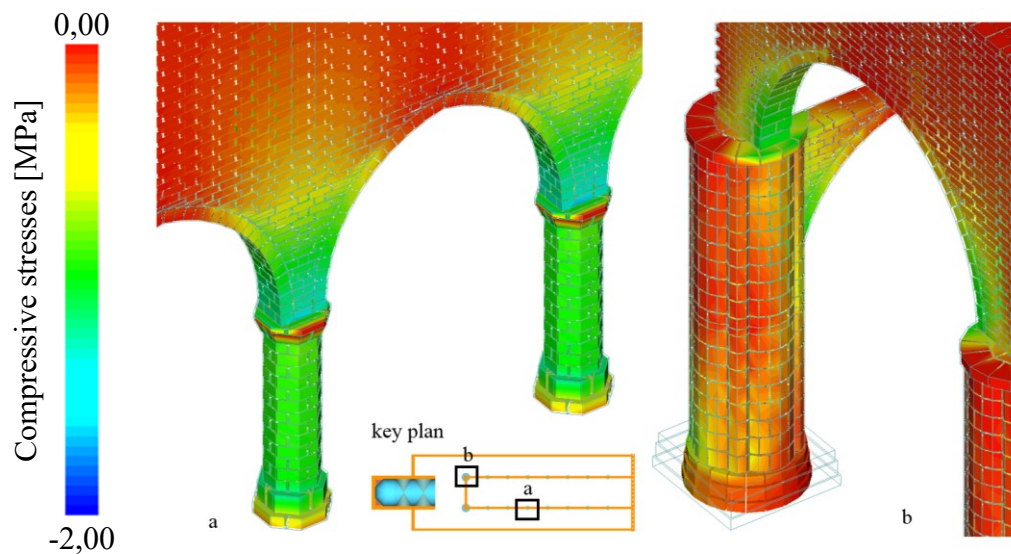
Figure 58. Distribution of compressive stresses in nave's (a) and transept (b) columns, dead load only.

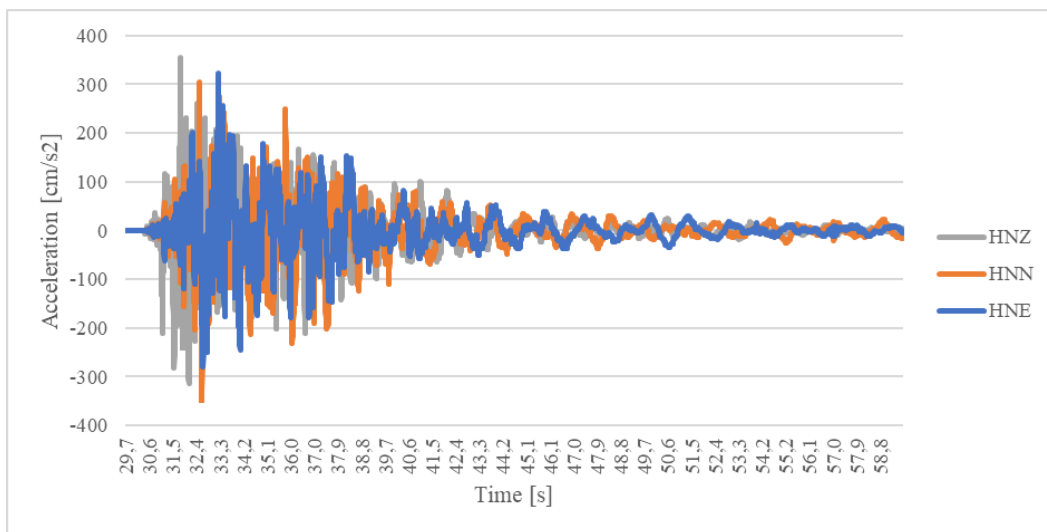
Figure 61. Ground motion at the nearest gauge to the Basilica di Collemaggio. Data from (Russo et al. 2022).

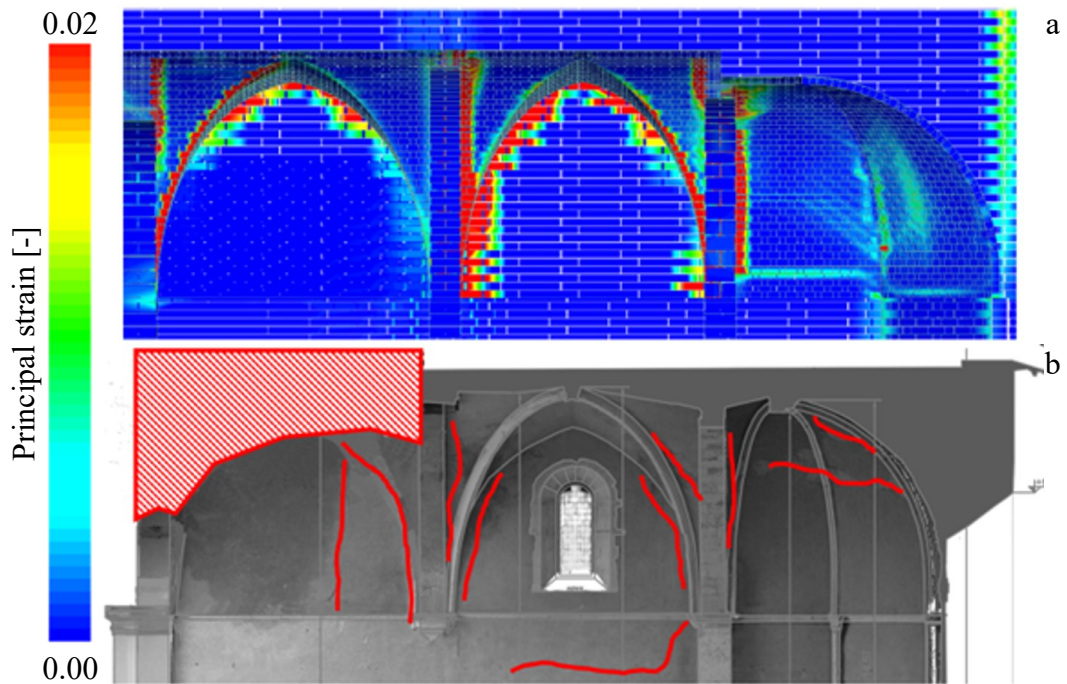
Figure 62. Comparison between the analysis results (a) and actual distribution of cracks observed after the 2009 L'Aquila earthquake (b); orthophoto reproduced with permission from Tracciatori srl (2021).

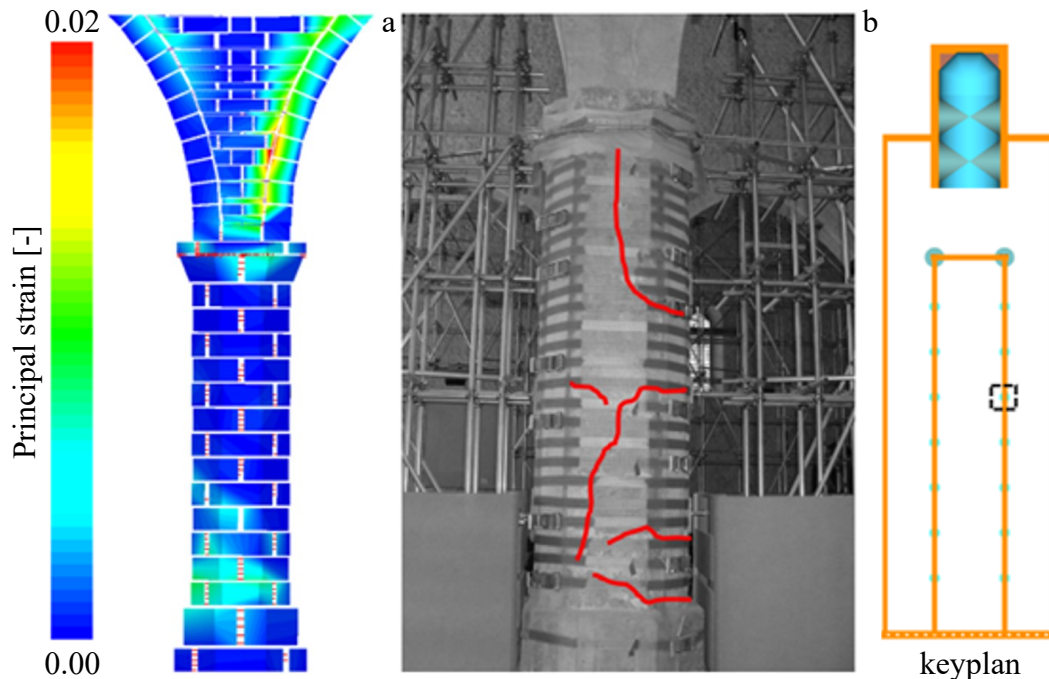
Figure 64. Comparison between the analysis results (a) and actual distribution of cracks observed after the 2009 L'Aquila earthquake (b) in one of the nave's columns.

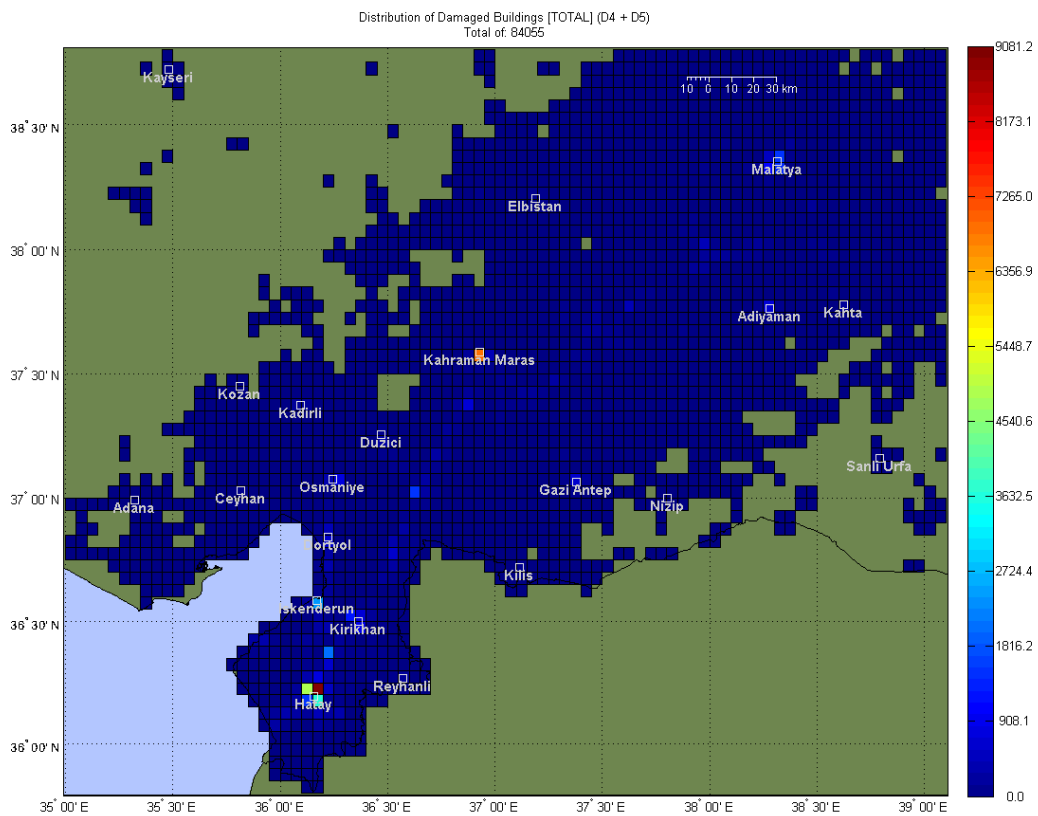
Figure 65. Distribution of Collapsed, to be immediately demolished and heavily damaged buildings (Hancilar et al. 2023).
