Doctoral Dissertation
Doctoral Program in Civil and Environmental Engineering (36th Cycle)

Collapse Analysis and Selective Retrofitting

using the Applied Element Method, AEM

Cosimo Pellecchia

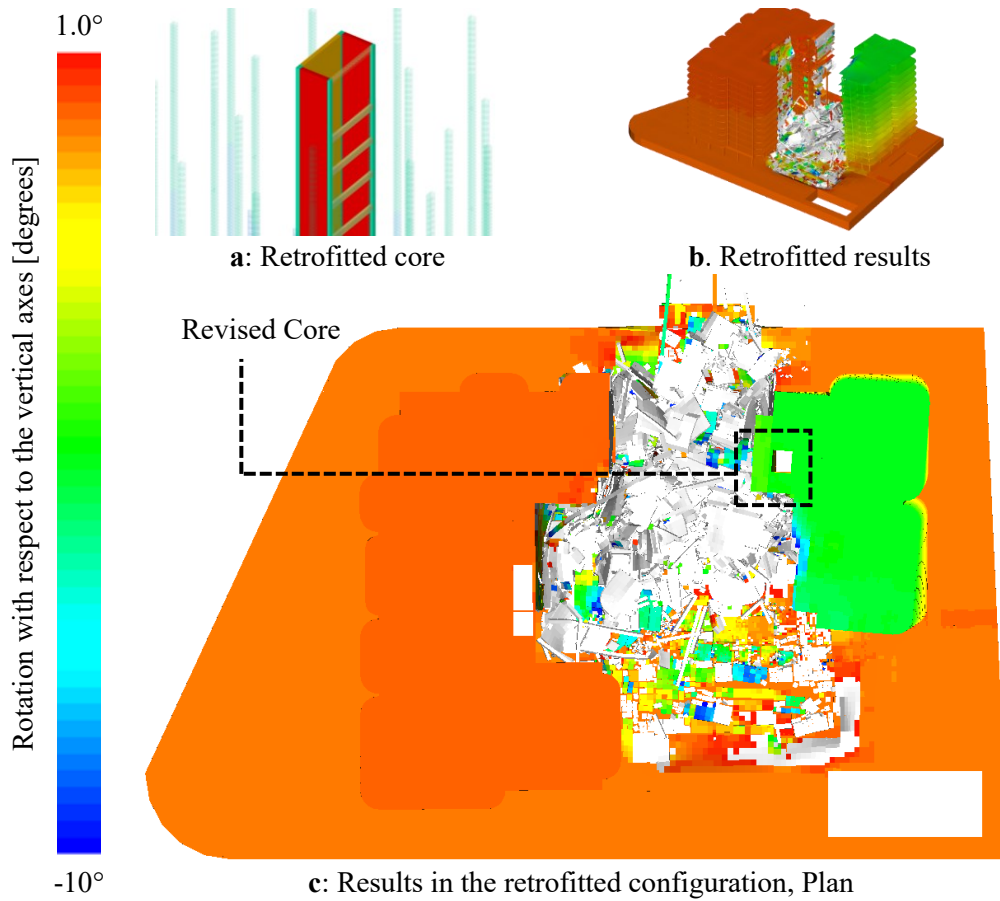
Figure 69. Retrofitting design of the eastern shear core (a), 3D (b), and plan view (c) of the analysis results in the retrofitted configuration.

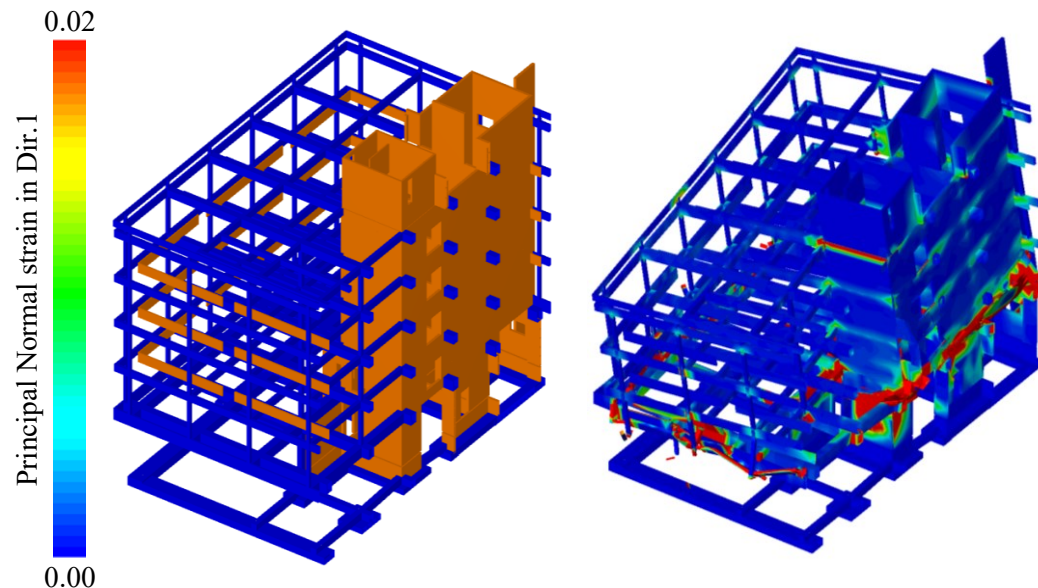
Figure 76. Pyne Gould Building, PBC, detected failure mechanism.

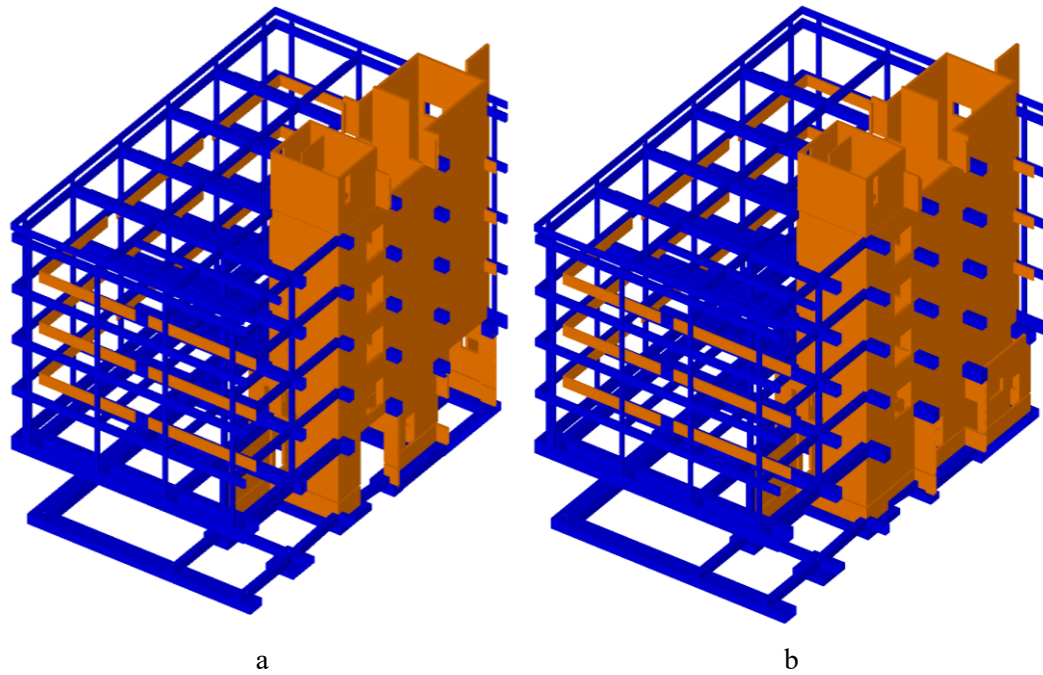
Figure 77. Pyne Gould Building, as-built (a) and retrofitted (b) configuration.

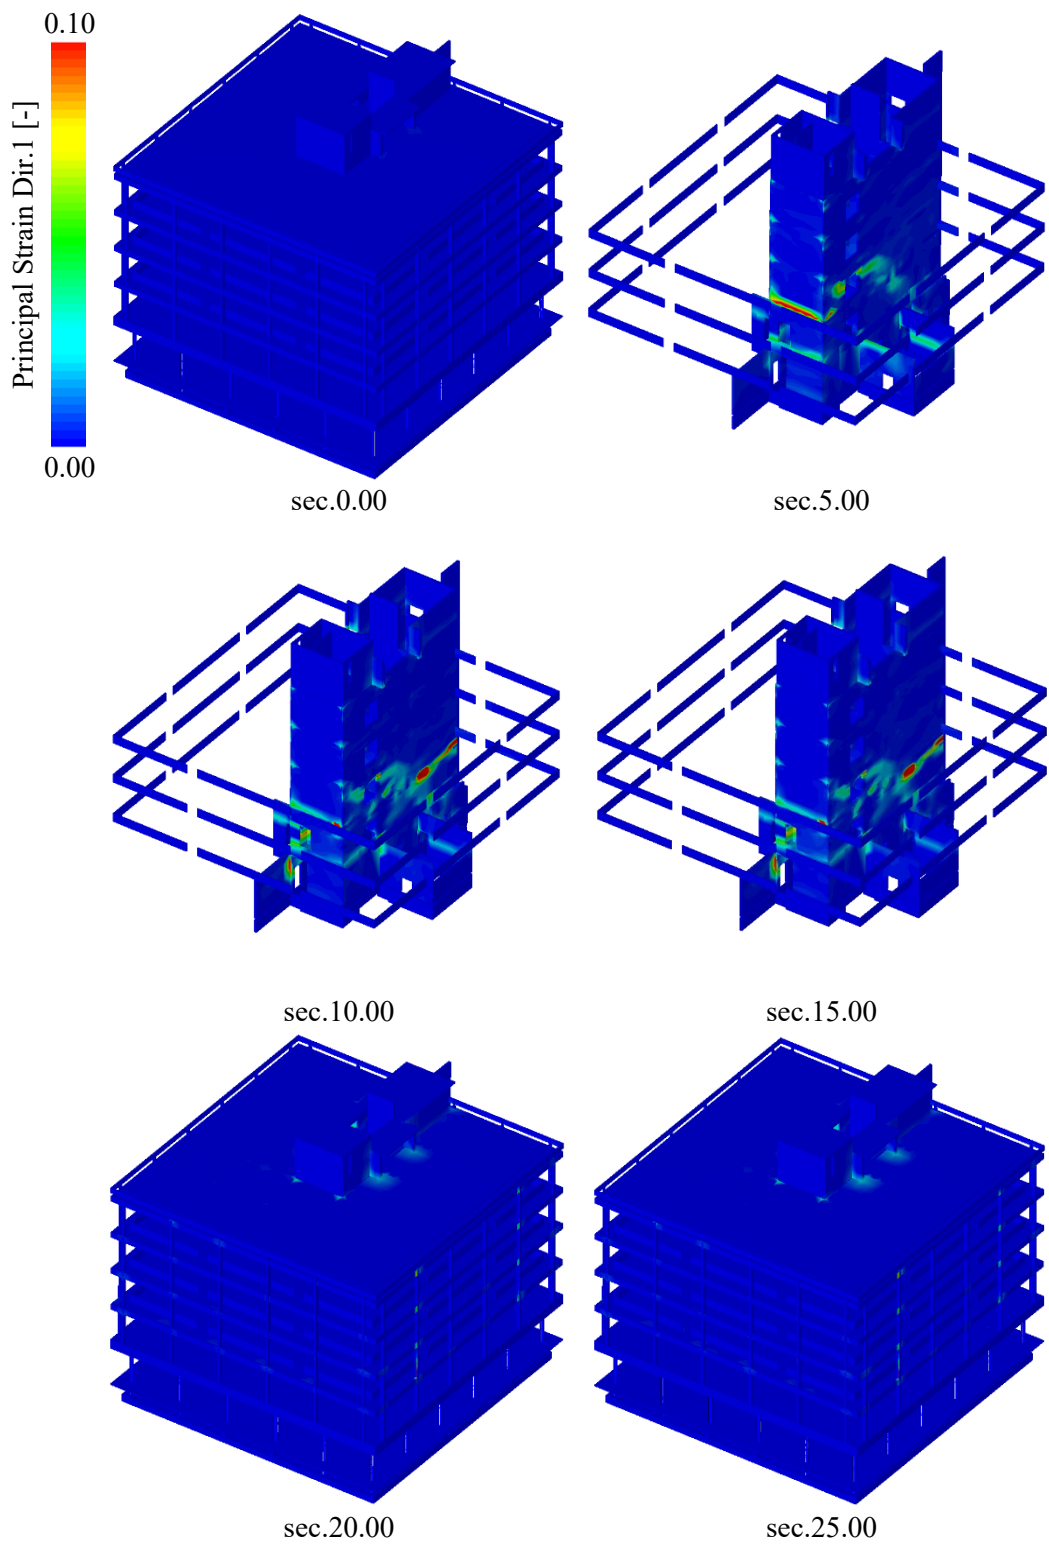
Figure 80. Pyne Gould Building, PBC, retrofitted configuration, non-linear dynamic analysis results employing the February 2023 Turkey record.
