A tool for monitoring rockfall protection works and plan the maintenance: the case of the autonomous region of Valle d'Aosta

Maddalena Marchelli*
 Marco Paganone**
 Davide Bertolo**
 Valerio De Biagi***
 Daniele Peila*
 Stefano Vigna*

* Dipartimento di Ingegneria per l'Ambiente, il Territorio e le Infrastrutture (DIATI). Politecnico di Torino

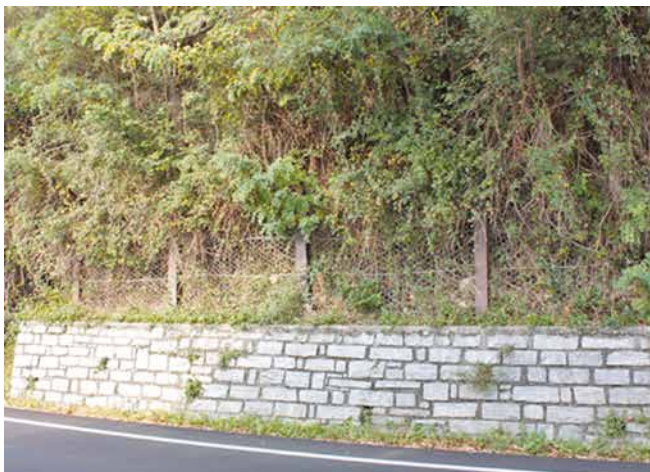
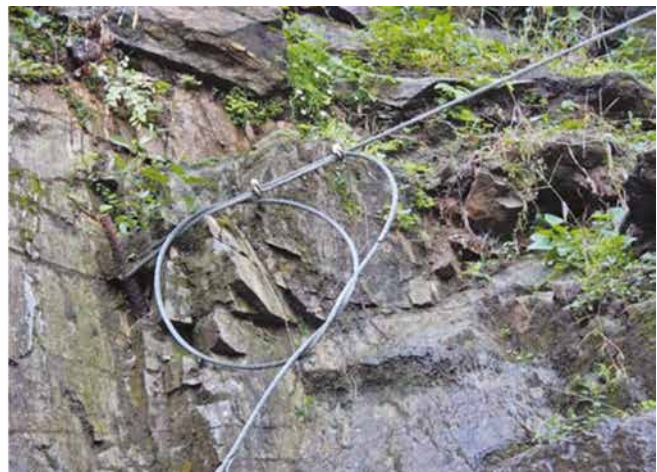
Neglecting the design aspect, several damages frequently observed relate with installation errors, and suitable or unsuitable certified technologies (Fig. 1). Focusing directly on degradation and ageing incorrect/absent maintenance procedures, among the problems, the ones related to vegetation, directly interacting with the works or otherwise influencing their performances, are the most common. Corrosion has been frequently observed in several components, even in the anchors, where disrupted. Accumulation of debris, due also to impacts with energy much smaller than the design one, as well as impacts of element differing from rock blocks, i.e. trees after some severe or unexpected

Fig. 1 – Installation errors, and unsuitable or not certified technologies.
