Review on the Experimental Characterization of Fracture in Active Material for Lithium-Ion Batteries

Abstract: Nowadays, lithium-ion batteries are one of the most widespread energy storage systems, being extensively employed in a large variety of applications. A significant effort has been made to develop advanced materials and manufacturing processes with the aim of increasing batteries performance and preserving nominal properties with cycling. Nevertheless, mechanical degradation is still a significant damaging mechanism and the main cause of capacity fade and power loss. Lithium ions are inserted and extracted into the lattice structure of active materials during battery operation, causing the deformation of the crystalline lattice itself. Strain mismatches within the different areas of the active material caused by the inhomogeneous lithium-ions concentration induce mechanical stresses, leading ultimately to fracture, fatigue issues, and performance decay. Therefore, a deep understanding of the fracture mechanics in active materials is needed to meet the rapidly growing demand for next-generation batteries with long-term stability, high safety, excellent performance, and long

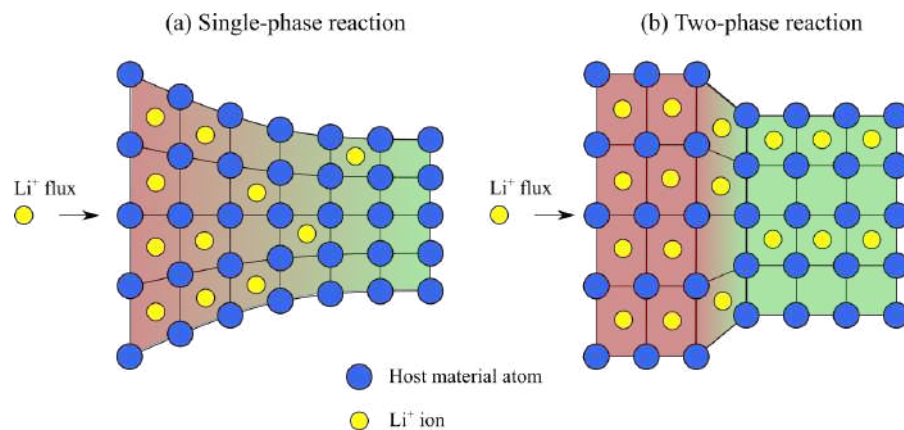
Figure 1. Mechanical stress resulting from inhomogeneous concentration due to (a) single phase-reaction and (b) phase transition.

Then, the inhomogeneous lithium concentration within the particle causes differential deformation of the lattice structure, leading to diffusion-induced stress (DIS) [8–13,21]. Furthermore, some materials show a two-phase behavior, i.e., two phases with a different lithium content coexist in the same particle, causing a significant strain mismatch at the interface between them, and thus stress, as illustrated in Figure 1b.

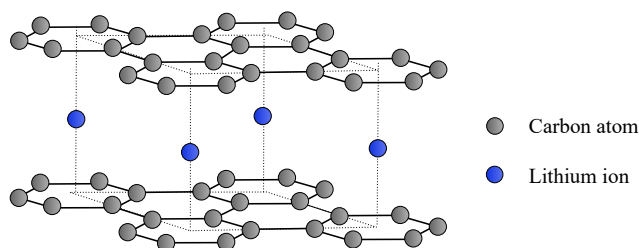
Figure 2. Crystalline structure of lithiated graphite. Lithium ions are depicted in blue and intercalate between the graphene planes. Carbon atoms are depicted in gray.

The structure of graphite is characterized by a stacking sequence of graphene layers, where carbon atoms are arranged in a hexagonal pattern. Lithium intercalates in the graphite structure occupying the interstitial defects between the graphene planes, as shown in Figure 2.

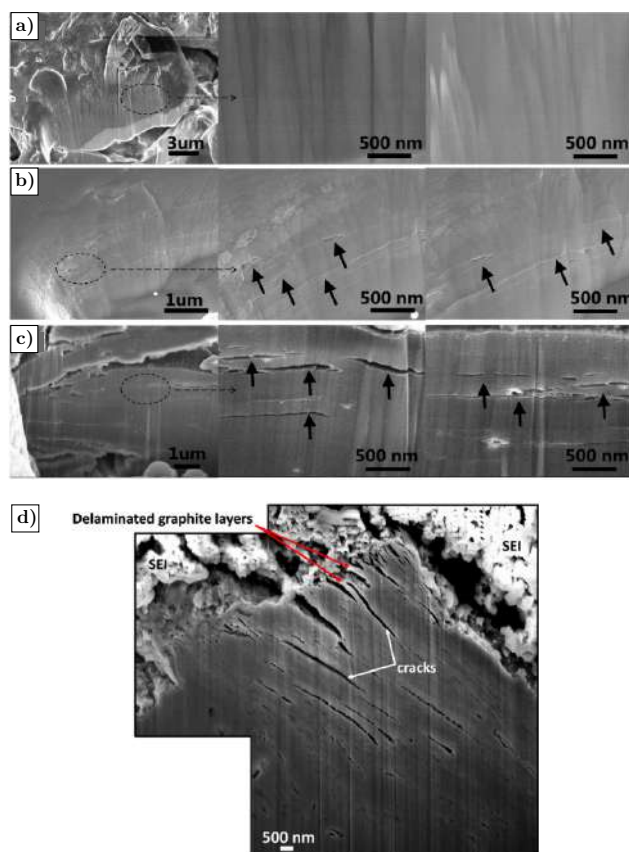
Figure 3. Cross-sectional SEM image of the (a) pristine graphite and graphite particles from cells cycled at 1C for (b) 200 and (c) 800 cycles. Black arrows point to the cracks. Reproduced with permission from Elsevier from [40], Copyright 2017. (d) Cross-section SEM image of graphite particle and SEI layer; parallel cracks may cause delamination. Reproduced with permission from Elsevier from [45], Copyright 2011.

Cracks in graphite particles are reported in the literature, and the research community is in agreement that the number of cycles and current rate are the main factors affecting the crack growth [40–44] (Figure 3), and that the formation of SEI over the fresh active material surfaces is the ultimate cause of capacity fade. Cracks are observed parallel to the larger external surface, leading the graphite to exfoliate [40,45], as shown in Figure 3c,d.

The EDX analysis revealed the presence of SEI inside the graphite particles, because electrolyte components react with the fresh active material, thereby increasing the SEI growth rate [43,45]. On the other hand, the formation of SEI on the cracks surfaces is supposed to reduce the stress intensity factor, hindering the crack growth. This phenomenon is known as roughness or asperity-induced crack closure, and it is caused by the physical contact of the SEI layers grown on the opposite flanks of the crack [45].

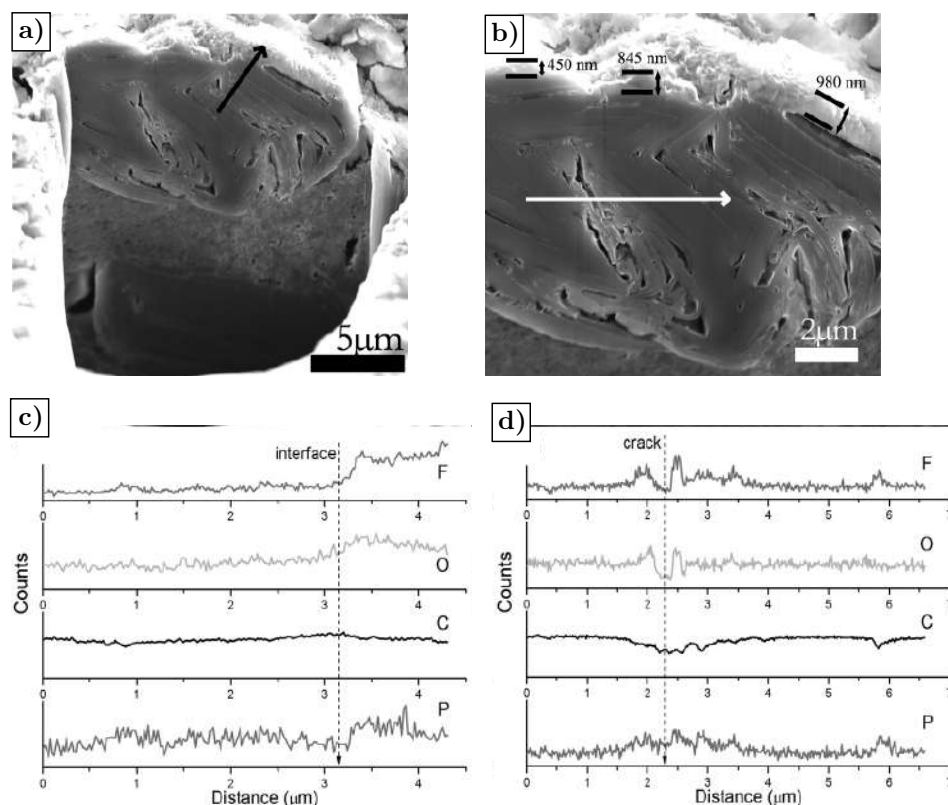
Figure 4. (a,b) Secondary electron FIB images of the cross-section of a graphite particle. (c,d) The elemental line scan analysis along the black and white lines in panels (a,b), respectively. Adapted with permission by American Chemical Society from [46], Copyright 2005.

Zhang et al. [46] used element scan analysis (ELSA) to identify the location and composition of the SEI layer. According to Figure 4, ELSA shows peaks in F, O and P elements when SEI is encountered, as it is composed of fluorides (LiF), Li-alkyl carbonates ($\text{CH}_3\text{OCO}_2\text{Li}$, $(\text{CH}_3\text{OCO}_2\text{Li})_2$) from EC/DMC decomposition and electrolytes (LiPF_6). Then, they observed the SEI layer both on the particle surface and at the core, confirming the presence of surface and internal cracks.

The SEI layer on the external surface is between 450 nm and 950 nm, while the internal SEI is in the order of 100 nm. Furthermore, an ELSA analysis carried out in aged electrodes (25–50 cycles) showed that the composition remained unchanged, suggesting that SEI remains stable once formed. Zhang et al. [46] explained the nonlinear capacity fade of graphite according to a three-stage approach: in the first stage, where most of the capacity fade occurs, SEI forms on the particle surfaces and in the internal cracks, causing a severe reduction in lithium; in the second stage, the continuous breaking and repairing of the SEI film depleted the lithium further without increasing the SEI layer; in the last stage, structural degradation of graphite particles decreases the number of lithium sites, and this is the cause of the final capacity reduction.

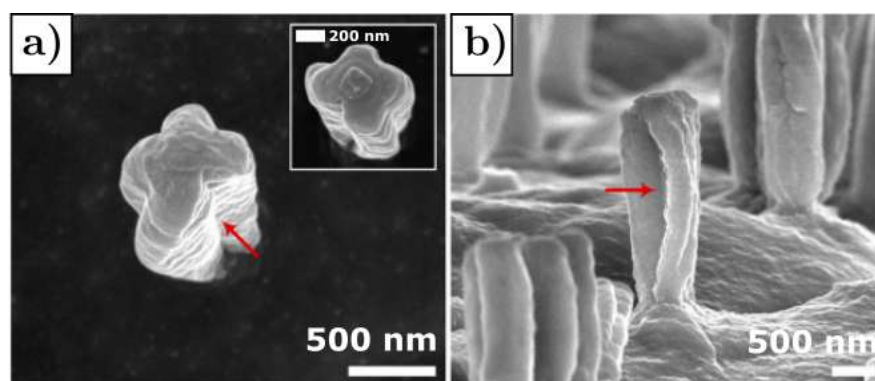
Figure 5. SEM images showing cracks in silicon nanowire, pointed out by the red arrow. (a) Top view and (b) Side view. Reprinted with permission from [54], Copyright 2012.

Concerning nanowires, they are characterized by a continuous 1D electronic pathway that facilitates efficient charge transport, as compared to nanoparticles [48]. Furthermore, they can grow directly from the current collector, making binder and conductive agents unnecessary but limiting the lithium flux and current rate as a consequence. Several studies observed an anisotropic expansion during the alloying process, which is greater in the [110] direction, making the cross-section elliptical [52,53]. As a result, intense tensile hoop stress arises along the shorter axis of the ellipse, causing severe crack propagation [54], as confirmed by the SEM images in Figure 5.

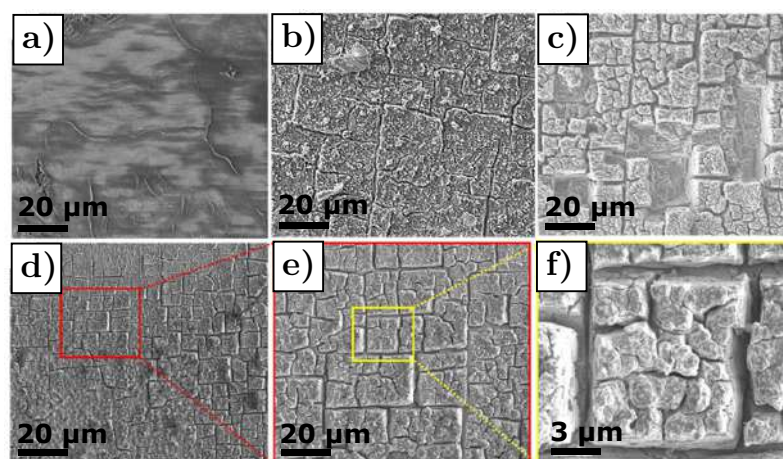
Figure 6. Crack growth as a function of lithiation cycles in thin film after (a) 3, (b) 8, and (c) 50 cycles. (d–f) Detail of crack pattern after 30 lithiation cycles. Reprinted with permission by Nature Publishing Group from [55], Copyright 2016.

The lithiation of thin film electrodes causes strains leading to the curvature of the film, which ultimately leads to surface cracks, resembling the ones occurring in drying media, as shown in Figure 6.

A particular crack pattern arises on the surface of the silicon thin film as a result of lithiation cycles, as observed with SEM [55,57]. Shi et al. [55] showed that the crack density is a function of the number of cycles, as shown in Figure 6. In addition, Li et al. [57] reported that crack density depends on the thickness of the film as well, and a critical size below which cracks do not propagate exists.

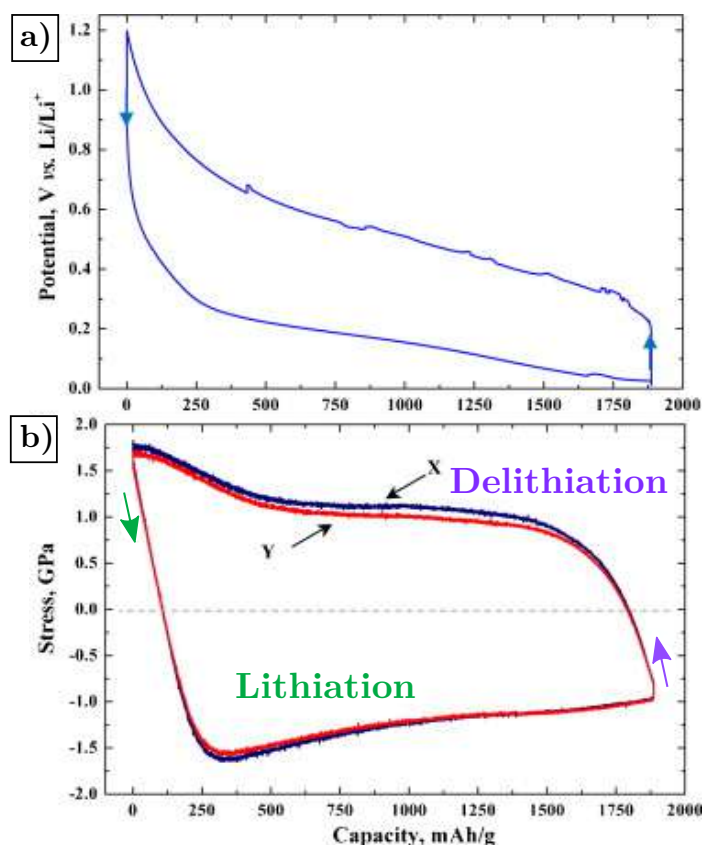
Figure 7. (a) Cell potential vs. capacity curve corresponding to lithiation and delithiation Si thin–film electrode cycled at C/4 rate, and (b) the corresponding average stress computed from the measured curvature of the substrate. Adapted with permission by Elsevier from [56], Copyright 2010.

Sethuraman et al. [56] computed the average stress of silicon thin film from the substrate curvature with a Multi-beam Optical Sensor (MOS) during lithiation and delithiation. The results of their in-situ experiments are reported in Figure 7.

It was shown that the average stress becomes elastically compressive during lithiation until 12% of the total capacity, reaching -1.75 GPa. Then, plastic flow occurs until the end of lithiation. Stress is reversed during delithiation and becomes elastically tensile until 75% capacity, reaching 1 GPa, followed by plastic flow. Therefore, delithiation is the critical phase from the fracture point of view, as the electrode is subjected to severe tensile stress.

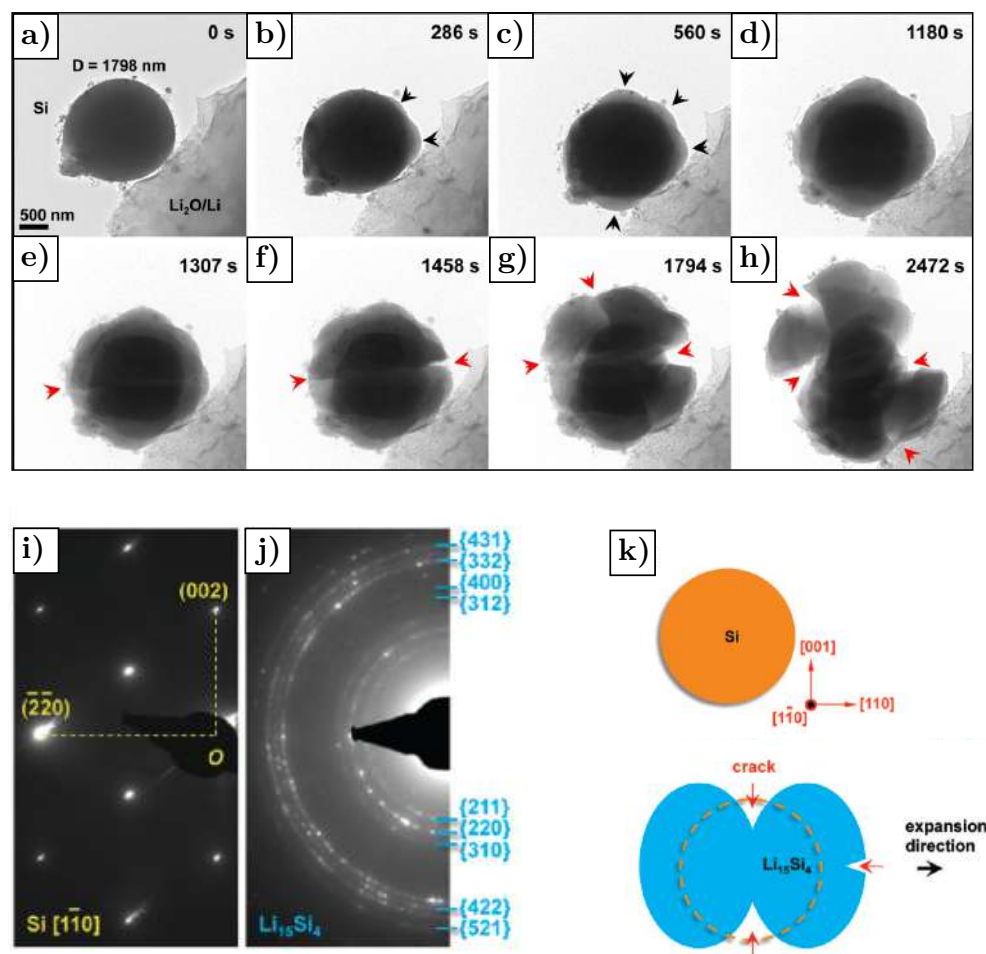
Figure 8. (a–h) Crack growth during single lithiation cycle in silicon nano-particle. The black arrows mark the bumps due to anisotropic lithiation of Si before crack formation, whereas the red arrows mark the cracks. (i,j) Electron diffraction pattern showing the silicon phase transformation from (i) crystalline structure (Si) to (j) polycrystalline structure ($\text{Li}_{15}\text{Si}_4$). (k) Anisotropic swelling in silicon nanoparticle favoring cracks in [110] direction. Reprinted with permission by American Chemical Society from [51], Copyright 2012.

Concerning silicon nano-particles, crack growth within the same particle was observed during a single lithiation, as reported in Figure 8a–h [51]. At the end of lithiation, the particle is heavily damaged, and cracks propagating along the [110] direction affect the structural stability considerably. Furthermore, the electron diffraction pattern (EDP) analysis reported in Figure 8i,j shows the phase transformation from crystalline (Si) (Figure 8i), to polycrystalline ($\text{Li}_{15}\text{Si}_4$) (Figure 8j) due to the lithiation process. Figure 8k explains the anisotropic swelling characteristic of silicon nano-particles, leading to cracks predominantly along the [110] direction [51,58].

Furthermore, it was reported that size has a significant impact on the fracture of silicon nanoparticles, and fractures do not occur below a critical size. For example, Liu et al. [51] showed that the critical size is 150 nm in their case study.

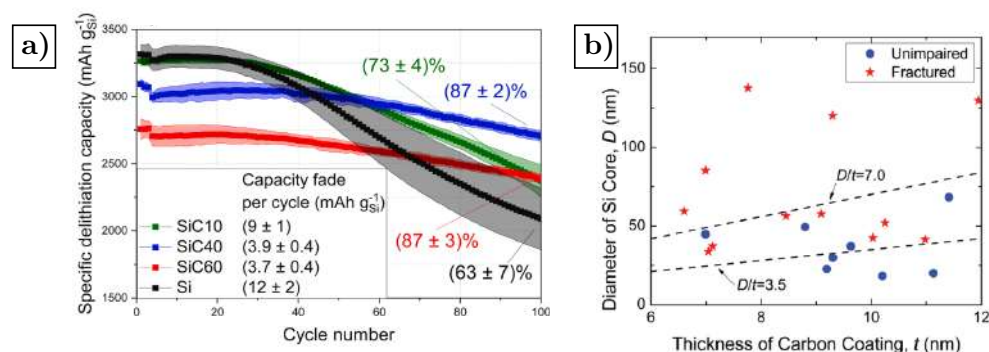
Figure 9. Effect of carbon coating on capacity fade. (a) Specific delithiation capacity as a function of the number of cycles for silicon thin film with carbon coating of different thickness, namely 10 nm, 40 nm, and 80 nm, for SiC10, SiC40 and SiC80, respectively. Reprinted with permission by Elsevier from [64], Copyright 2021. (b) Occurrence of fracture as a function of the ratio between particle diameter (D) and coating thickness (t). Reprinted with permission by Royal Society of Chemistry from [65], Copyright 2016.

In particular, Casino et al. [64] demonstrated that carbon coating mitigates the capacity fade. They observed that an increased coating thickness reduces the capacity drop, but a thickness greater than 60 nm does not have greater beneficial effects. On the other hand, the greater the coating thickness, the lower the nominal capacity. Consequently, a trade-off should be found to obtain the best performance; Casino et al. showed that a coating thickness of 60 nm guarantees good nominal capacity and capacity fade mitigation, as depicted in Figure 9a.

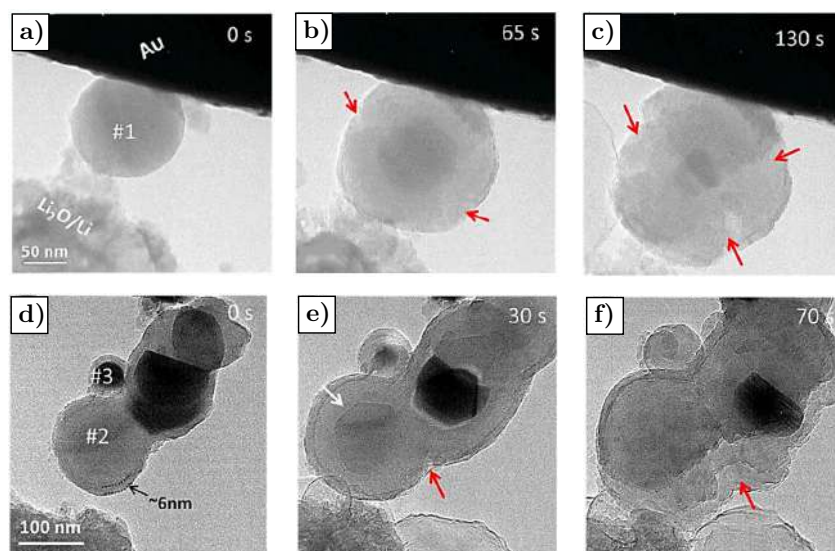
Figure 10. Lithiation of (a–c) uncoated silicon particle and (d–f) coated silicon particles. The time value depicted in the figure refers to the lithiation time. Reprinted with permission by Elsevier from [68], Copyright 2016.

Fractures were observed with TEM in carbon-coated silicon particles in some works [65,67,68]. Xu et al. [68] compared the lithiation of two sets of geometrically similar particles (130–150 nm), one with a 6 nm carbon coating and the other without coating. Few fractures were observed in the coated particles, depicted by the red arrows in Figure 10e,f. On the other hand, a greater number of fractures were observed in the uncoated particles, as confirmed by the red arrows in Figure 10a–c. During the lithiation of the coated particles, the coating thickness increases from 6 nm to 8 nm, because of the strong radial stress due to the silicon core expansion. Then, fractures are triggered in the coating thickness and they further propagate in the silicon core. These factors may explain the reason why fracture occurs in coated particles that are smaller than the critical fracture size, i.e., 150 nm as explained by Liu et al. [51].

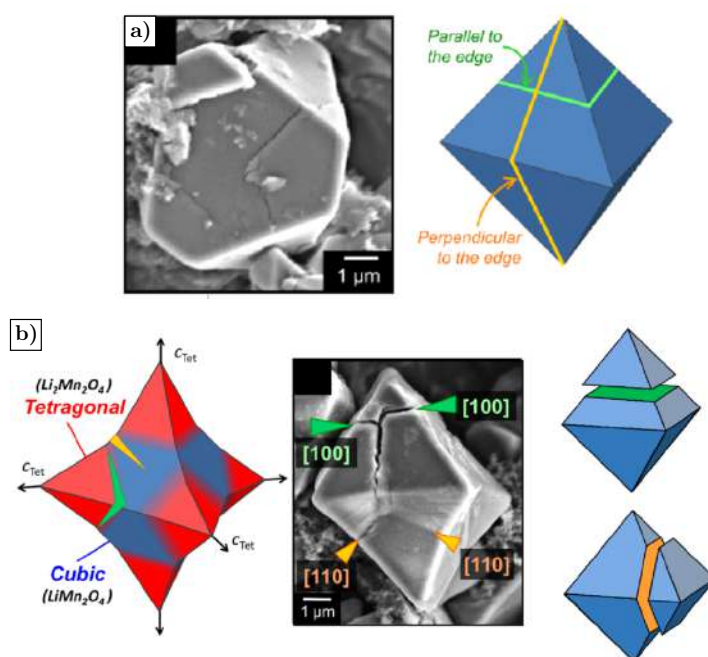
Figure 11. (a) Cubic and (b) tetragonal structure of LMO with the corresponding preferential cracks directions. Reprinted with permission by American Chemical Society from [83], Copyright 2021.

Severe cracking is observed when the LMO undergoes Jahn–Teller transformation, and intragranular cracks are observed at the cubic/tetragonal ([100] direction) and tetragonal/tetragonal ([110] direction) grain boundaries, indicated in green and orange in Figure 11b, respectively. Thus, cracks appear oriented along the [100] and [110] directions [83].

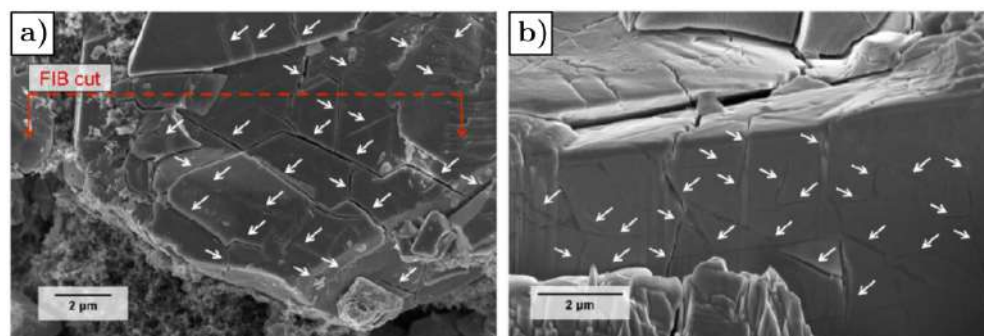
Figure 12. (a) Fracture in LMO particle after 16 deep discharge cycles with Jahn–Teller transformation and 51 cycles without Jahn–Teller transformation. (b) Internal view of LMO particle shown in (a) after FIB milling. White arrows point to the cracks. Reprinted with permission by Journal of The Electrochemical Society from [84], Copyright 2018.

McGrogan et al. [84] cycled the LMO electrode above Jahn–Teller transformation and milled the cycled electrode with FIB to study the internal cracking network, as shown in Figure 12a,b. The dense crack network, probably caused by Jahn–Teller transformation, allows the electrolyte to penetrate inside the particle, causing the dissolution of Mn^{2+} , as will be explained in Section 4.

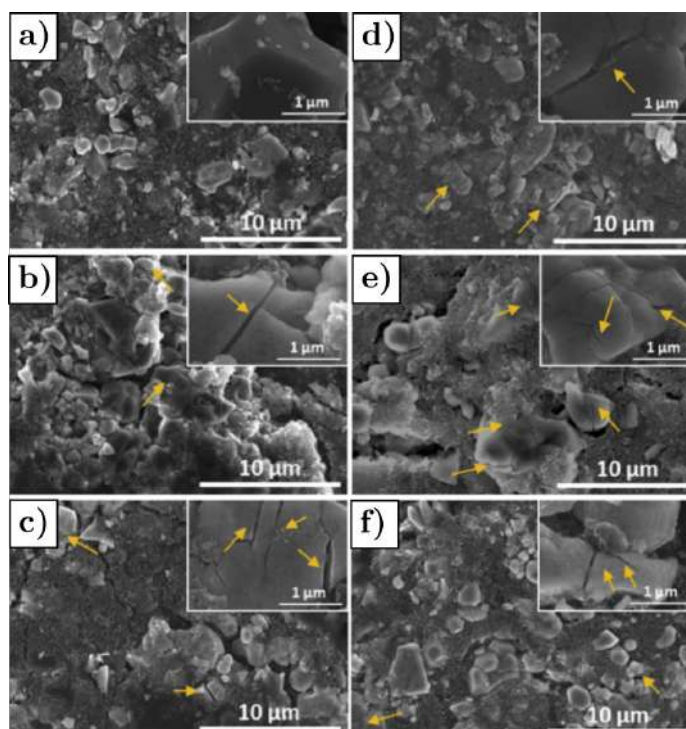
Figure 13. SEM images of the electrode structure (a) before cycling and after (b) 40 cycles, (c) 125 cycles, (d) 500 cycles, (e) cycled at low voltage to trigger Jahn-Teller transformation and (f) cycled at high temperature. Reprinted with permission by Elsevier from [88], Copyright 2017.

Some works tried to correlate the capacity fade in LMO with the occurrence of fracture due to cycling. Liu et al. [88] compared the increase in free surfaces created by cracks with capacity loss, observing an interesting correlation. They analyzed different samples subjected to an increasing number of cycles with TXM and SEM (Figure 13), and measured the increase in free surfaces created by cracks with an image processing tool.

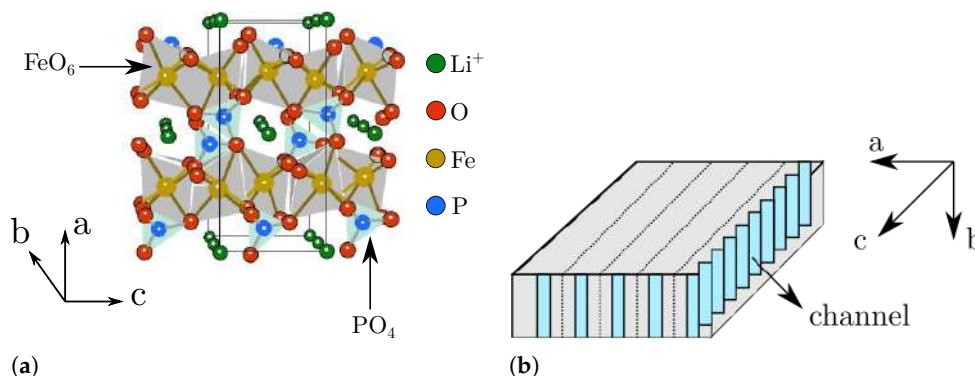
Figure 14. (a) Crystal structure of LFP. Reprinted with permission by Elsevier from [92], Copyright 2009. (b) Schematic illustration of lithium intercalation mechanism in LFP single crystal. Lithium ions diffuse along 1D channels in the b -direction, and channels are stacked in layers parallel to bc planes, indicated by the dotted lines.

LFP crystallizes in the olivine structure, consisting of FeO_6 octahedra and PO_4 tetrahedra, as shown in Figure 14a. The FeO_6 octahedra contact each other by sharing corners and forming layers in the bc planes. The FeO_6 layers are linked together by PO_4 tetrahedral units. Lithium ions are located in the interstitial voids of the framework, forming continuous linear chains along the c -axis in the alternate ac planes. In this structure, the most favorable lithium diffusion path is through channels aligned with the b -direction [91], as illustrated in Figure 14b.

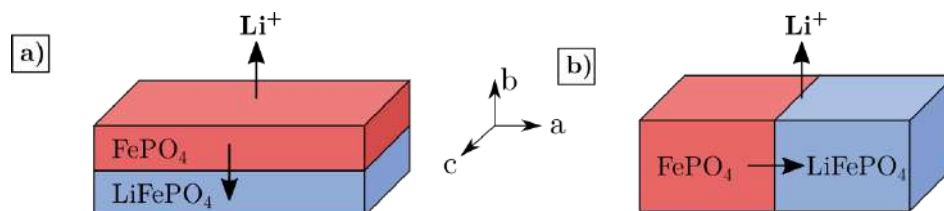
Figure 15. Scheme of the phase boundary movement for LFP. (a) Phase boundary moving along the b -axis; (b) Phase boundary moving along the a -axis.

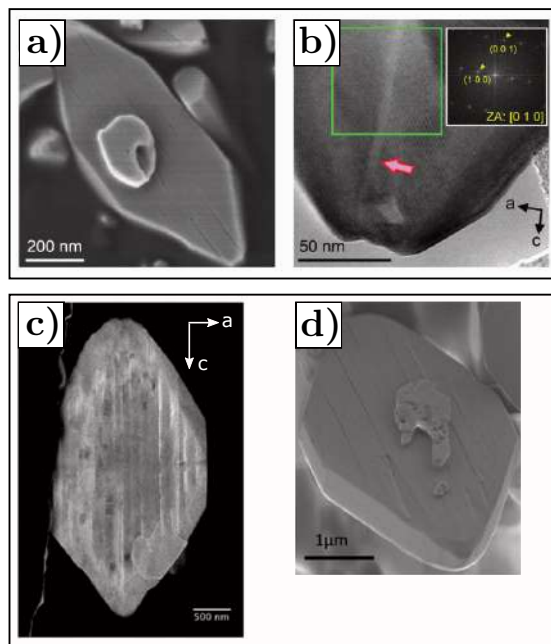
Figure 16. Top: Electron microscopy results for a micrometric plate-like LFP crystal subjected to partial chemical delithiation. (a) SEM image and (b) High-resolution transmission electron (HRTEM) image with the inset of the Fourier transform pattern obtained from the region marked with the green box. The red arrows indicate the crack running parallel to the c -axis. Reprinted with permission by American Chemical Society from [97], Copyright 2015. Bottom: SEM observations of partially delithiated $\text{Li}_{0.5}\text{PO}_4$ crystal. (c) SEM image and (d) STEM-HAADF image, showing cracks evenly spaced and oriented along the c -axis. Reprinted with permission by American Chemical Society from [96], Copyright 2013.

A similar mechanism, with the phase boundary oriented along the bc plane, was also supported by other experimental observations in ex-situ chemically delithiated LFP particles, as reported in [96,97] and illustrated in Figure 16a–d.

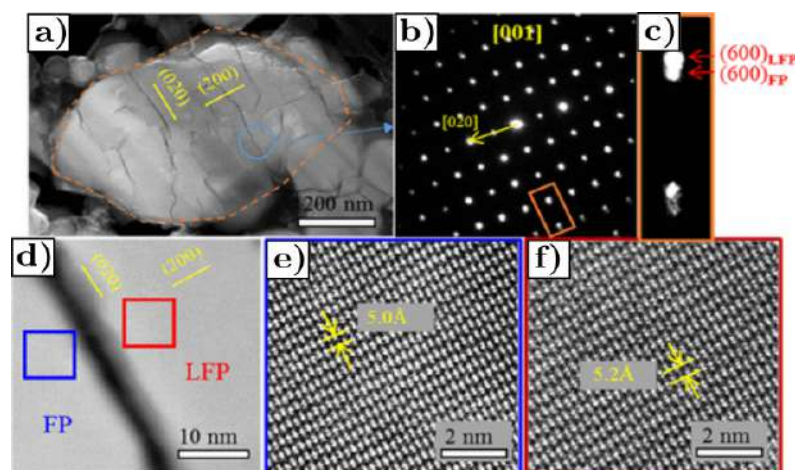
Figure 17. LiFePO_4 and PO_4 phases separated by ac plane cracks in a LFP crystal electrochemically cycled, with (a) STEM-HAADF image of the crystal at 100% SOC, (b,c) SAED patterns and (d–f) STEM-HAADF images. Reprinted with permission by American Chemical Society from [99], Copyright 2020.

Similarly, Wang et al. [101] performed electron microscope analyses using TEM and SEM on a cycled LFP cathode composed of almost spherical particles with sizes ranging from 300 to 600 nm. Their results showed the formation of through-cracks within the LFP particles during cycling. Authors attributed the fracture to the strain misfit induced at the $\text{LiFePO}_4/\text{FePO}_4$ phase boundary interface, which was supposed to lie in the ac plane and move along the b -axis.

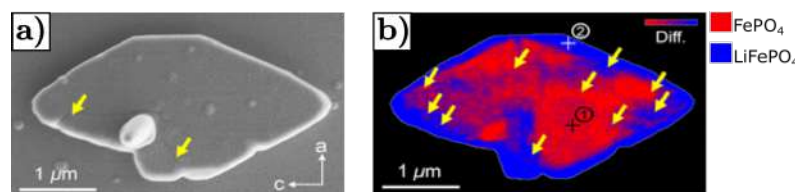
Figure 18. Relation between defects and phase distribution within micrometric LFP chemically delithiated plate-like crystal, with (a) SEM image and (b) Chemical phase distribution map. Reprinted with permission by American Chemical Society from [97], Copyright 2015.

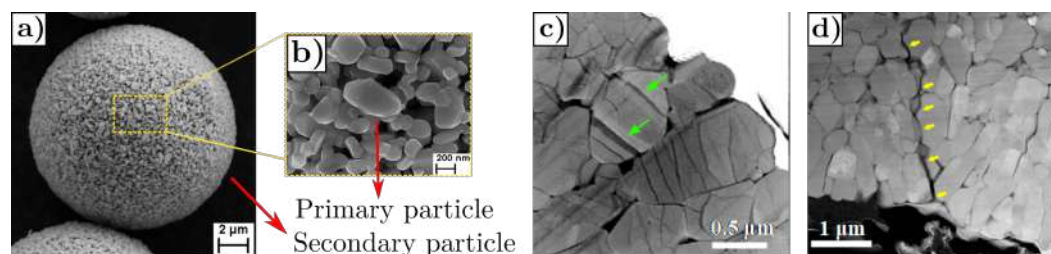
Figure 19. (a,b) SEM images of NMC secondary and primary particles. Reproduced with permission from [105], ©2020 American Chemical Society. (c,d) TEM images of the cross-section of discharged NMC cathode after 100 cycles: intragranular cracks within primary particles are marked with green arrows, whereas intergranular cracks developing along grain boundaries are marked with yellow arrows. Reprinted with permission by American Chemical Society from [106], Copyright 2018.

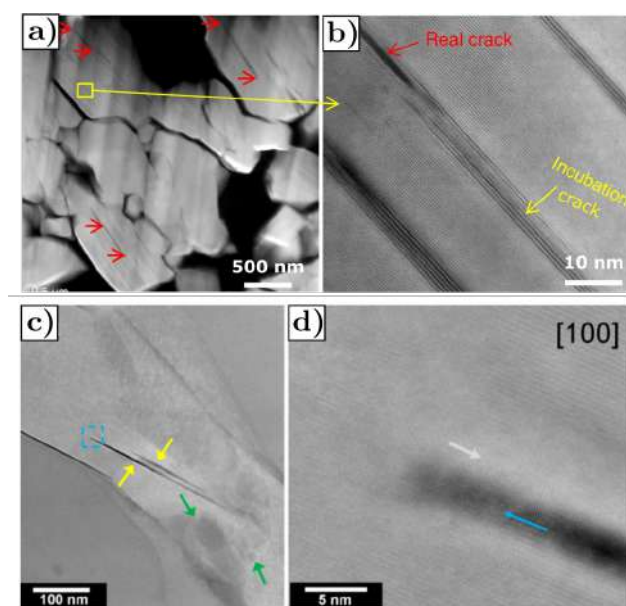
Figure 20. (a,b) SEM image of electrochemically cycled $\text{LiNi}_{0.6}\text{Mn}_{0.2}\text{Co}_{0.2}\text{O}_2$ (NMC622) particles, showing cracks parallel to the (003) planes. Cracks are marked with red arrows. Reprinted with permission of [109] ©2018 Springer Nature. (c) Intragranular cracks in $\text{Li}_{1+x}(\text{Ni}_{0.85}\text{Co}_{0.1}\text{Mn}_{0.05})_{1-x}\text{O}_2$ (NCM851005) after 200 cycles, with (d) High-resolution image of the marked area in (c) showing the rock-salt phase along the crack surface. The direction parallel to (003) planes, cracks and the rock-salt phase are marked with grey, yellow and blue arrows, respectively. Reprinted with permission from American Chemical Society by [110], Copyright 2019.

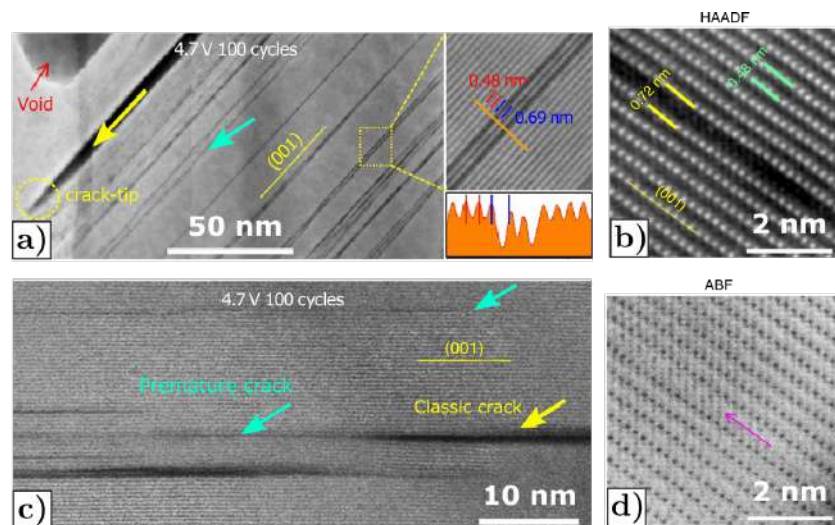
Figure 21. (a,c) HAADF images from cycled NMC333 cathode particle showing intragranular cracks along the (001) plane. The yellow and light blue arrows indicate classic and premature cracks, respectively. (b) HAADF and (d) ABF images along [010] axis of the premature crack showed in (a). Reprinted with permission from Springer Nature by [108], Copyright 2017.

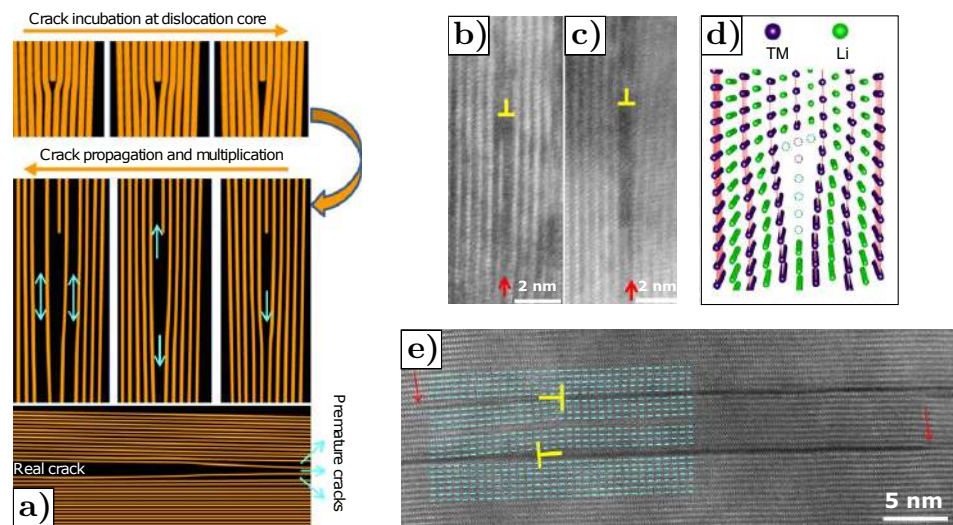
Figure 22. (a) Schematic diagrams of the dislocation-assisted crack incubation, propagation and multiplication process in NMC cathode particles. (b,c) Nucleation of premature cracks at the dislocation core in NMC333 cycled particles, also schematized in (d). (e) Edge dislocations associated with intragranular cracks in cycled NMC333 particles. Crack tip is indicated with the red arrows. Reprinted with permission from Springer Nature by [108], Copyright 2017.

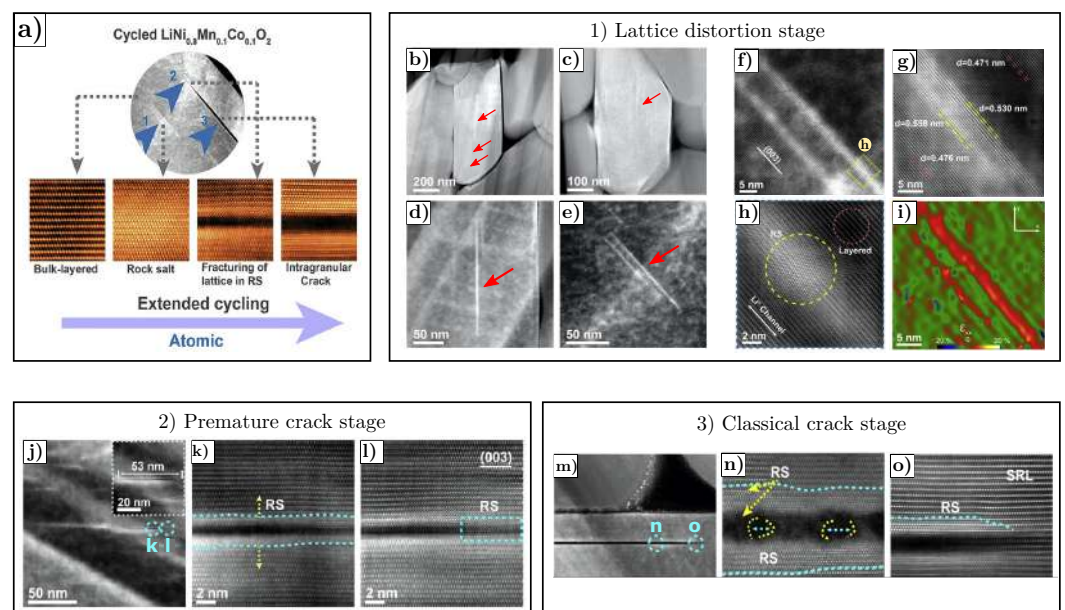
Figure 23. (a) Development process of intragranular cracks in NMC811: (b–i) Lattice distortion stage, (j–l) Premature crack stage and (m–o) Classical crack stage. STEM-HAADF images of cycled NMC811 particle in $\langle 010 \rangle$ zone projection, after (b–d) 50 cycles and (c–e) 20 cycles. The white lines appear with different length. (f) STEM-HAADF image of enlarged morphology of a white line shown in (a). (g) High-resolution STEM-HAADF image, showing the lattice distortion of the white line region. (h) Atomic-resolution STEM-HAADF image from the region marked by yellow dashed square box in (f), showing the detailed structure of the white line, with the formation of the rock-salt phase. (i) Strain map simulated by GPA due to lattice distortion. (j–l) Atomic-resolution STEM-HAADF images of premature intragranular crack in NMC811 particle after 50 cycles, showing the presence of the rock-salt phase both in the (k) partially cracked region and (l) uncracked tip. (m–o) Atomic-resolution STEM-HAADF images of mature intragranular crack in NMC811 particle after 100 cycles, showing the increase in the crack length along the (003) plane and in the rock-salt phase thickness. Reprinted with permission from Elsevier by [111], Copyright 2020.

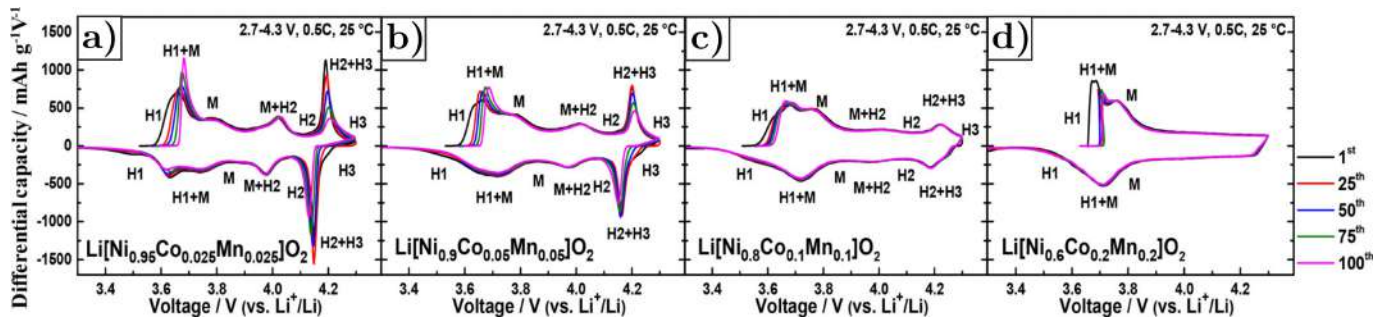
Figure 24. Differential capacity curves of $\text{Li}[\text{Ni}_x\text{Co}_y\text{Mn}_{1-x-y}]\text{O}_2$ with different Ni content: (a) $x = 0.95$, (b) $x = 0.9$, (c) $x = 0.8$, and (d) $x = 0.6$ as a function of the number of cycles. Reprinted with permission of [106], ©2018 American Chemical Society.

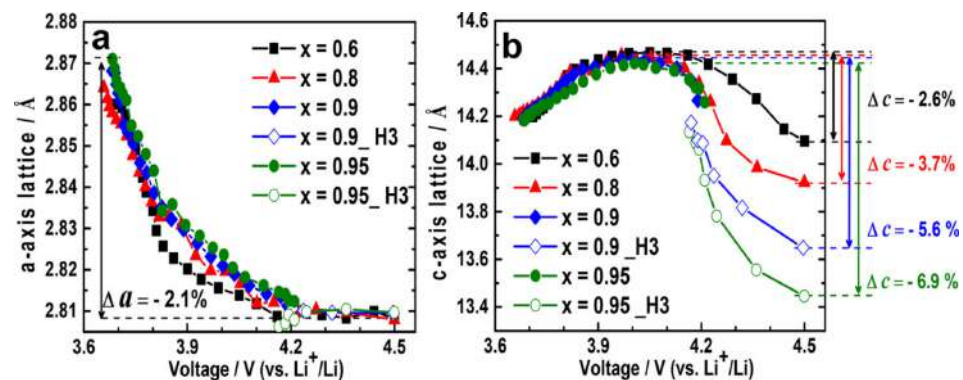
Figure 25. (a) a -axis and (b) c -axis lattice parameters of $\text{Li}[\text{Ni}_x\text{Co}_y\text{Mn}_{1-x-y}]\text{O}_2$ as a function of the Ni content ($x = 0.95$, $x = 0.9$, $x = 0.8$ and $x = 0.6$) and the cell voltage. Reprinted with permission of [106], ©2018 American Chemical Society.

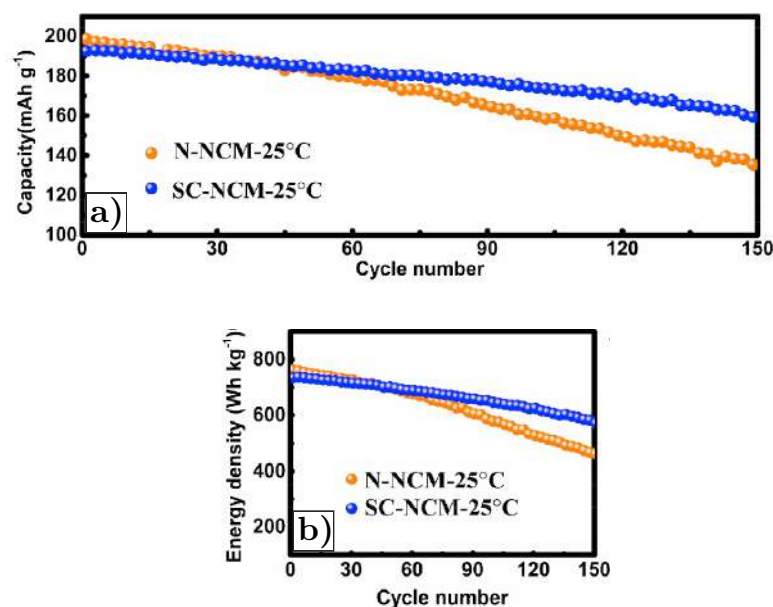
Figure 26. (a) Comparison of capacity and (b) Energy density decay between single-crystalline (SC-NMC) and commercial polycrystalline (N-NMC) NMC831106 cycled at 1C in the voltage range of 2.75–4.4 V over 150 cycles. Reprinted with permission of [123], ©2020 Elsevier.

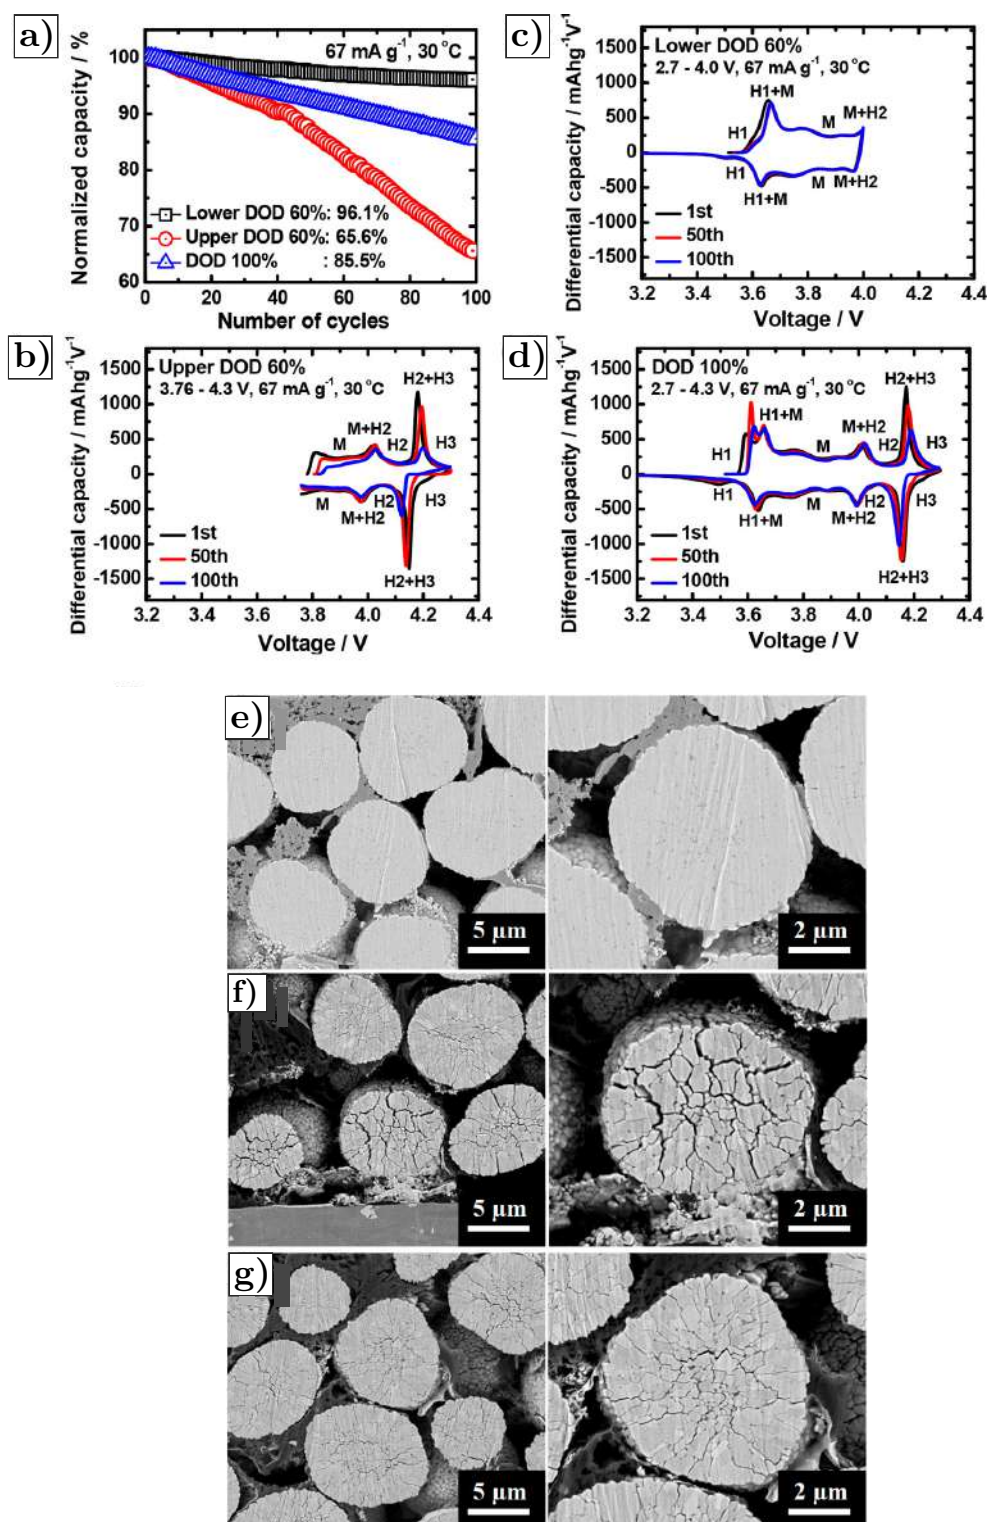
Figure 27. (a) Capacity decay of NCA95 during cycling at different DOD and initial SOC values. Derivative of charge-discharge curves of NCA95 cycled (b) from SOC 40 to 100% (3.76–4.3 V) (c) from SOC 0 to 60%, (d) from SOC 0 to 100%. Cross-sectional SEM images of NCA95 particles cycled for 100 cycles (e) from SOC 0 to 60%, (f) from SOC 40 to 100% and (g) from SOC 0 to 100%. Reprinted with permission by American Chemical Society from [132], Copyright 2019.

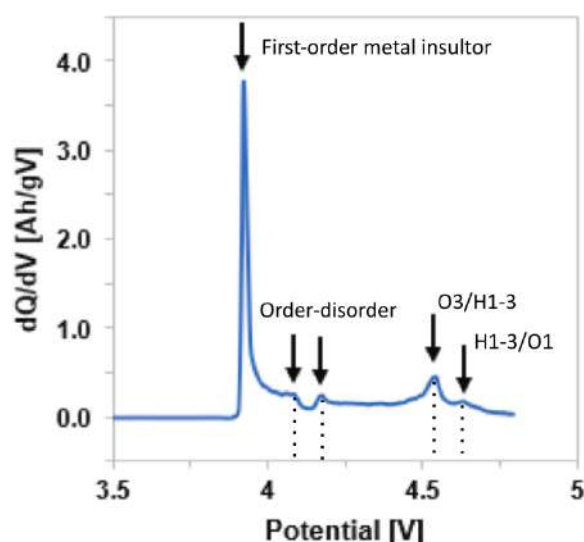
Figure 28. Differential capacity curve of a fresh LCO half-cell charged to 4.8 V at 0.05C. Most relevant phase transitions are highlighted by the black arrows. Adapted with permission by Elsevier from [137], Copyright 2022.

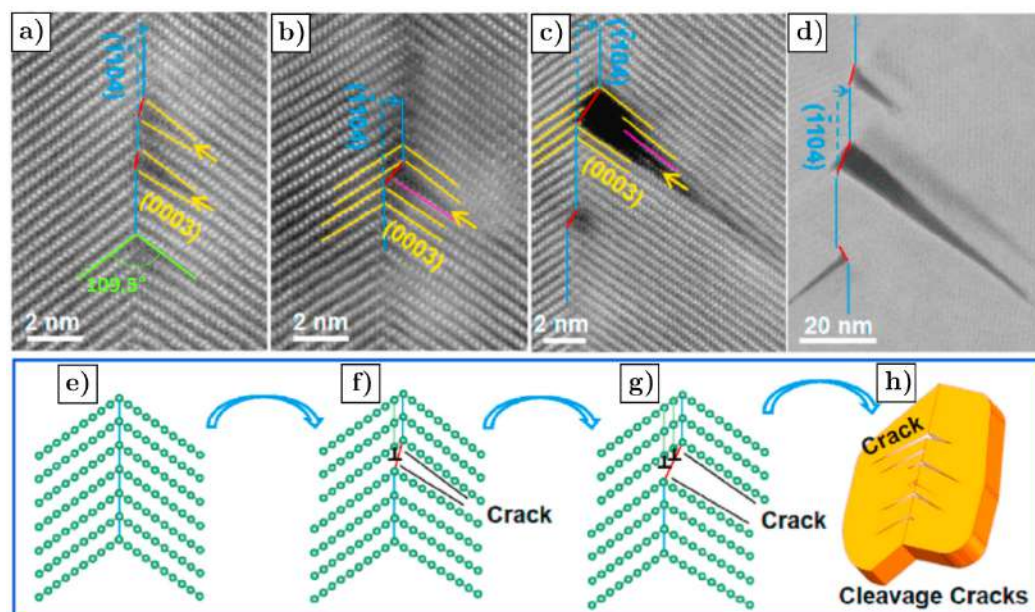
Figure 29. Cleavage crack's nucleation and propagation. (a) STEM-HAADF image showing the nucleation of cleavage cracks at the kinks occurring after 50 cycles. The (0003) plane is highly strained as indicated by the yellow arrows. (b,c) Further deformation-induced crack growth at the twin boundary. Pink lines indicate the extra (0003) planes generated to release the local strain. (d) V-shaped cleavage cracks induced by deformation. (e–h) Schematic diagrams to illustrate the cleavage crack nucleation and growth process. Reprinted with permission by Elsevier from [136], Copyright 2020.

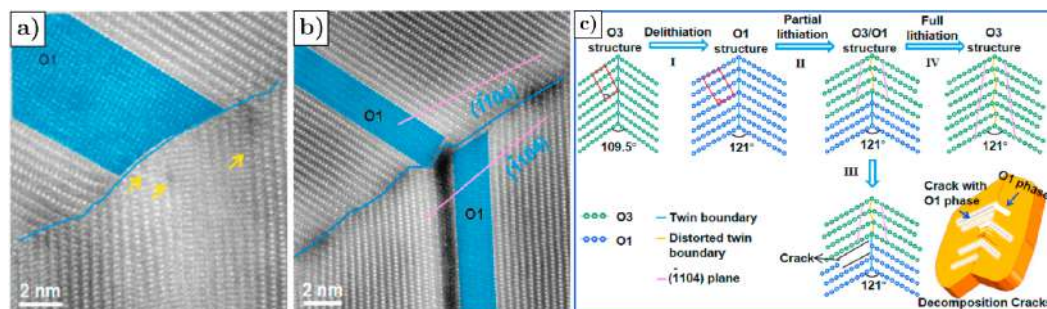
Figure 30. Phase transition induced cracking at the twin boundary. (a) A STEM-HAADF image showing the O1 phase (light blue region) formed at the highly distorted twin boundary, indicated by the light blue line. Incubation cracks at the twin boundary are marked by yellow arrows. (b) Decomposition crack formed along an O1 phase strip. (c) Schematic diagrams illustrating the cracking mechanism induced by phase transition at the twin boundary. Reprinted with permission by Elsevier from [136], Copyright 2020.

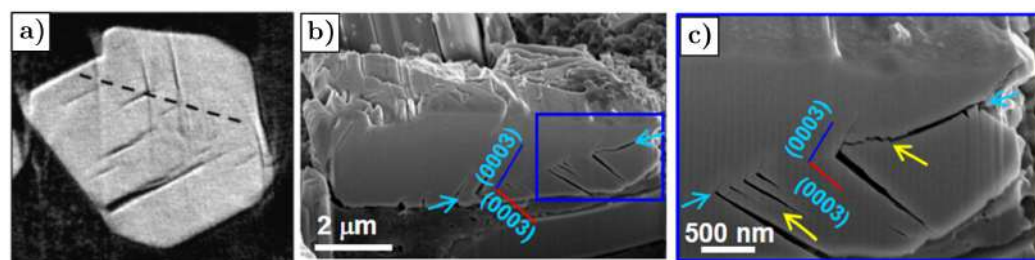
Figure 31. Cracking along the twin boundary. (a) Reconstructed image from X-ray nano-tomography reprinted from [137]. (b,c) SEM images of a cross-section of LCO particles (milled with FIB), showing cracks originating from twin boundary and their planes direction. Reprinted with permission by Elsevier from [136], Copyright 2020.

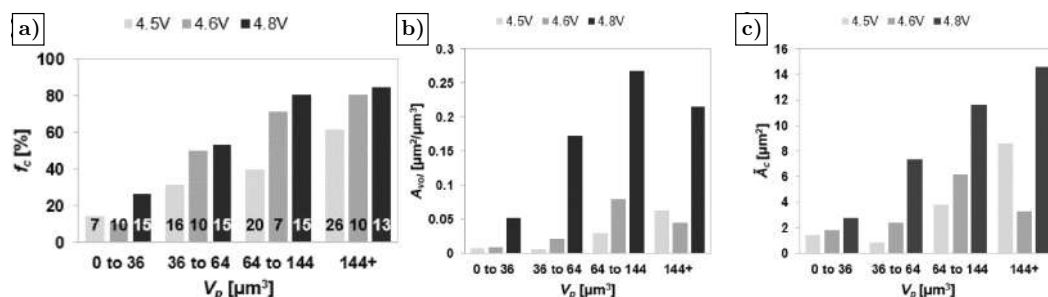
Figure 32. (a) The percentage of LCO particles within a given volume range that contains cracks after a single charge cycle to a given cutoff voltage. (b) The crack area per unit of volume for particles within a given volume range after a single charge cycle to a given cutoff voltage. (c) The average individual crack area (proportional to crack length) for particles within a given volume range after a single charge cycle to a given cutoff voltage. Reprinted with permission by Elsevier from [137], Copyright 2022.

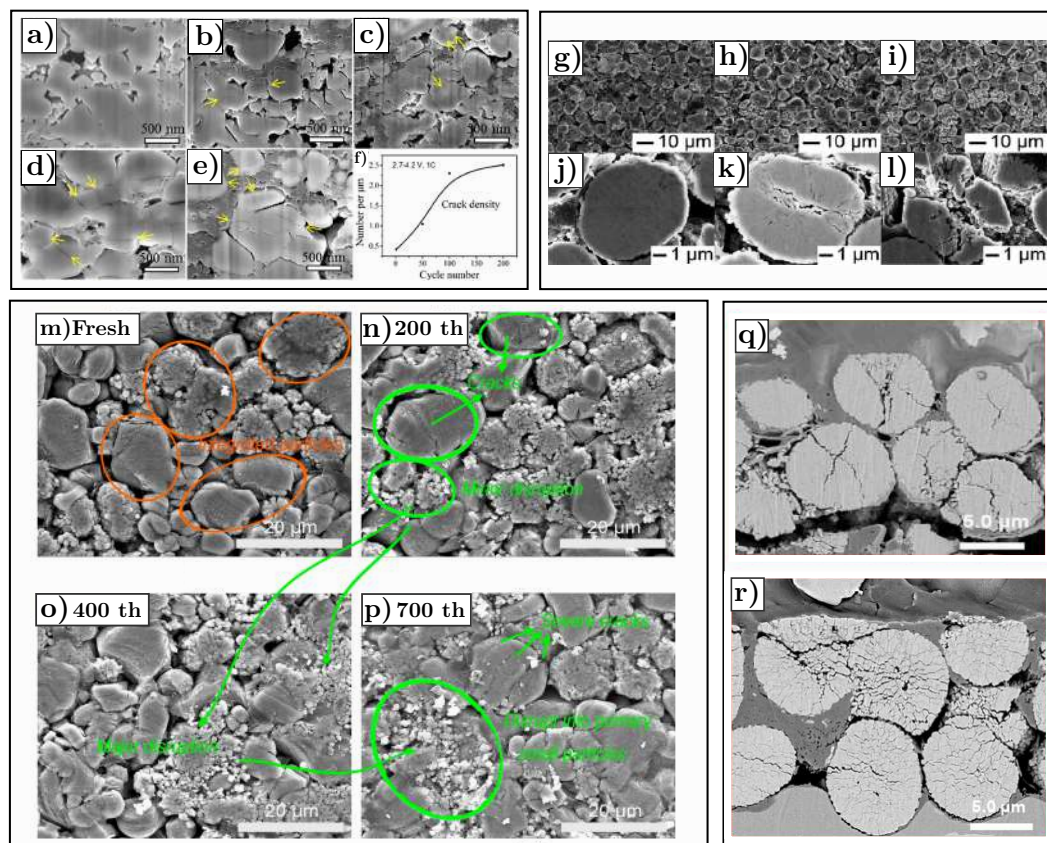
Figure 33. (a–f) Cross sectional SEM images of cracks evolution in LiFePO_4 cathode cycled at 1C. Samples (a) before cycling, (b) after 1 cycle, (c) after 50 cycles, (d) after 100 cycles, (e) after 200 cycles, and (f) crack density as a function of the cycle numbers. Reprinted with permission by American Chemical Society from [99], Copyright 2018. Top view and cross-sectional SEM images of the NCM851005 cathode (g,j) before cycling, (h,k) after 100 cycles and (i,l) after 500 cycles at 1C. Reprinted with permission by American Chemical Society from [154], Copyright 2019. (m–p) FESEM images of hervester LCO/NMC532 cathode electrodes at various cycle numbers. Reprinted with permission by MDPI from [153], Copyright 2017. (q,r) Cross-sectional SEM images of $\text{Li}[\text{Ni}_{0.90}\text{Co}_{0.05}\text{Mn}_{0.05}]\text{O}_2$ at first cycle and after 1000 cycles, respectively. Reprinted with permission by American Chemical Society from [152], Copyright 2019.
