Review on the Experimental Characterization of Fracture in Active Material for Lithium-Ion Batteries

Abstract: Nowadays, lithium-ion batteries are one of the most widespread energy storage systems, being extensively employed in a large variety of applications. A significant effort has been made to develop advanced materials and manufacturing processes with the aim of increasing batteries performance and preserving nominal properties with cycling. Nevertheless, mechanical degradation is still a significant damaging mechanism and the main cause of capacity fade and power loss. Lithium ions are inserted and extracted into the lattice structure of active materials during battery operation, causing the deformation of the crystalline lattice itself. Strain mismatches within the different areas of the active material caused by the inhomogeneous lithium-ions concentration induce mechanical stresses, leading ultimately to fracture, fatigue issues, and performance decay. Therefore, a deep understanding of the fracture mechanics in active materials is needed to meet the rapidly growing demand for next-generation batteries with long-term stability, high safety, excellent performance, and long

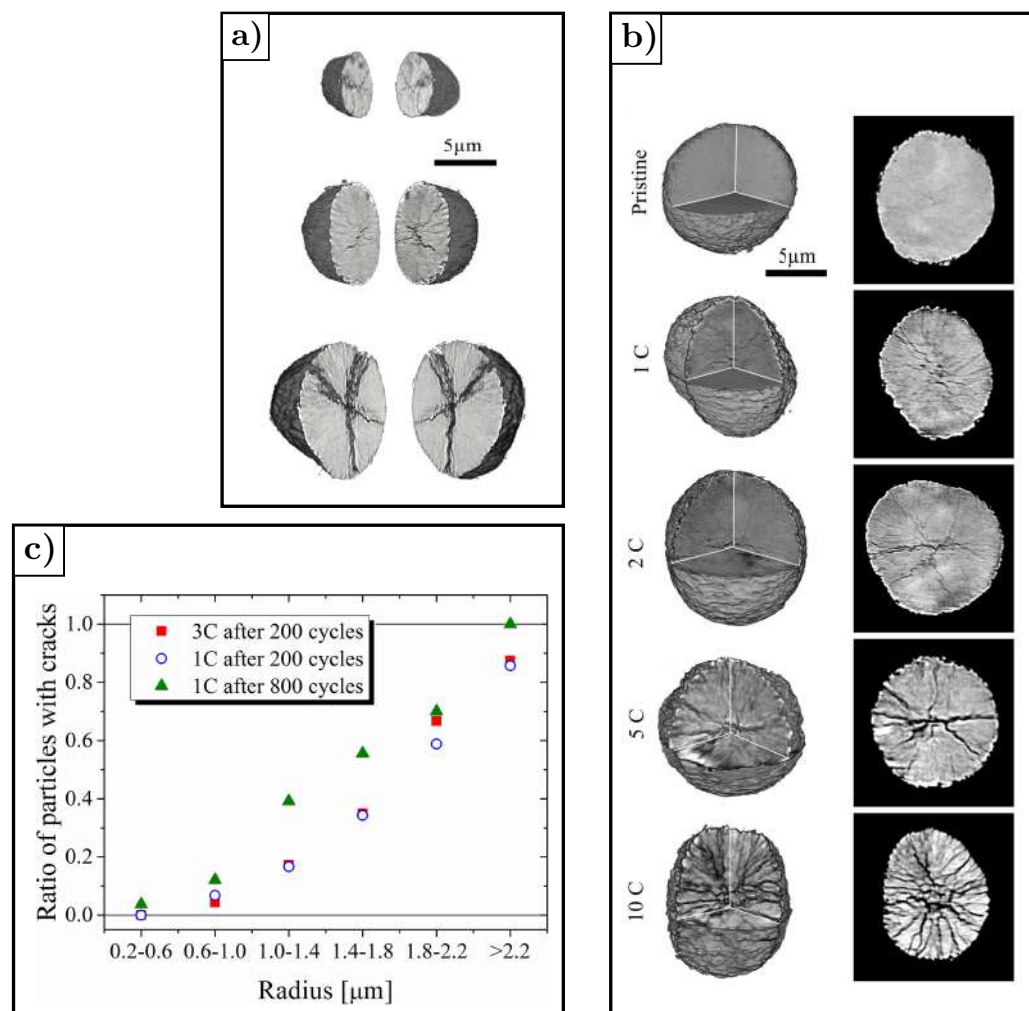
Figure 34. (a) Fracture in NMC particles of different size, after 50 cycles at 10C. (b) Fracture in NMC particles after 50 cycles at 1C, 2C, 3C, 5C and 10C. Reprinted with permission by Elsevier from [116], Copyright 2018. (c) Fracture occurrence in $\text{LiMn}_{1.95}\text{Al}_{0.05}\text{O}_4$ as a function of current rates and particles radius. Reprinted with permission by Elsevier from [155], Copyright 2017.

Cracks are found more frequently in larger particles than in smaller ones (Figure 34a,c).

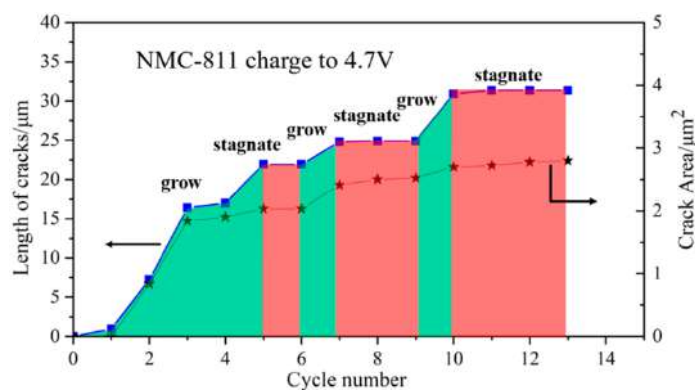
Figure 35. Measures of crack length and area as a function of number of cycles with in-situ SEM. The material is NMC811 cycled with a lithium counter electrode at 0.5C and 2.7 V–4.7 V. Reprinted with permission by Elsevier from [157], Copyright 2021.
