Hydric erosion in touristic beaches influenced by extreme rainfall events: case contribution of the pluvial drainage of the Ancon Hotel, Cuba

*Proceedings of the 61st ESReDA Seminar
Politecnico di Torino, Italy
22-23 September 2022*

Hydric erosion in touristic beaches influenced by extreme rainfall events: case contribution of the pluvial drainage of the Ancon Hotel, Cuba.

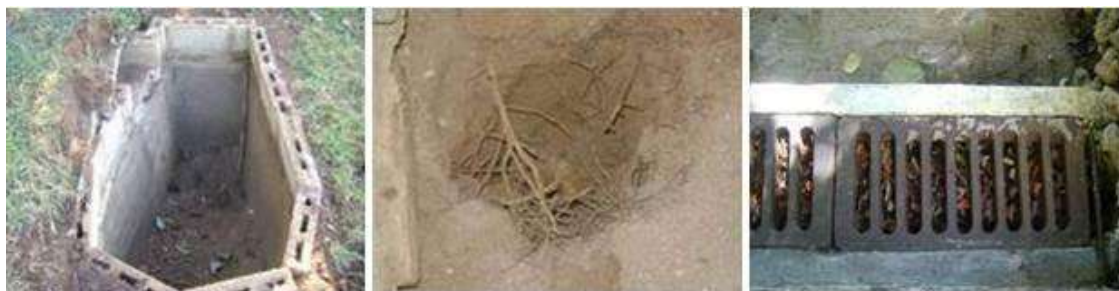
With a glance to the Figure 5, could be appreciated that filter beds were silted and filled with trash, soil, and sediment carried away by runoff from outside or covered areas. Regarding these issues, joint to the fact of plant rooting inside the filter beds the infiltration capacity of the wells was sensibly decreased with slow relative absorption (infiltration rate of 3.21 min).

Figure 5. Evidence of technical and maintenance deficiencies in the infiltration works.

Palliative solutions consist of relief leveling, soil tillage, turf improvement, technological improvements in the infiltration wells and the construction of infiltration ditches, and collectors. The infiltration trenches were also considered as a palliative solution according with its application in similar study case [35].
