# Failure and Damage of Reciprocating Lip Seals for Pneumatic Cylinders in Dry Conditions

**Abstract:** Lip seals are components subjected to high mechanical stress and they are responsible for many out-of-service in pneumatic cylinders. The aim of this work is the development of an experimental methodology to evaluate lifetime duration and analyse failures and damages of rod lip seals for pneumatic cylinders. A dedicated test bench was designed and manufactured which reproduces actual working conditions of the seals i.e., compressed air action (seal pressurisation) and relative linear reciprocating motion. Three types of seals made of two elastomers (NBR and polyurethane) were tested; dry condition was considered to speed up the tests. The influence of geometric parameters like seal seat dimension and seal axis misalignment with respect to the rod axis, was analysed by multiple experimental tests. Results in terms of seal life duration and failure modes are presented which allow comparison of seals performance and provide a helpful tool to end-users in a proper selection of seals geometry, material and key working parameters.

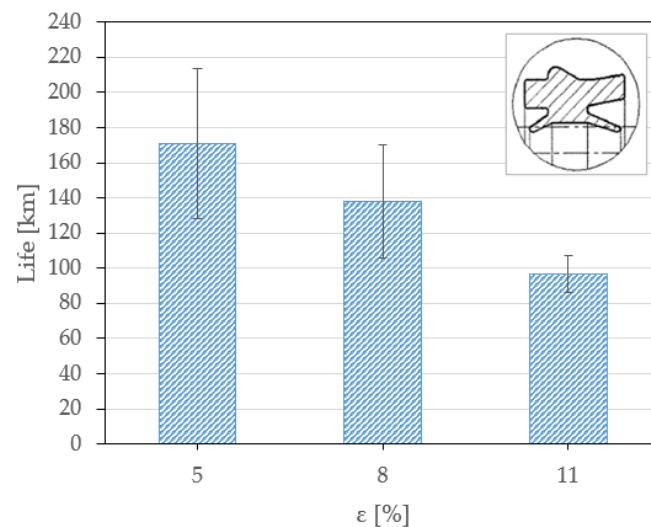
Figure 8 shows the estimated life of A2 seals as a function of the mounting eccentricity. These seals showed very long endurance, even under critical working conditions. No extrusion problems (mode II failure) were detected. High strength is due to both the squat shape of the section and the presence of the locking ridge that prevents any axial movement of the seal and provides high rotational stiffness to the section. The most frequently observed failure modes are modes I and III.

**Figure 8.** Lifetime for seal type A2 due to increased eccentricity.

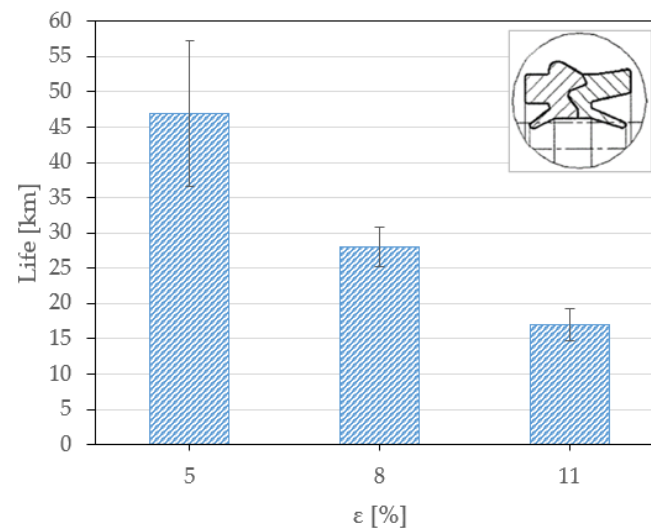
Figure 9 shows the estimated life of A3 seals. Compared with type A2, the life of these sealing elements is shorter when loaded through the same eccentricity value. Since A2 and A3 seals have the same geometry, the problem is related to materials. Polyurethane demonstrated its higher wear resistance with respect to NBR. Failure is typically from wear damages (failure mode III), where no case of seal extrusion was detected.

**Figure 9.** Lifetime for seal type A3 due to increased eccentricity.
