Garden building diagnostic systems for sustainable preservation

Abstract—A garden building located in Torino, 25 VERDE, designed by the architect Luciano Pia is object of a monitoring diagnostic campaign, started in 2016 and still in progress, for ensuring a long-lasting sustainable preservation. The residential complex of sixty-three apartments conceived as a habitable forest in which almost 200 trees cut down the fine dust caused by cars, is characterized by irregularly shaped terraces, supported by weathering steel tree-like structures. The weathering steels or high-strength low alloy steels have a unique interesting characteristic: they corrode under proper environmental conditions, forming a compact and tightly adherent oxide barrier that seals out the atmosphere and retards further corrosion. Dry and wet cycles create a protecting patina layer, meanwhile the constant presence of humidity and of aggressive gaseous pollutants (SO_2 , NO_x , etc) in the atmosphere degrades the properties of the layer. The diagnostic intervention is centered in the monitoring of the weathering steel structures by means of in situ electrochemical techniques, as Electrochemical Impedance Spectrosc

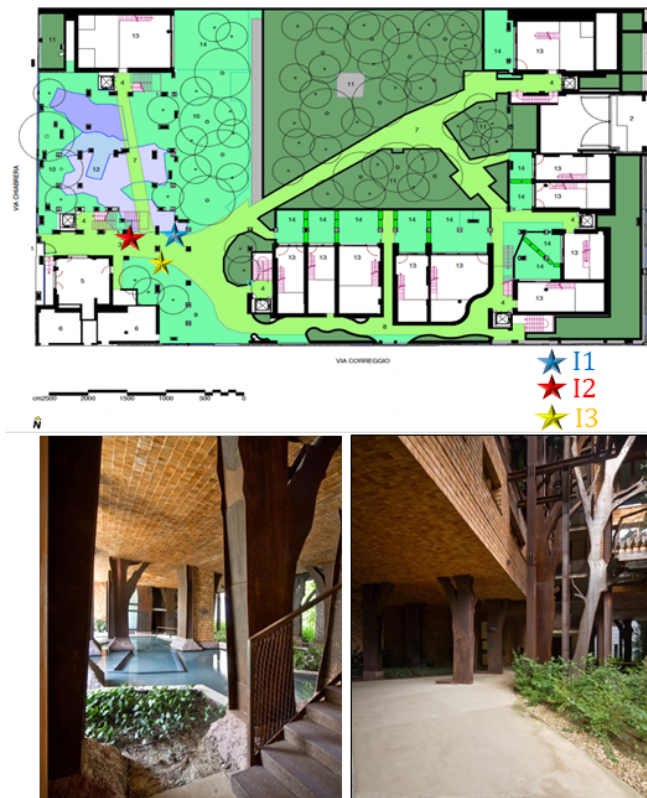
Fig. 5. Map of the ground floor of 25 VERDE (top) and pictures of the building (bottom).

In the case of 25 VERDE, our diagnostic intervention, Fig. 5 and Fig. 6, was centered in the monitoring of the weathering steel structures by means of in situ electrochemical techniques, as Electrochemical Impedance Spectroscopy (EIS) [17] [18]. The ultimate goal is to understand and assess the effect of the exposure conditions to the atmospheric corrosion of the weathering steel in these modern heritage buildings and structures [11] [19]. The paper presents the electrochemical results collected during an in situ monitoring campaign started in 2016 and still running.

Thanks to the visual inspection, the primary step of every building inspection, the monitoring points were identified, as shown on the maps of ground floor and of the second level of the building, Fig. 5 and Fig. 6. Particular attention has been paid to the appearance of the structural and non-structural components of the building, observing the presence

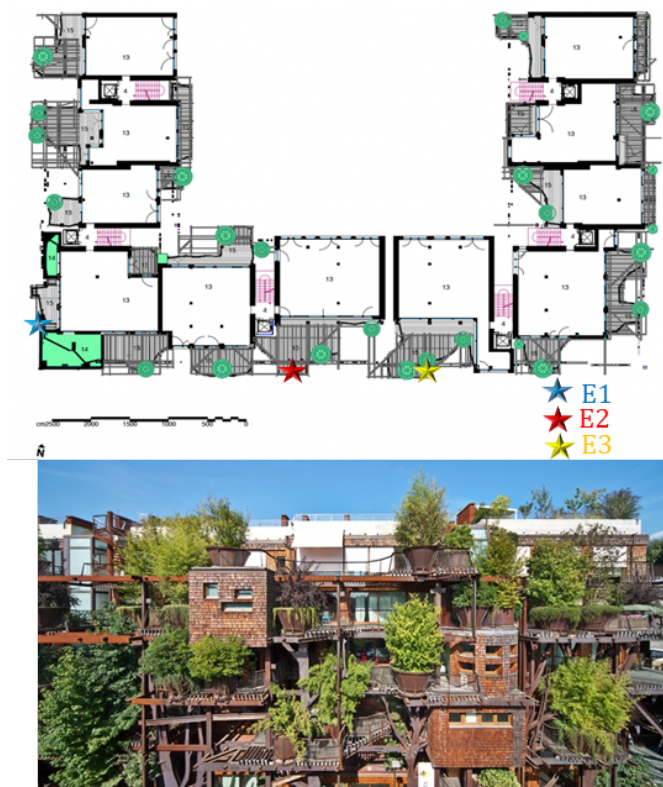
Fig. 6. The map of the second floor of 25 VERDE (top) and picture of the façade (bottom).
