Non-destructive testing on aramid fibres for the long-term assessment of interventions on heritage structures

2015 J. Phys.: Conf. Ser. 628 012102

R Ceravolo¹, A De Marchi², E Pinotti¹, C Surace¹, L Zanotti Fragonara¹

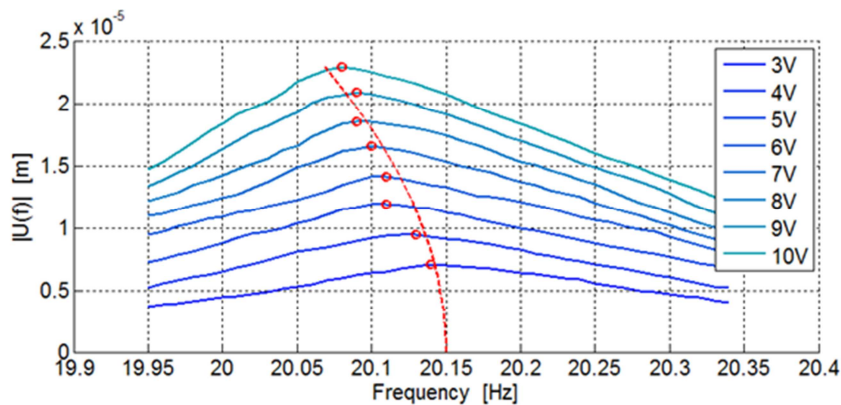
Figure 8. Back-bone nonlinear curve identification - undamaged Kevlar-29 sample.

Equation (1) was used to identify the so-called back-bone non-linear curve of the response, as it is highlighted by a red line in Figure 8 and Figure 9.

For the first Kevlar-29 (not damaged sample) the non-linear stiffness χ was identified at $-3.23 \cdot 10^{11}$ N/m³, whilst for the second Kevlar-29 sample (after damage) it was ca $-3.04 \cdot 10^{11}$ N/m³.

From Figures 8 and 9, where the backbone non-linear curves were represented, no significant differences can be appreciated between the pristine and damaged samples, as regards the inclination of the back-bone curve and the value of the index of non-linearity.
