# Land reclamation at an opencast Italian asbestos mine: some problems recently faced

B. Chiaia & G. Manzone

**ABSTRACT:** The Balangero mine, in North Western Italy, was till the '70ties one of the most important European asbestos producers, with more than 5.000.000 t yearly blasted rock, and a production of 150.000 t/y of asbestos - chrysotile- fiber. The mine exploitation was carried out in opencast, and attached to the excavation site were both the ore beneficiation plant and the waste tailings: the overall area involved by the mining activity rises to 0.8 km<sup>2</sup>, 0.15 km<sup>2</sup> and 1.5 km<sup>2</sup> for the extractive activities, the ore beneficiation plant and the tailings respectively. The mining activities having been abruptly stopped in 1990 due to company financial problems, the RSA Co established by public agreement (L.n. 257/92) was charged in 1994 of the restoration of the site, abandoned in quite critical conditions, the task involving a series of quite concerning technical problems, made all the more complex by the presence of asbestos and the associated criticalities in terms of both workers health protection and environmental pollution management. M

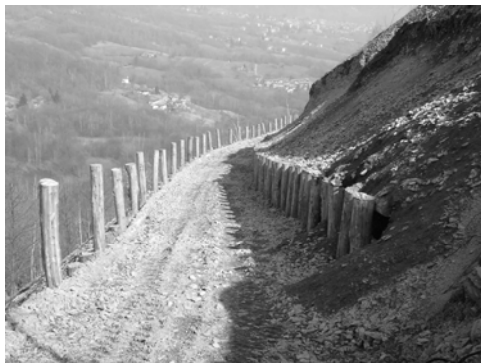
Figure 3. On the left, The reshaping of the upper part of the dump: the benches and the draining works are well visible. On the right, the berms created in the central part of the slope, to stabilize the dump body and intercept the run-off.

- reshaping of the upper part of the slope through the creation of 3 large benches (10 m height, 32° slope), and water control with draining channels (Fig. 3);
- run-off control in the central part of the slope through the creation of a number of little berms (3-4 m large) distant 30-40 m from each other (Fig. 3);
- reshaping of the toe of the slope and creation of a sedimentation basin where all the water drained along the slope has to be collected before reaching the Fandaglia river;
- starting the natural growing of vegetation through a first artificial planting.

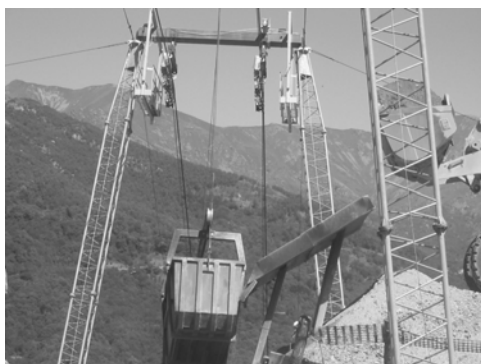
Figure 4. The earth-moving organization in the upper floor of the dump. On the right, a particular of the loading operation of one bucket of the ropeway.

A very critical phase of the work was the earthmoving, due to the topographic set and to the characteristic of the material to be moved. The final work organization resulted in (Fig. 4):

- a main transportation system based on a two-cable ropeway, with independent haulage ropes, single bucket capacity of 3 m<sup>3</sup>, capable of approx. 50 m<sup>3</sup>/h on a descent of 400 m;
- an earth moving organization on the upper part of the slope, based on a hydraulic excavator (bucket 0.8 m<sup>3</sup>), 2 trucks (capacity 12 m<sup>3</sup>), 1 wheel loader (bucket 0.8 m<sup>3</sup>).

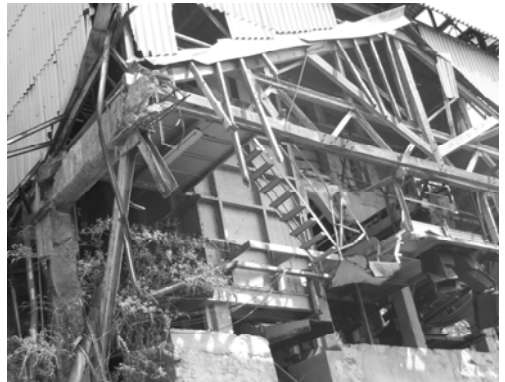
The building is densely occupied with plants containing a high quantity of asbestos fibres. It is the remaining part of a larger building partially demolished during a wrong operation which did not take into account the static characteristics of the frames (Fig. 6). The base of the building, on the valley side, rests on the remaining parts of two cantilever beams (in the original static scheme they were beams supported at both sides), stiffened by means of diagonal steel members. These two beams are severely damaged in correspondence of the support on the columns, due to a combined shear-flexural effect due to the modification of the static scheme. Collapse of these beams would presumably provoke the collapse of the entire building due to domino effect.

Figure 6. The state of building “B” showing the incipient risk for collapse.

Therefore, supporting the free edge of these two cantilever beams appears extremely urgent, and should be done before starting any other operation. These supports should be put in place by remotely shifting a pre-mounted frame below the cantilevers and then putting it into contrast by means of hydraulic jacks. The revealed presence of high percentages of asbestos fibres requires the same wetting and filming operations described in the case of building “A”.

Again, the obliged approach, which implies reasonable costs associated to a high degree of safety, is the controlled mechanical demolition (FDS), with progressive removal and transport of the debris from the top of the structure to the bottom, to be carried only after the initial consolidation of the cantilever frames described above.
