Land reclamation at an opencast Italian asbestos mine: some problems recently faced

FIFTEENTH INTERNATIONAL SYMPOSIUM ON MINE PLANNING & EQUIPMENT SELECTION

B. Chiaia & G. Manzone

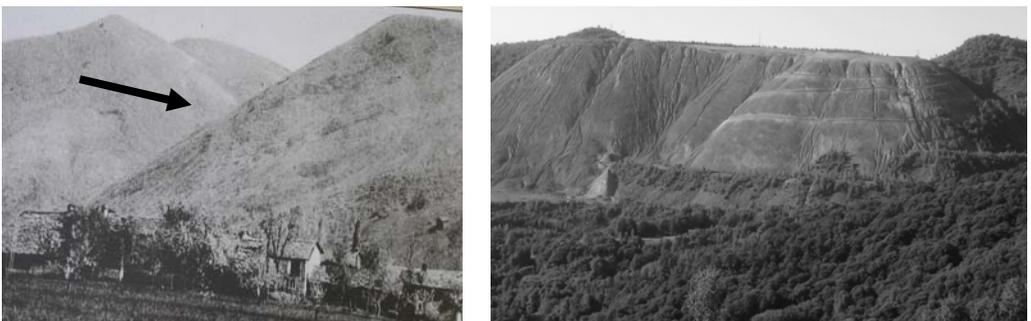
A serious problem the Balangero mining company had to face was the dumping of both exploitation wastes and processing tailings. Huge volumes of material were involved and the result, in terms of landscape reshaping, is impressive (Fig. 2).

Figure 2. On the left, a 1945 picture of the Fandaglia Valley, the area destined to host the second dump of Balangero mine. On the right the same area as appears today, after a first stage of rehabilitation works.

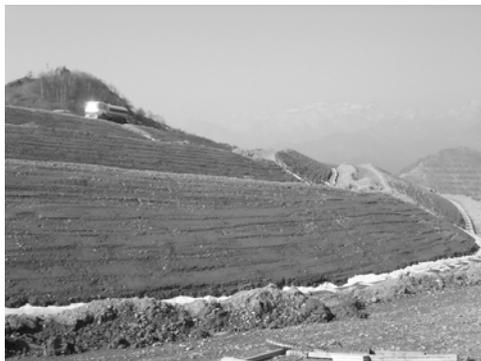
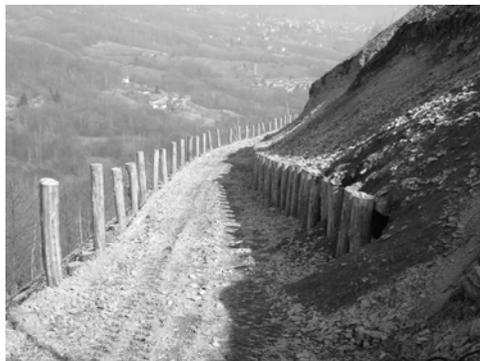
Figure 3. On the left, The reshaping of the upper part of the dump: the benches and the draining works are well visible. On the right, the berms created in the central part of the slope, to stabilize the dump body and intercept the run-off.

- reshaping of the upper part of the slope through the creation of 3 large benches (10 m height, 32° slope), and water control with draining channels (Fig. 3);
- run-off control in the central part of the slope through the creation of a number of little berms (3-4 m large) distant 30-40 m from each other (Fig. 3);
- reshaping of the toe of the slope and creation of a sedimentation basin where all the water drained along the slope has to be collected before reaching the Fandaglia river;
- starting the natural growing of vegetation through a first artificial planting.

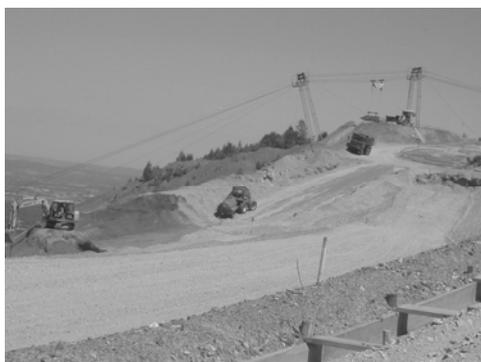
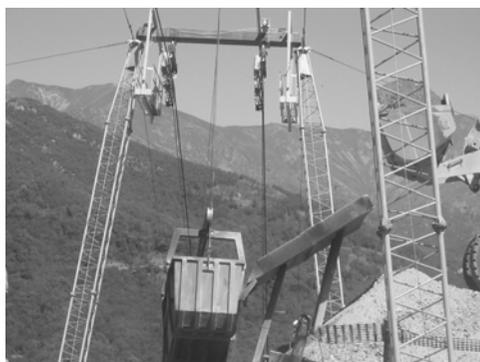
Figure 4. The earth-moving organization in the upper floor of the dump. On the right, a particular of the loading operation of one bucket of the ropeway.

A very critical phase of the work was the earthmoving, due to the topographic set and to the characteristic of the material to be moved. The final work organization resulted in (Fig. 4):

- a main transportation system based on a two-cable ropeway, with independent haulage ropes, single bucket capacity of 3 m³, capable of approx. 50 m³/h on a descent of 400 m;
- an earth moving organization on the upper part of the slope, based on a hydraulic excavator (bucket 0.8 m³), 2 trucks (capacity 12 m³), 1 wheel loader (bucket 0.8 m³).

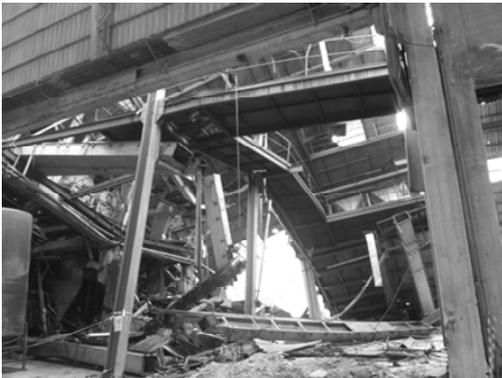
The building fell down in the past and is not recoverable (Fig. 5). Moreover, previous actions were carried out to remove plants and part of the load-carrying steel members. However, damage is only partial and further sudden collapses cannot be excluded. Although the area is easily reachable from the ground level, the presence of plants and relicts fully impregnated of asbestos forces to choose a sequence of removal operations alternated with induced highly-controlled partial collapses.

Figure 5. Partial collapse of the steel/reinforced concrete structures sustaining Building “A”.

Due to the highly dangerous and chaotic situation, controlled demolition shall be executed with the help of telescopic equipments remotely controlled, with a sequence of removal operations starting from the upper parts to the lower ones. The correct determination of the collapse kinematics appears of great importance, to avoid uncontrolled asbestos dispersion due to uncontrolled collapses. For the same reason, we suggest that, in any case, selective removal of relicts, although more time-demanding, should always be preferred to induced collapses.

The final option, which implies a reasonable cost, associated to a satisfactory degree of safety, is the controlled mechanical demolition, with progressive removal and transport of the debris from the top of the structure to the bottom. A 50m moving brace linked to a fixed crane shall be used, allowing the operator to stay sufficiently far from the building under demolition. The so-called FDS (Flying

Demolition System) is remotely controlled under absolute safety and allows to make controlled partial demolition and move the debris directly from above, thus eliminating the risk of debris flow outside the bounded safety area. Moreover, FDS permits to limit also the risk of uncontrolled collapses of the underlying structure under critical static conditions.

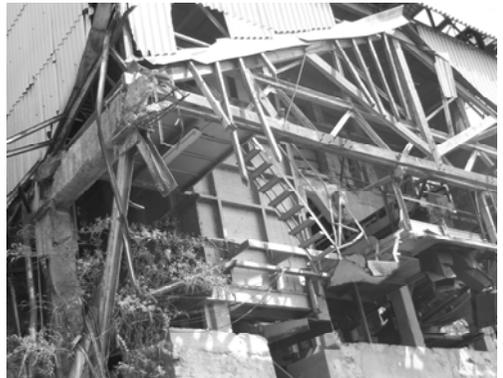
The building is densely occupied with plants containing a high quantity of asbestos fibres. It is the remaining part of a larger building partially demolished during a wrong operation which did not take into account the static characteristics of the frames (Fig. 6). The base of the building, on the valley side, rests on the remaining parts of two cantilever beams (in the original static scheme they were beams supported at both sides), stiffened by means of diagonal steel members. These two beams are severely damaged in correspondence of the support on the columns, due to a combined shear-flexural effect due to the modification of the static scheme. Collapse of these beams would presumably provoke the collapse of the entire building due to domino effect.

Figure 6. The state of building “B” showing the incipient risk for collapse.

Therefore, supporting the free edge of these two cantilever beams appears extremely urgent, and should be done before starting any other operation. These supports should be put in place by remotely shifting a pre-mounted frame below the cantilevers and then putting it into contrast by means of hydraulic jacks. The revealed presence of high percentages of asbestos fibres requires the same wetting and filming operations described in the case of building “A”.

Again, the obliged approach, which implies reasonable costs associated to a high degree of safety, is the controlled mechanical demolition (FDS), with progressive removal and transport of the debris from the top of the structure to the bottom, to be carried only after the initial consolidation of the cantilever frames described above.
