Terrestrial Laser Scanning and Settled Techniques: a Support to Detect Pathologies and Safety Conditions of Timber Structures

Keywords: Cultural Heritage, Wood dome, Structural assessment, Digital Photogrammetry, Laser survey, Orthophoto.

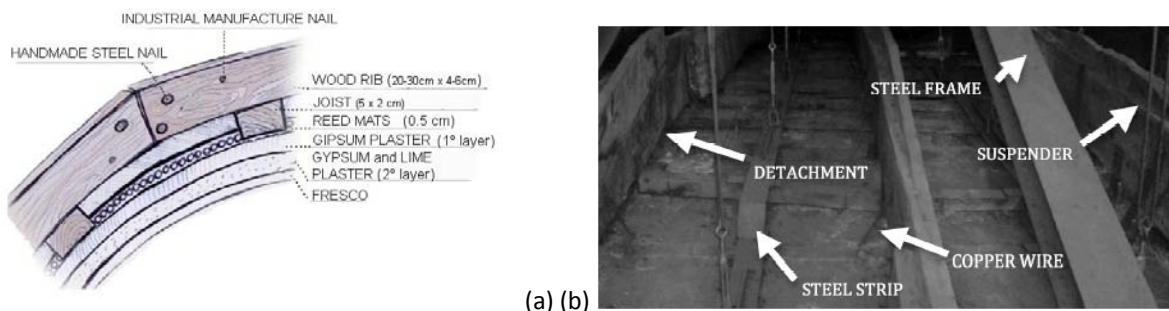
Figure 1: Scheme of "camorcanna" layers [5] (a), extrados of the Hall of Honor (b) of the Valentino Castle.

The principal structure is the above wood rib frame (Fig. 1a) that rules the curved shape of the dome. Each rib is obtained joining together two or more shaped planks with steel nails. The wood planks are 3 – 6 cm thick, 20 – 40 cm wide, and usually 2 – 3 m long. The rib spacing is around 0.7 m. The ribs are connected with steel nails to the underlying orthogonal wood joists. Joist section is 5 cm wide and 2 cm height. The joist spacing is around 25 cm. The continuous reed mat is hanging on the joists, and realizes the surface for the subsequent layers of plaster and stucco for the frescoes.

recently the roof structure was renewed and a steel frame structure was placed above the dome, and connected, with vertical suspender cables, to iron strips that were screwed to the little wood carpentry. (Fig. 1b) Nowadays, a survey revealed that the suspender cables above the vault in the region close to the abutments have lost their tension. This may indicate an increase of the vault deformation; therefore a structural assessment of the dome is mandatory.

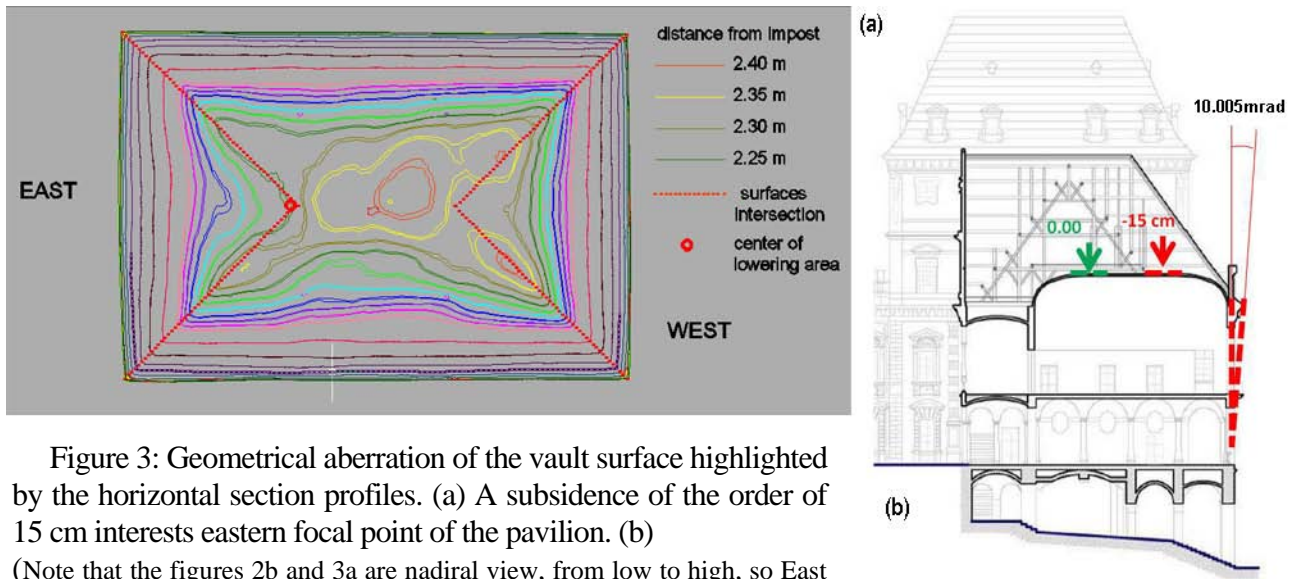
We can estimate the greater loss of the original geometrical shape in the subsiding area near eastern point of intersection of the cylinders of pavilion (red spot in Fig. 3a). Adding to the XXth restorations, this asymmetric subsidence may be related to a general rotation of eastern perimeter wall, that we observed and measured by means of the section profiles on walls (Fig. 2c and 3b). The rotation of about half degree, coincide with 8 cm measured in the centre line, near the impost plane.

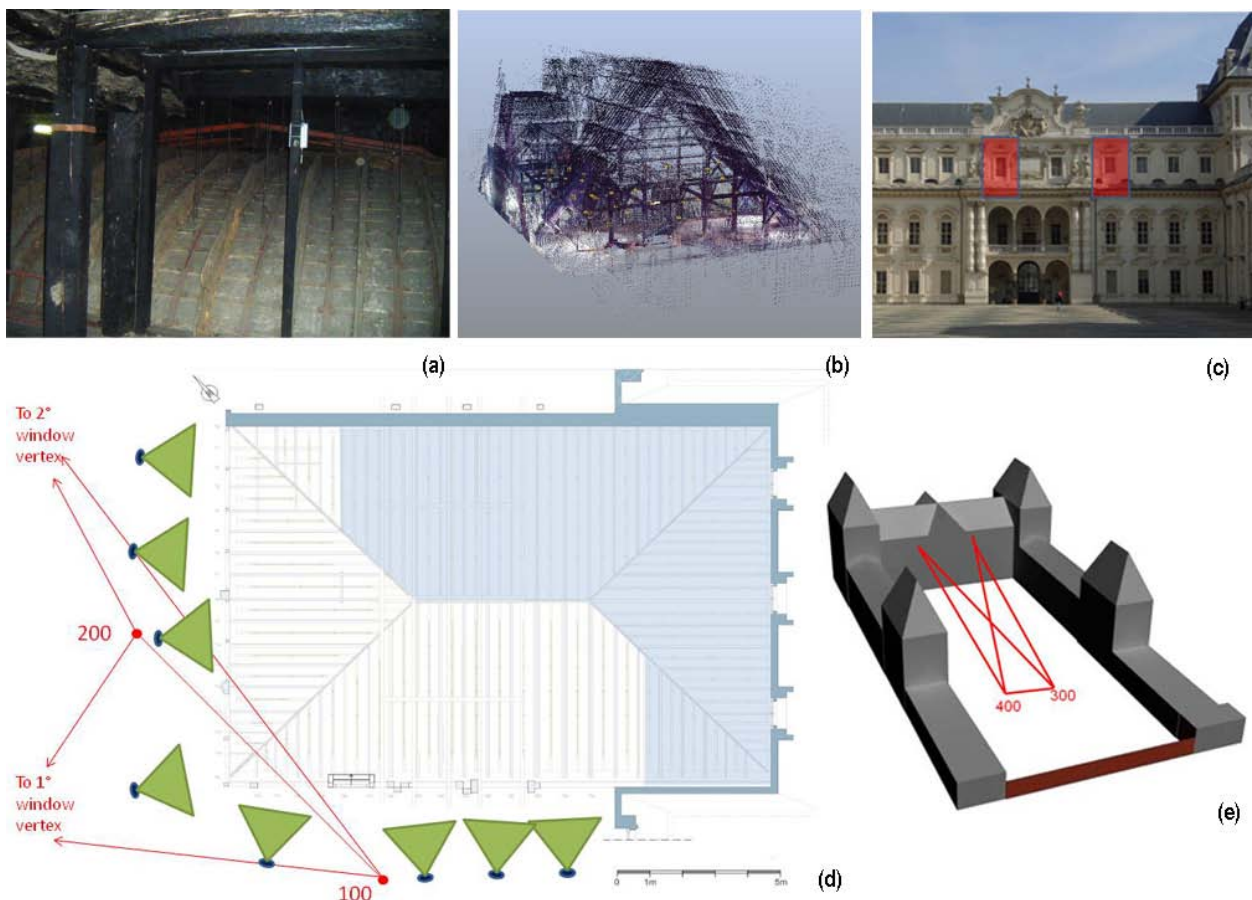
The laser survey of vault extrados has been more complex than the lower, because of the encumbrances of the roof carpentry and since a wooden planking is placed over the vault (Fig. 4a)

Moreover the northern side is unreachable for the presence of a bearing wall, and obviously the curvature makes the measurable portion very reduced (in the Fig. 4d, the light blue points out the unmeasurable portion of the vault).

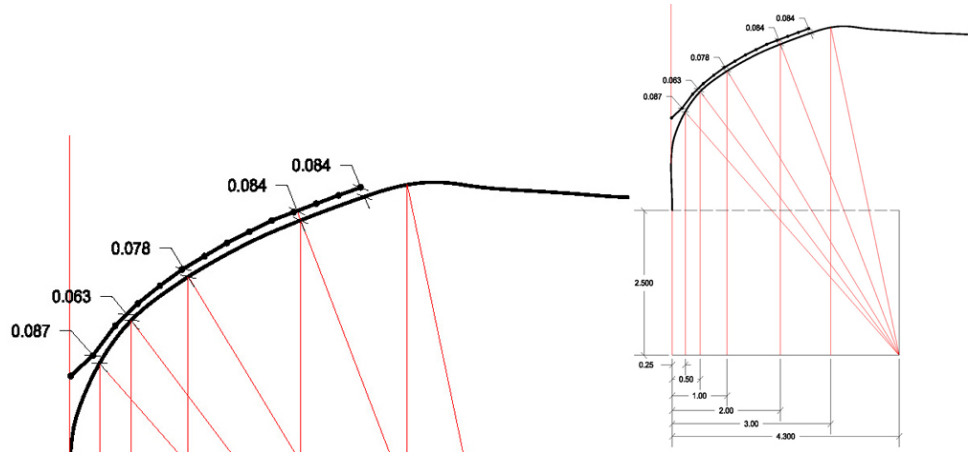
The maximum thickness is 0.22 m at the springing line. At the range distance between 0.5 m to 1m in plan from the walls, the average thickness decreases and becomes rather equal to 0.10 m. At the reins the thickness is minimum, and rather equal to only 0.06 m. In the central part of the dome the thickness is about 0.11 m, probably due to restorations and material additions. (Fig. 6-7)

Figure 7: A sample section derived with the aim to examine the thickness of the vault.

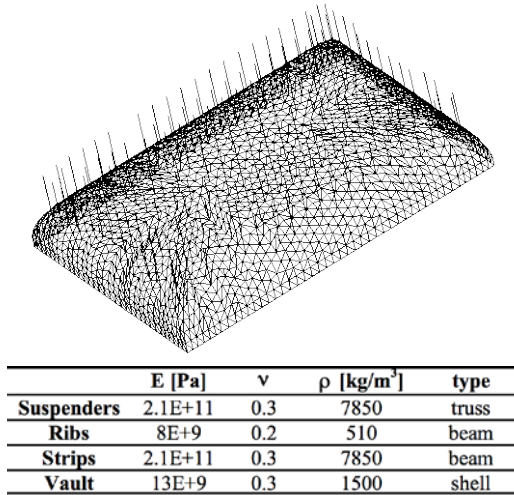
Figure 8: Mesh of the model (*above*); mechanical parameters of the model (*below*).

The shell represents the behaviour of the plaster, of the reed mat and of the wood joists in a single equivalent layer. The linear analysis has been carried out with the finite element program DIANA [11]. The overall mesh of the model is shown in Fig. 8a, while the table in Fig. 8b reports the basic mechanical assumption. The model is subjected to the only action of dead load due to gravity. At the present stage, the nonlinear behaviour of the materials has not been considered yet. Therefore, the model can provide only preliminary information about the structural behaviour of the dome. Nevertheless, the obtained deformed shape, shown in figure 9, is in agreement with the anomalies measured by the laser-scanning survey. In particular, the annular region around the big chandelier appears to be the most prone to displacements. On the other side, the suspenders, which are located in the outer region of the vault, are not elongated at all. This corresponds well with the evidence of the survey, which reveals that many of them have actually lost their tension (Fig. 10).

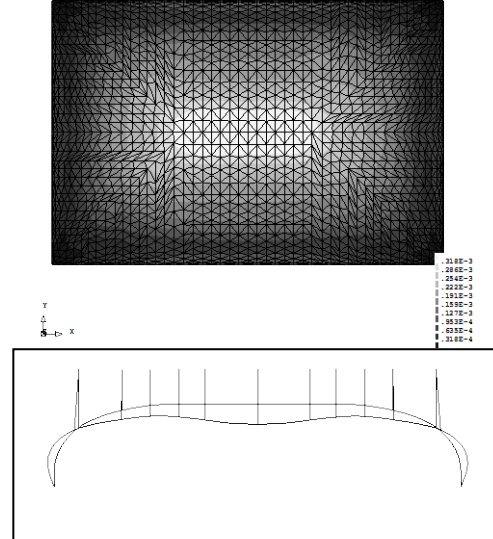
Figure 9: Contour plot of vertical displacements (*above*); transverse section with vertical displacements (*below*).

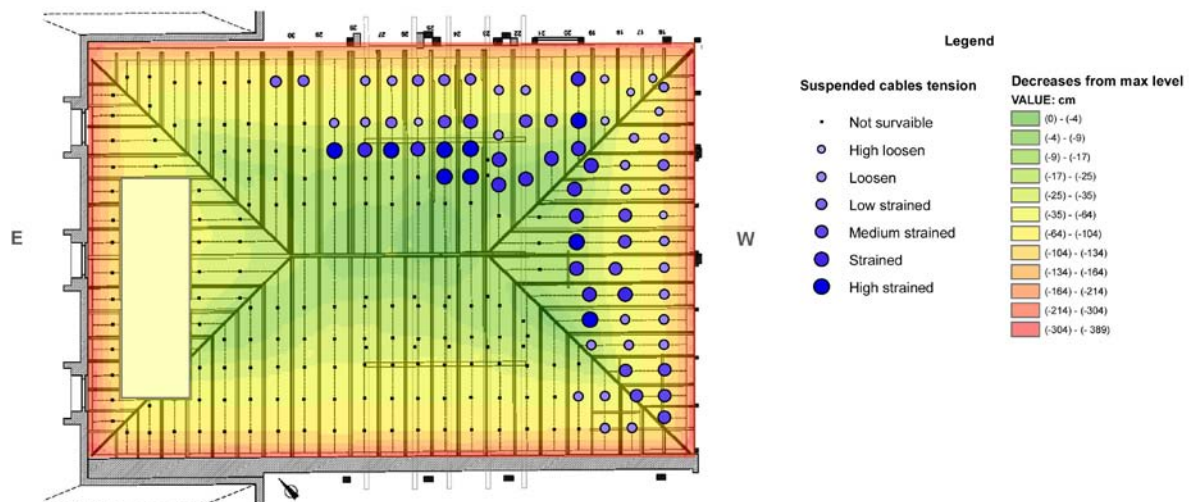
Figure 10: The survey representation of the state of tension in the suspenders is metrically referenced to the intrados Dem by GIS tools. The nadiral view is from low to high.

The preliminary finite element model is confirmed as far as the deformed shape is concerned, and also the loosen suspenders can be localized. The suggestion is not to provide tightening to the loosen suspenders [1, 12].
