AE monitoring and structural modelization of the Asinelli Tower in Bologna

Stefano Invernizzi¹, Giuseppe Lacidogna¹, Gianni Niccolini¹, Amedeo Manuello¹,
Alberto Carpinteri¹

Keywords: Acoustic emission, finite element method, structural assessment.

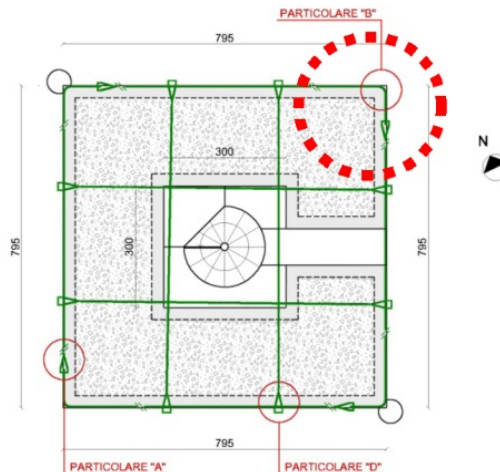
Figure 3. Cross-section of the tower at a height of ca 10 m above ground. Drawing supplied by the Municipality of Bologna. The corner where the sensors were applied is marked with a circle.

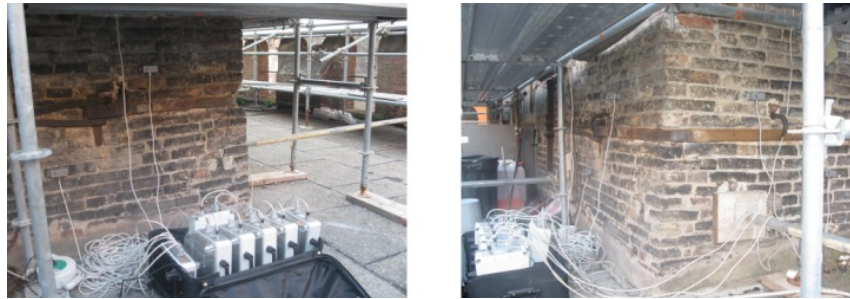
Figure 4. Photos of the AE data acquisition system on the monitoring site.

Only a limited number of sensors were available and hence the AE devices were positioned in a zone that would be both significant for monitoring purposes and easy to reach. In particular, six AE sensors were applied to the northeast angle of the tower at an average height of ca 9.00 m above ground level, immediately above the terrace atop the arcade. In this area, the double-wall masonry has an average thickness of ca 2.45 m (see Figs. 2 and 3). AE monitoring began on 23 September 2010 at 5:40 PM, and ended on 28 January 2011 at 1:00 PM. It was carried on for ca 2915 hours, corresponding to 122 consecutive days. The arrangement of the AE sensors, shown in the photos in Fig. 4, corresponds to the scheme illustrated in Fig. 5. The sensors were glued to the outer surface of the masonry with cold set silicone based adhesives, selected on account of their good ultrasound signal transmission capacity, resulting in reduced damping at the interface between the masonry and the sensors.

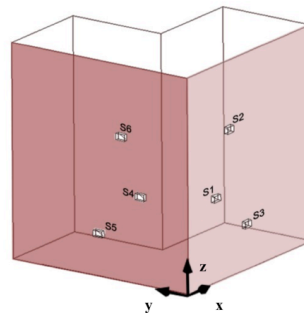
Figure 5. Axonometric scheme of the points of application of the AE sensors at the north-east corner of the tower.

The coordinates of the sensor application points are given in Table 1. The origin of the coordinate system of reference, as can be seen in Fig. 5, is at the bottom corner of the masonry at the intersection with the outer surface of the terrace surrounding the tower.

Sensors	x	y	z
S1	51.50	0.00	98.00
S2	78.00	0.00	171.0
S3	110.00	0.00	53.00
S4	0.00	63.50	102.00
S5	0.00	121.06	50.00
S6	0.00	89.00	167.00

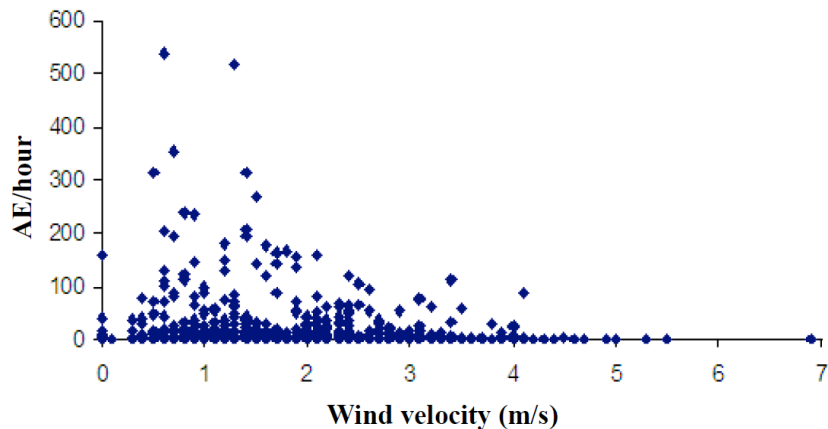
Figure 10: Chart relating the wind velocity and the AE count rate during all the monitoring time, the two time series seem to be statistically unrelated.

Moreover, the chart of Fig 10 relates the wind velocities and the AE count rate obtained during all the monitoring period (2915 hours). This graph makes clearer that the two phenomena are completely statistically unrelated.
