# Experimental and Numerical Analysis of Delamination Repair Plaster Applied to Historical Masonry Building

**Abstract:** Often masonry walls of historical buildings are subject to rising damp effects due to capillary or rain infiltrations. In the time, their cyclic action produces decay and delamination of historical plasters. An experimental laboratory procedure for the pre-qualification of repair mortars is described. Long-term plaster delamination frequently occurs because of the mechanical incompatibility of new repair mortars. The tested mortars are suitable for new dehumidified plasters applied to historical masonry walls. Compression static tests were carried out on composite specimens of stone block-repair mortar, which specific geometry can test the de-bonding process of mortar in adherence with historical masonry structure. A numerical simulation based on the cohesive crack model was used to follow the experimental data, in order to describe the evolutionary phenomenon of de-bonding as a function of a small number of parameters. This method supplies useful indication for selecting the product that is best in keeping with the mechanical characteristics of the historical

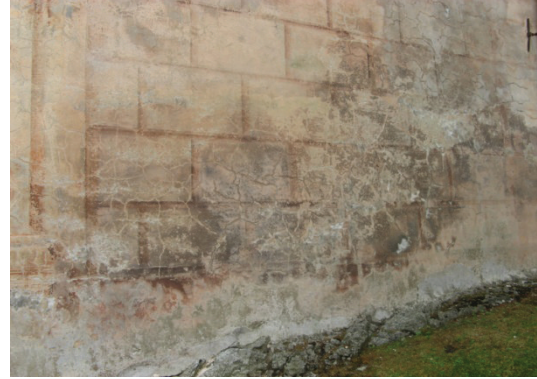
Fig. 3 Delamination and detachment of artistic plasters because of the rising damp effects due to capillary action or rain infiltration (Chapel n. 23—Jesus is taken).

Because of the rising capillary damp, the freeze-thaw cycles and the abundant rain and snow precipitations that characterize this mountain area, the historical plaster of the chapels has been subjected to progressive material decay over a long period of time (Figs. 3 and 4).

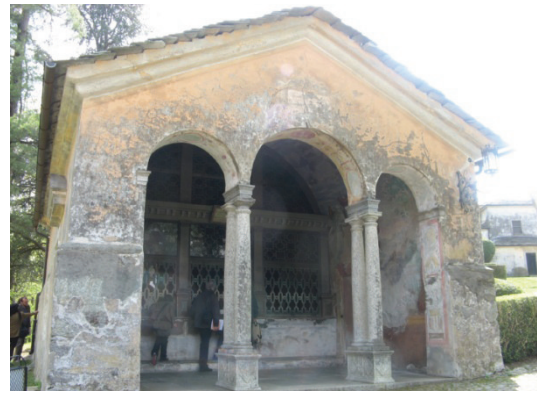
Fig. 4 Decay of historical plasters because of the rain infiltrations (Chapel n. 13—The Temptations).

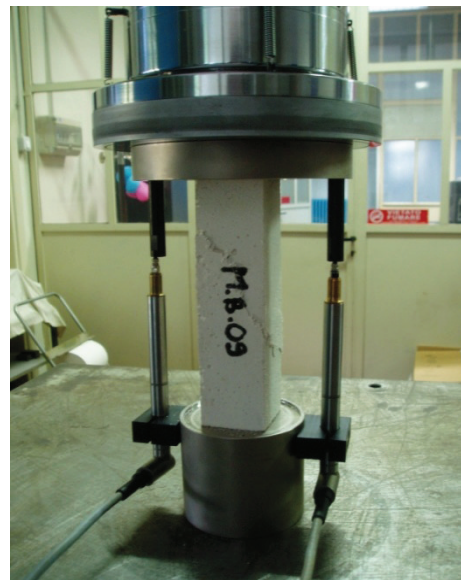
Fig. 5 Compression test on single mortar specimen.

The mechanical and hygrometric characteristics of single materials have been investigated by means of 10 test pieces  $40 \text{ mm} \times 40 \text{ mm} \times 160 \text{ mm}$  for each mortar typology. All tests were carried out 28 days after the casting of repair mortar. The single specimens were labelled “M.A.” for mortar A and “M.B.” for mortar B, following the number code (Fig. 5).

Static tests, according to UNI EN 1015-11 and UNI 6556, were performed by means of a 250 kN model 810 M.T.S. (material testing system). In particular 3 specimens for each repair mortar were employed for bending test and 4 specimens for compressive and elastic modulus test.

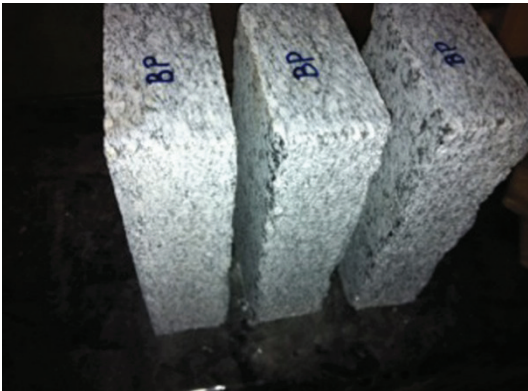
Fig. 8 Adherence surface of stone treated by pneumatic drill.

From the results of point 2.1, a typology of mortar was chosen and the experimental study was carried on with tests on composite stone block-repair mortar specimens. Compressive static tests were carried out on 4 specimens after 28 days of maturation. This mixed specimens were made by 30 mm thick layer of chosen repair mortar joining to the two shorter vertical sides of the stone block, selected similar to that of the Sacro Monti masonries (Fig. 7). The stone surfaces to contact with the mortar were treated by a specific pneumatic drill in order to improve the adherence of the strengthening product (Fig. 8).

Because of the wedges (Fig. 14), the cracks starting from the specimen bottom show a growing velocity larger than the cracks starting from the specimen top. Therefore, the second couple of cracks plays the role of main cracks. The surface treatment shown in Fig. 8 increases the values of  $w_{nc}$  and  $w_{tc}$  in comparison to the case of the interface between the same type of mortar and brick [14].

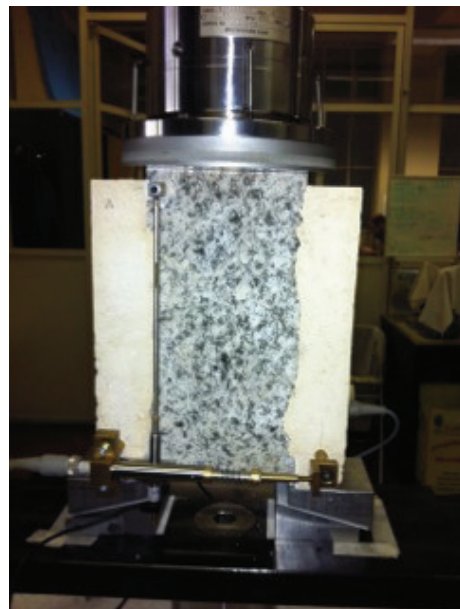
Fig. 10 Composite specimen stone-repair mortar.

The mixed pieces were instrumented with two symmetrical couples of inductive displacement transducers (Fig. 10). One transducer per side was arranged horizontally in the lower part of the specimen and connected between the two opposite mortar layers, measuring the displacements due to bulging. The other transducers, one per side, were placed vertically on the stone block.
