# Experimental and Numerical Analysis of Delamination Repair Plaster Applied to Historical Masonry Building

Pietro Bocca, Silvio Valente, Alessandro Grazzini and Andrea Alberto

*Department of Structural, Building and Geotechnical Engineering, Politecnico di Torino, Torino 10129, Italy*

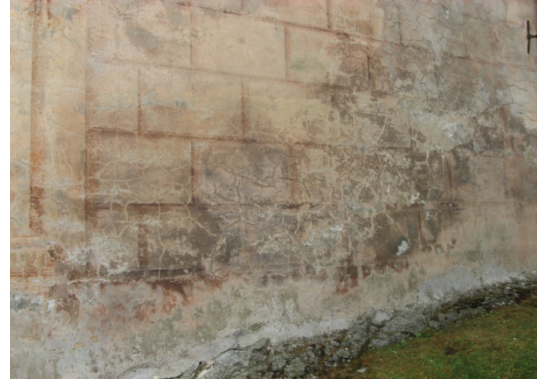
**Fig. 3** Delamination and detachment of artistic plasters because of the rising damp effects due to capillary action or rain infiltration (Chapel n. 23—Jesus is taken).

Because of the rising capillary damp, the freeze-thaw cycles and the abundant rain and snow precipitations that characterize this mountain area, the historical plaster of the chapels has been subjected to progressive material decay over a long period of time (Figs. 3 and 4).

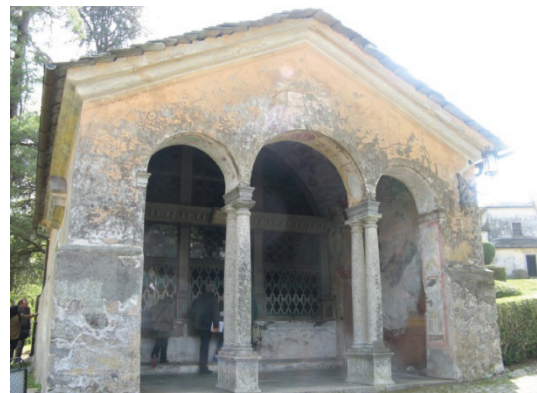
**Fig. 4** Decay of historical plasters because of the rain infiltrations (Chapel n. 13—The Temptations).

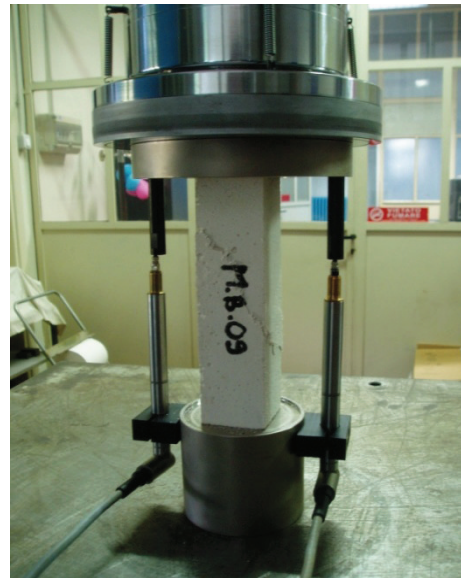
Fig. 5 Compression test on single mortar specimen.

The mechanical and hygrometric characteristics of single materials have been investigated by means of 10 test pieces  $40 \text{ mm} \times 40 \text{ mm} \times 160 \text{ mm}$  for each mortar typology. All tests were carried out 28 days after the casting of repair mortar. The single specimens were labelled “M.A.” for mortar A and “M.B.” for mortar B, following the number code (Fig. 5).

Static tests, according to UNI EN 1015-11 and UNI 6556, were performed by means of a 250 kN model 810 M.T.S. (material testing system). In particular 3 specimens for each repair mortar were employed for bending test and 4 specimens for compressive and elastic modulus test.

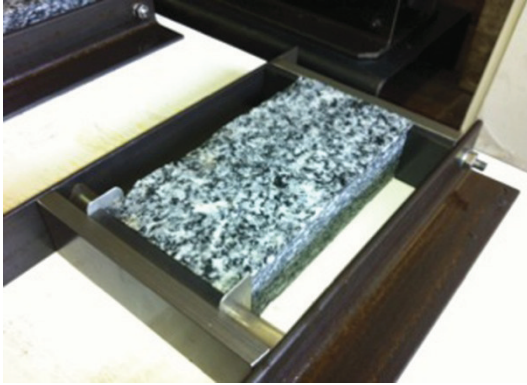
**Fig. 7** Preparation of mixed specimen into steel mould.

From the results of point 2.1, a typology of mortar was chosen and the experimental study was carried on with tests on composite stone block-repair mortar specimens. Compressive static tests were carried out on 4 specimens after 28 days of maturation. This mixed specimens were made by 30 mm thick layer of chosen repair mortar joining to the two shorter vertical sides of the stone block, selected similar to that of the Sacro Monti masonries (Fig. 7). The stone surfaces to contact with the mortar were treated by a specific pneumatic drill in order to improve the adherence of the strengthening product (Fig. 8).

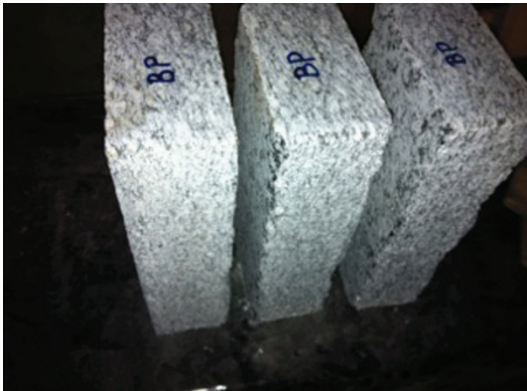
**Fig. 8** Adherence surface of stone treated by pneumatic drill.

Because of the wedges (Fig. 14), the cracks starting from the specimen bottom show a growing velocity larger than the cracks starting from the specimen top. Therefore, the second couple of cracks plays the role of main cracks. The surface treatment shown in Fig. 8 increases the values of  $w_{nc}$  and  $w_{tc}$  in comparison to the case of the interface between the same type of mortar and brick [14].

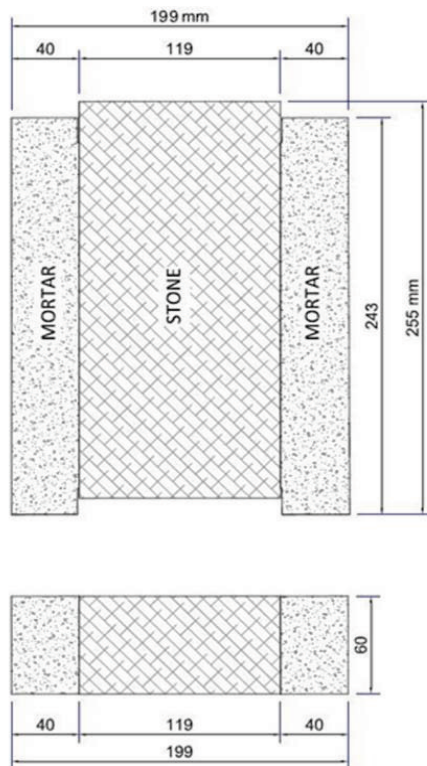
**Fig. 9** Geometry of mixed specimen stone-repair mortar.

The ad hoc geometry of the stone block-mortar specimens (Fig. 9) was able to test the adherence between the repair mortar and the masonry structures.

The dehumidifying mortar layers were not applied in complete adherence with the stone block support, on the contrary, they were applied in symmetrical and regular discontinuity at the bottom and the top of the specimen (Fig. 9). These discontinuities behaved like notches that which were able to trigger multiple crack propagation, in order to simulate the adherence capacity of each repair mortar applied to a specific masonry wall as dehumidified plaster.

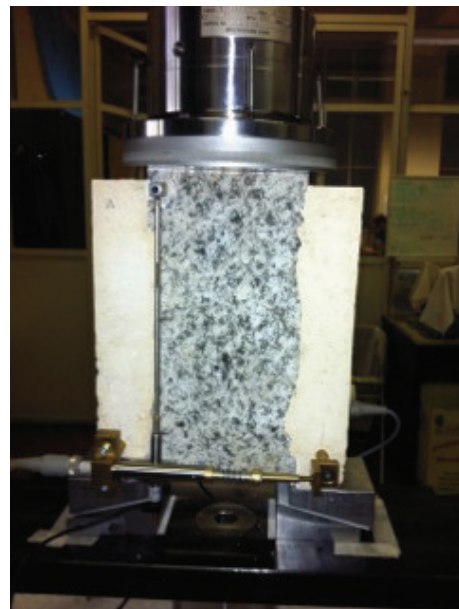
**Fig. 10** Composite specimen stone-repair mortar.

The mixed pieces were instrumented with two symmetrical couples of inductive displacement transducers (Fig. 10). One transducer per side was arranged horizontally in the lower part of the specimen and connected between the two opposite mortar layers, measuring the displacements due to bulging. The other transducers, one per side, were placed vertically on the stone block.

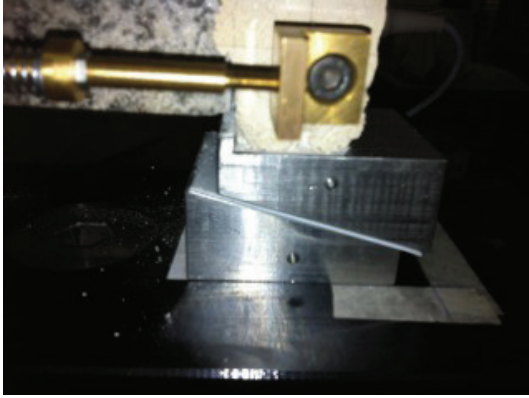
Fig. 11 Geometry of the wedges.

The lower mortars layer support was made up of a double system of steel wedges (Fig. 11), coupled with Teflon having thickness equal to 1 mm. It was for

reducing the friction related to the horizontal expansion of the plaster, and so to stabilize the load curves.

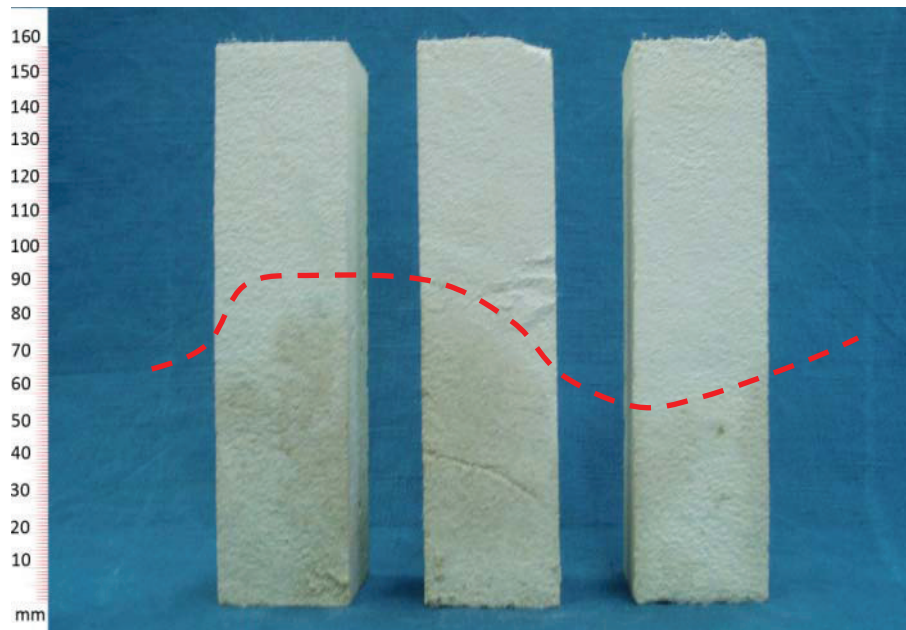
Fig. 11 Lift height of capillarity in specimens mortar B.

displayed (Fig. 12) a great lift height capillary for mortar B (up to 80 mm), while for mortar A the absorption was limited to 50-60 mm (Fig. 13).

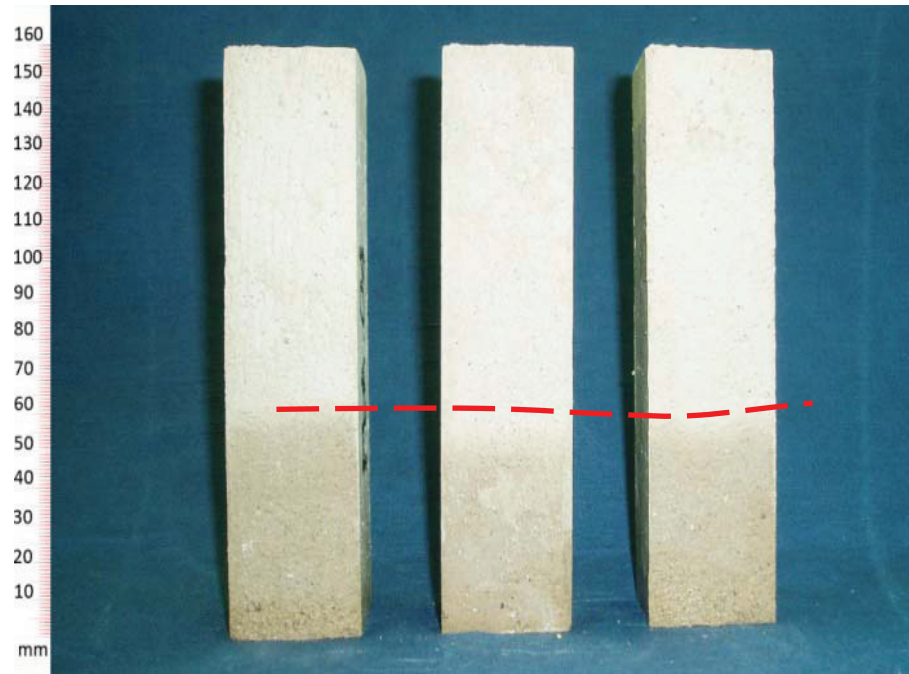
Fig. 12 Lift height of capillarity in specimens mortar A.

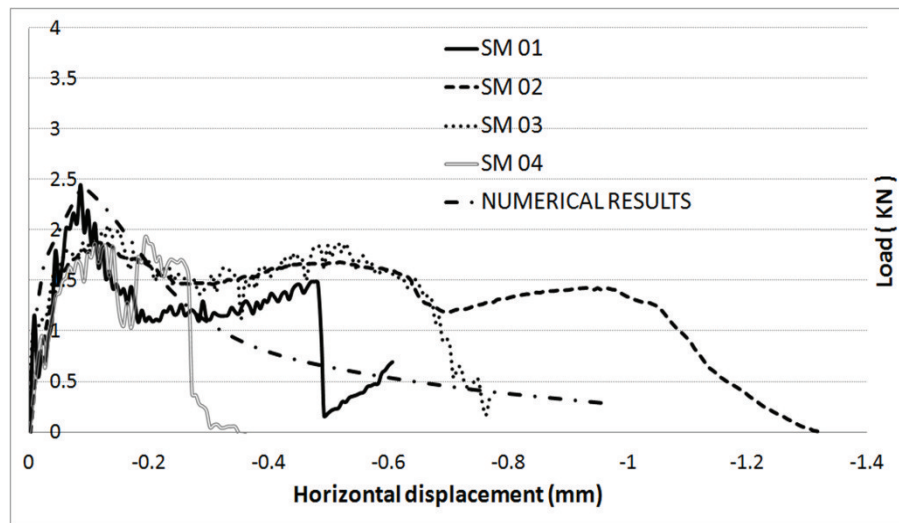
Fig. 13 Load-horizontal displacement curves of static tests.

The results of compressive static tests are showed in Fig. 13 and in Table 2. The composite specimens stone-mortar were displayed four stress singularity points: two notch tips at the specimen top, and two at the specimen bottom (Fig. 13). These points were the weakest planes involved in the singular stress fields. Because of the wedges, the cracks that start from the bottom of the specimen have showed a greater

To exception of SM 04, the other composite specimens were displayed a ductil behavior keeping a residual load and displacement after the peak load (Fig. 13). That is a fundamental requirement for a durable service life of repair plasters subjected to thermo-higrometric cycles stress as rising damp effects. The specific geometry of the composite specimens has allowed to test the adherence between dehumidified repair plaster and masonry structures, in order to pre-qualify the durability of the repair product. The notch tips have put to the test the adherence of the repair plaster applied to the stone support, simulating the fatigue loads that can compromise the restoration work.

Fig. 11 show that the teflon sheet, inserted at the contact surface between upper and lower wedge, is able to reduce the friction and therefore it reduces the load values too. In the numerical simulation, the friction is disregarded. Numerical and experimental results are in good agreement (Fig. 13).
