# DETACHMENT ANALYSIS OF DEHUMIDIFIED REPAIR MORTARS APPLIED TO HISTORICAL MASONRY WALLS

Pietro Bocca<sup>1</sup>, Silvio Valente<sup>2</sup>, Alessandro Grazzini<sup>3\*</sup>, Andrea Alberto<sup>4</sup>

Department of Structural, Building and Geotechnical Engineering (DISEG) – Politecnico di Torino

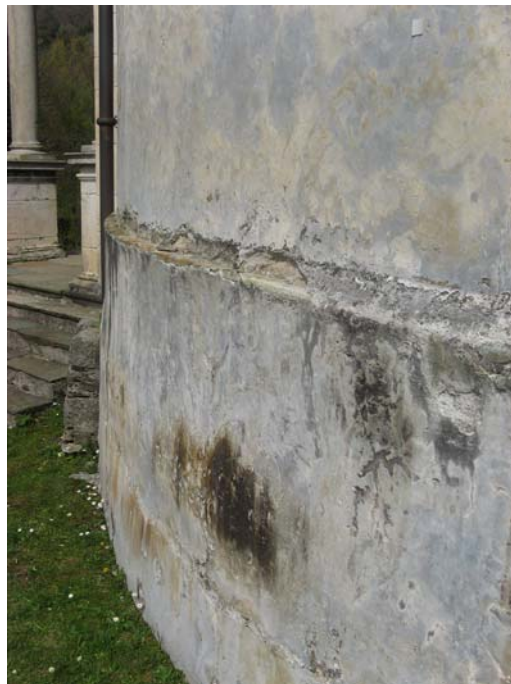
**Figure 2.** Detachment of historical exterior plasters at Transfiguration Chapel because of the rising damp effects due to capillary action or rain infiltration

Because of the rising capillary damp, the freeze-thaw cycles and the abundant rain and snow precipitations that characterize this mountain area, the historical plaster of the chapels has been subjected to progressive material decay over the long term (Figures 2-3).

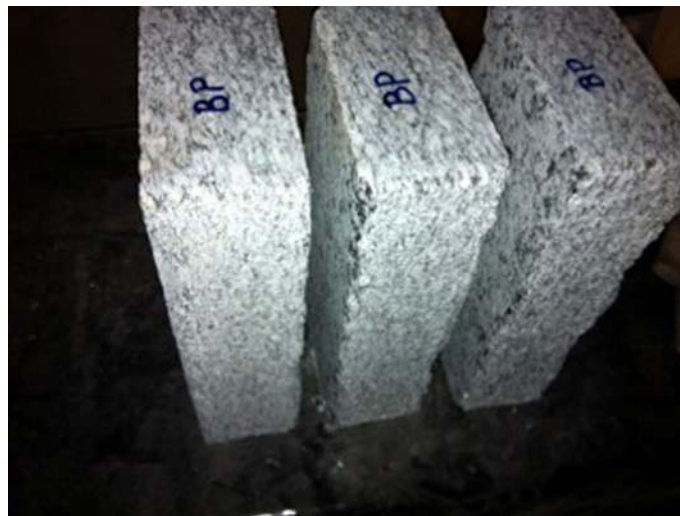
**Figure 5.** Adherence surface of stone treated by pneumatic drill

Four assembled specimens have been tested in compressive static load. This composite specimens were prepared by joining a stone block (similar to that of the Sacro Monte masonry) to symmetrical layers of repair mortar on the two shorter vertical sides of the stone block. It was obtained from cut stone placed in designed steel mould and joined to 40 mm thick layer of strengthening mortar cast onto it (Figure 4). This particular typology of assembled specimen has been tested already in precedents experimental researches to appraise the mechanical compatibility between strengthening mortars and historical masonry (Grazzini, 2006). The ad hoc geometry of this stone block-mortar specimens was able to test the adherence between the repair mortar and the masonry structures. The stone surfaces in contact with the mortar were treated by a specific pneumatic drill in order to improve the adherence (Figure 5).
