REVISIT

TO WUXI EXPERIMENTAL BUILDING

2014. 05

## INTRODUCTION

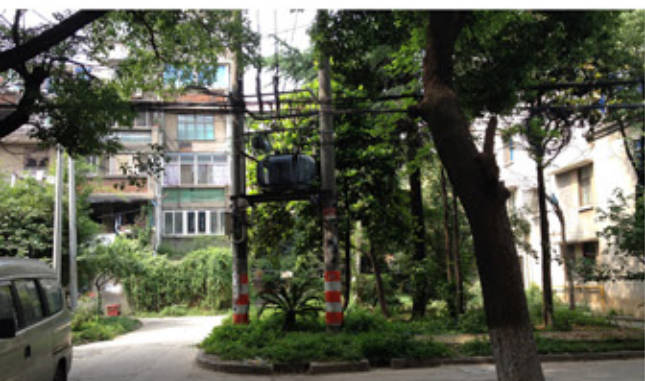
Picture of Open Space 2

Open space between buildings is not well used. Trees are seldom pruned, the grass is quite overgrown, and public facilities are disorderly arranged. Some people dry clothes or park the car there, but they would not stay longer.

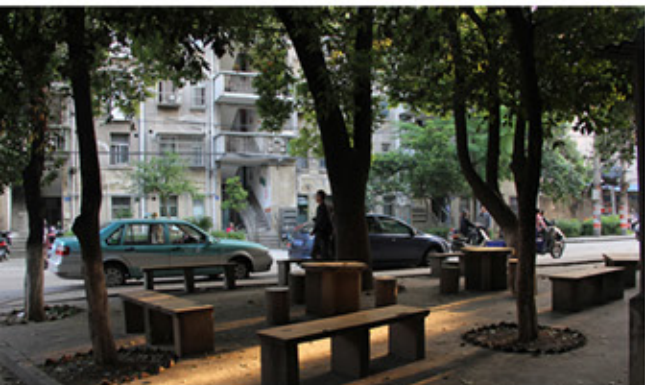
**Picture for Open Space 1**

Wooden benches are provided by the municipal department. People may have a rest here, but seldom stay for a long time.

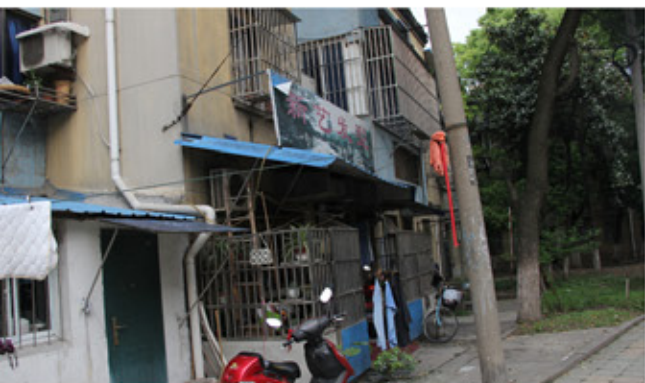
**Picture for Open Space 2**

The workplace has a positive influence on the open space along the street.

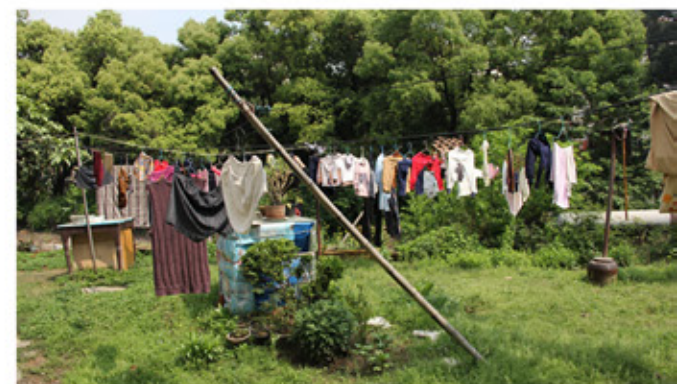
**Picture for Open Space 3**

People living in the northern part like to dry clothes in the grassy field which is with wonderful sunshine.

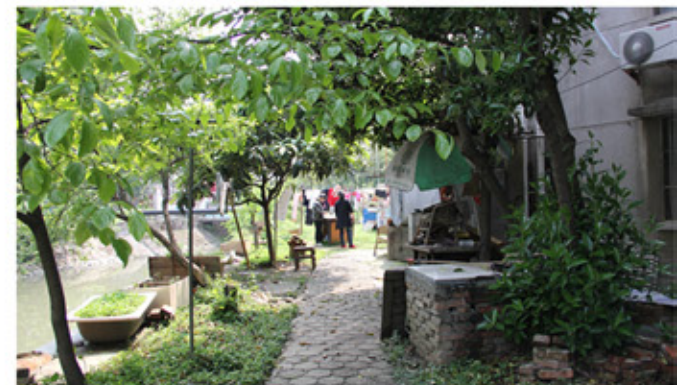
**Picture for Open Space 4**

People like to stand and chat by the river. Some of them even do their handwork there.

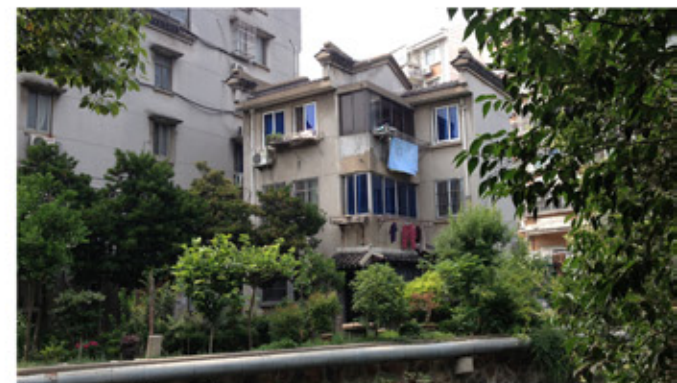
**Picture for Open Space 5**

Some trees are planted by residents, and a set of stone table and stool is provided by a family in the ground floor.

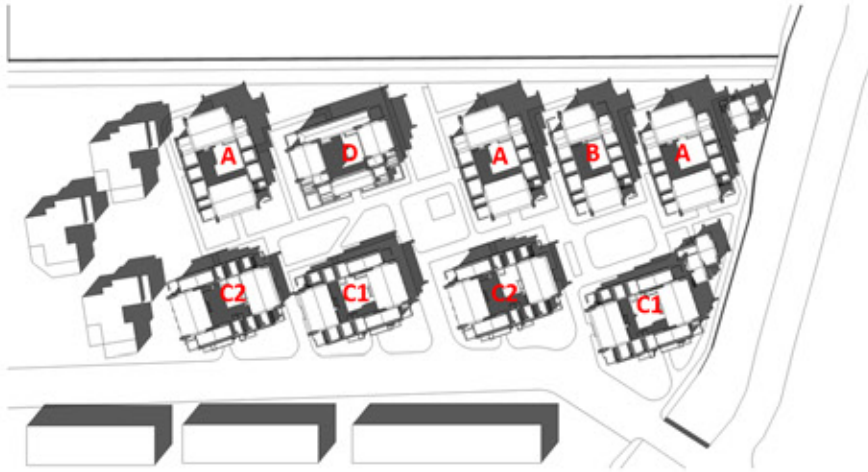
Type A

Shared courtyard is designed for every building in order to provide the opportunity for neighborhood communication. It should be admitted that this special building form has a negative impact on the natural lighting condition of suites in the northern part. And it attributes to users' wide complaints of this community.

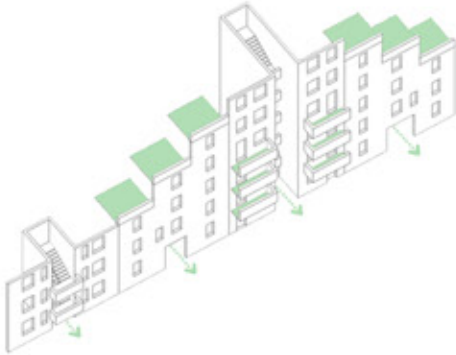
Access

However, it is observed that only very few people would stay at the courtyard although various accesses are design by the architect. In the group discussion, 10 participants attributes the disadvantage to the visual noise especially to the 'sensitive rooms' (for example, bedroom). While 6 of them mentioned the influence of 'negative rooms', for example bathroom and kitchen.

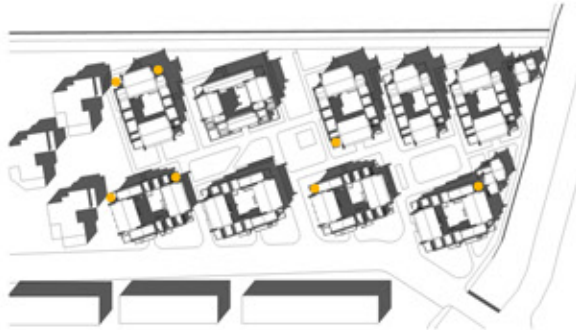
As additional room

Private gardens in the ground floor are used in three ways. Among all the 37 entrance gardens, 7 of them are completely abandoned. 23 are rebuilt as additional room, the great majority of which is storage room. The rest maintains the original function.

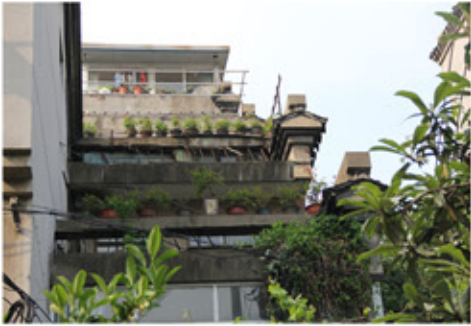
It is observed that spacious terraces that are design as private garden are now with two forms. Some maintain the original design, while the rest is shut off by users. The unorganized renovation of terrace has a negative influence on the appearance of building.

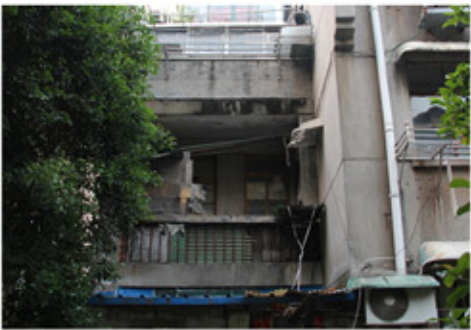
Open Balcony

Sealing balcony is very popular. While only a few balcony are left open.

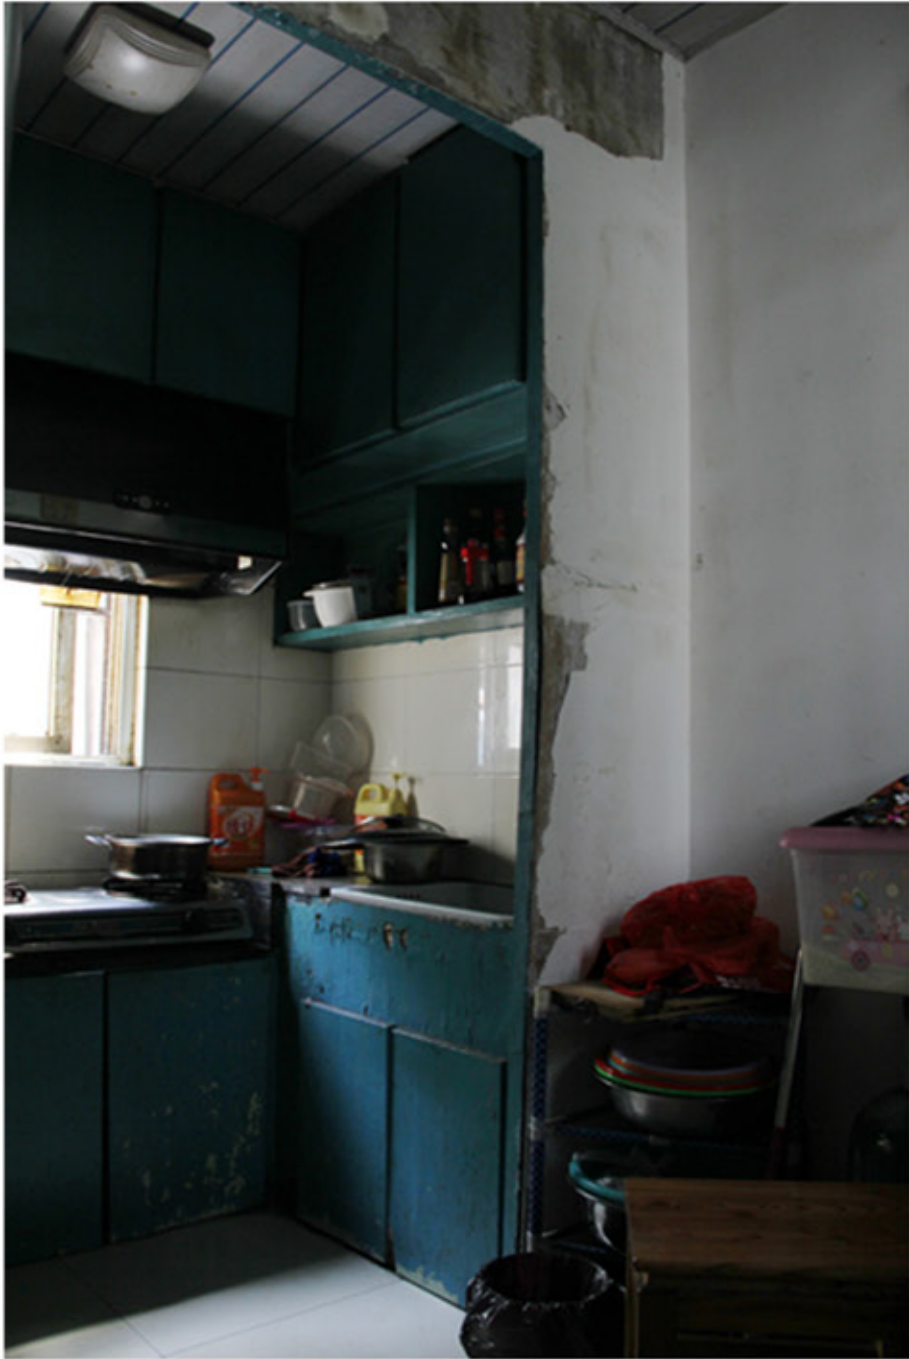
The current users are a couple about 35 years old and a 9 year-old daughter. In 2004, the couple bought this suite. Being unsatisfied with the narrow kitchen, they reorganized the space of kitchen and bathroom before they moved in.

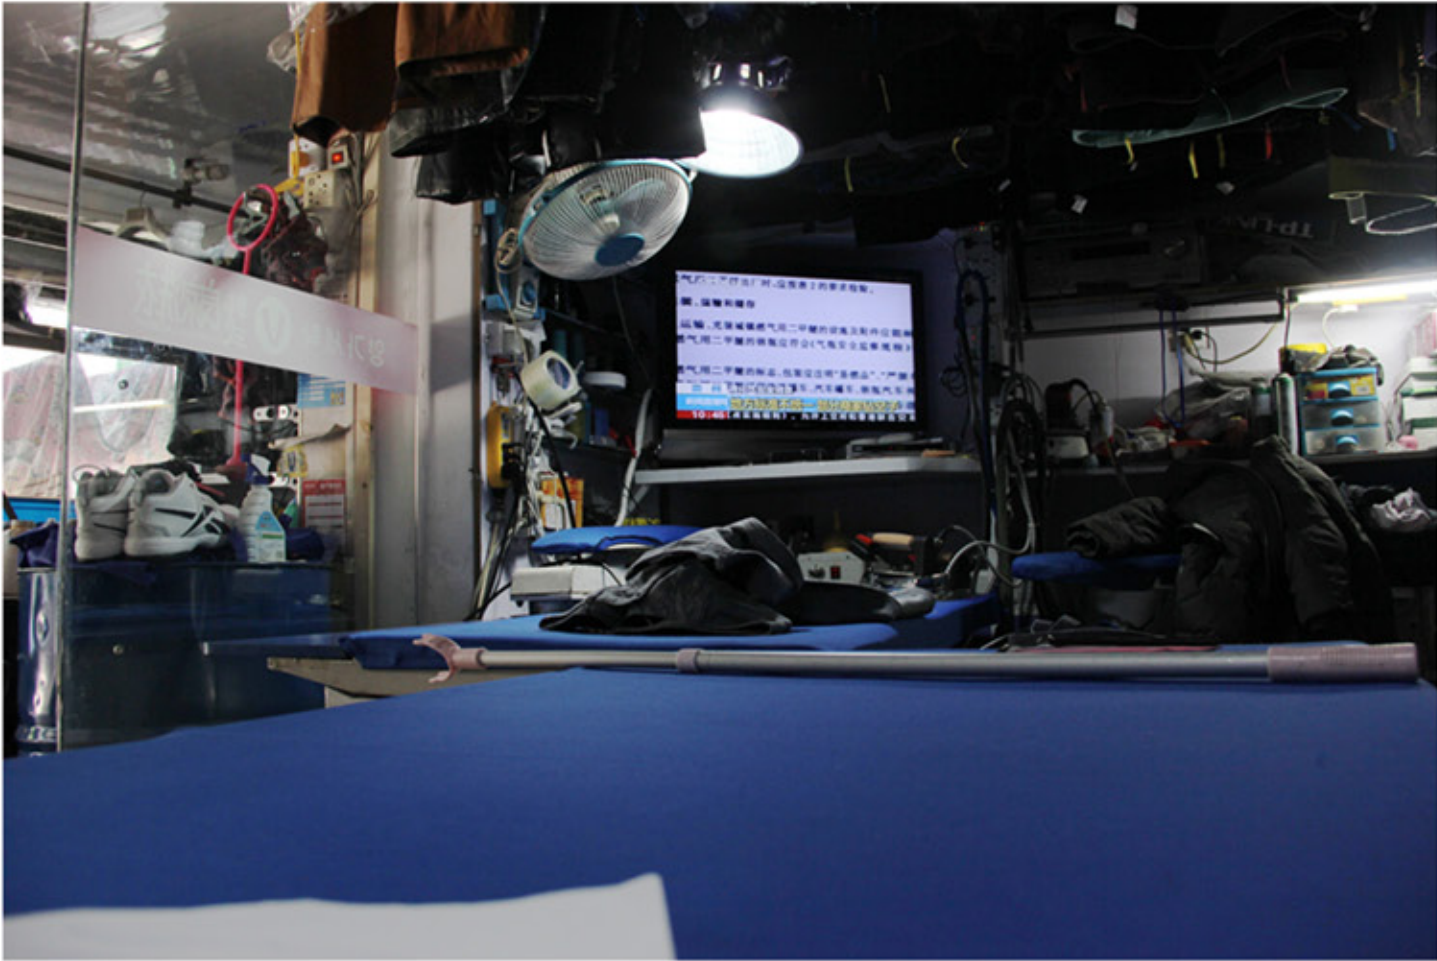
The suite is used as a workplace from the very beginning and the household is a 54 year-old tailor. There were two main renovations in this suite in the past thirty years. One was conducted in 1986, shortly after moving in. The user added a partition to divide the suite into a living part and a small tailor shop. The other was conceived since 2001, in which the whole suite was changed to a dry-cleaning shop.

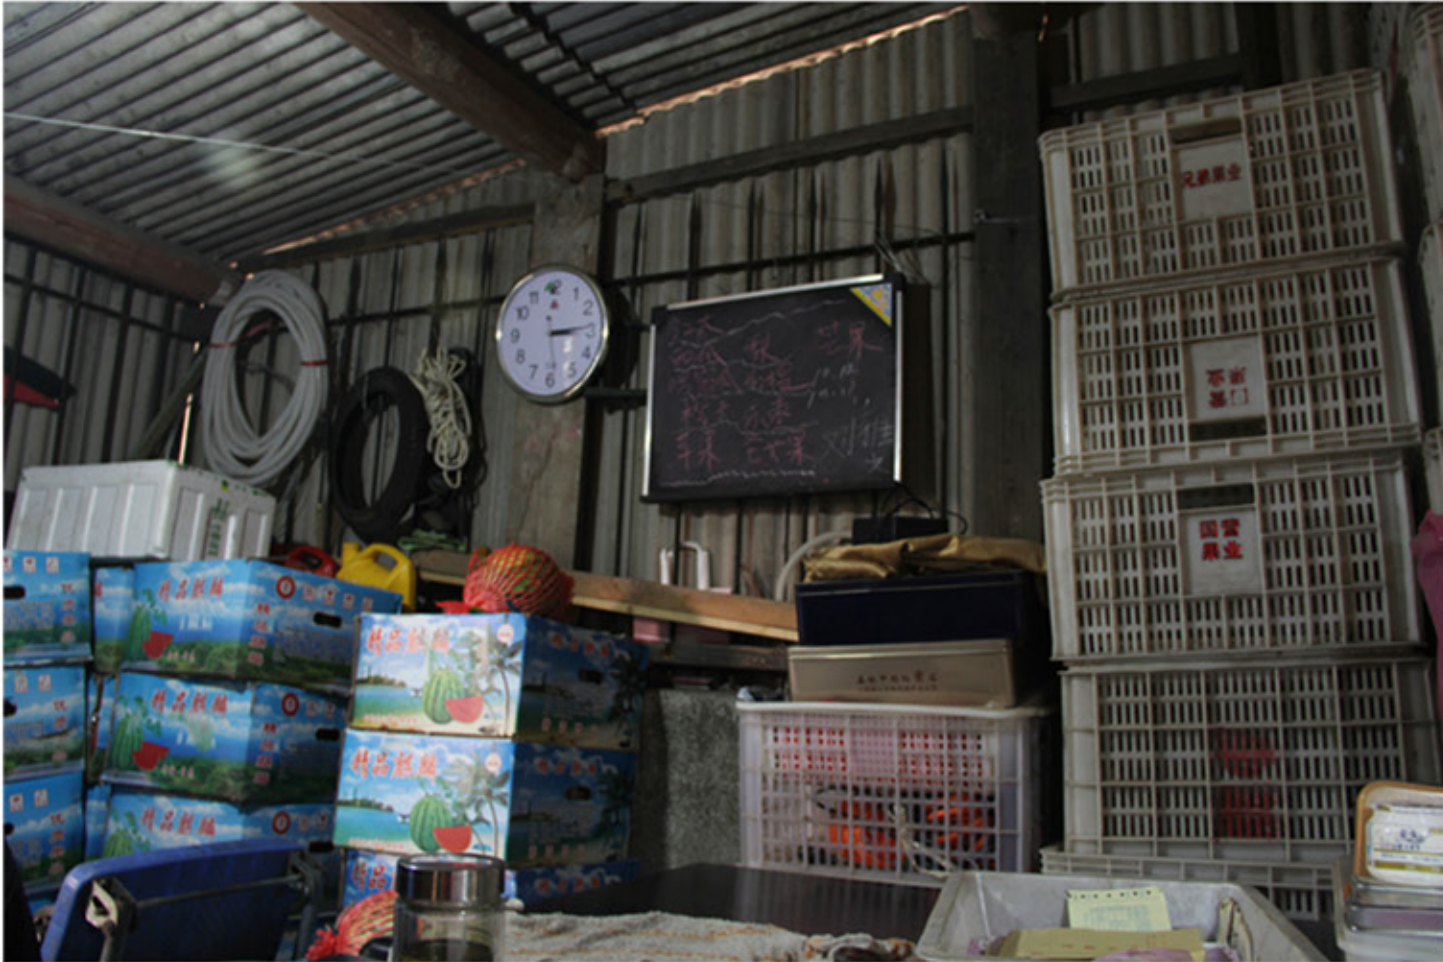
This is a rented suite that is used as storage house of fruits. The householder is living in Shanghai with his wife and son, and this apartment is rented to the fruit seller since 2009. The renovation is conducted by the rent. After that, two storage rooms are separated; the entrance garden is changed to an office; and the bathroom and kitchen are left empty.

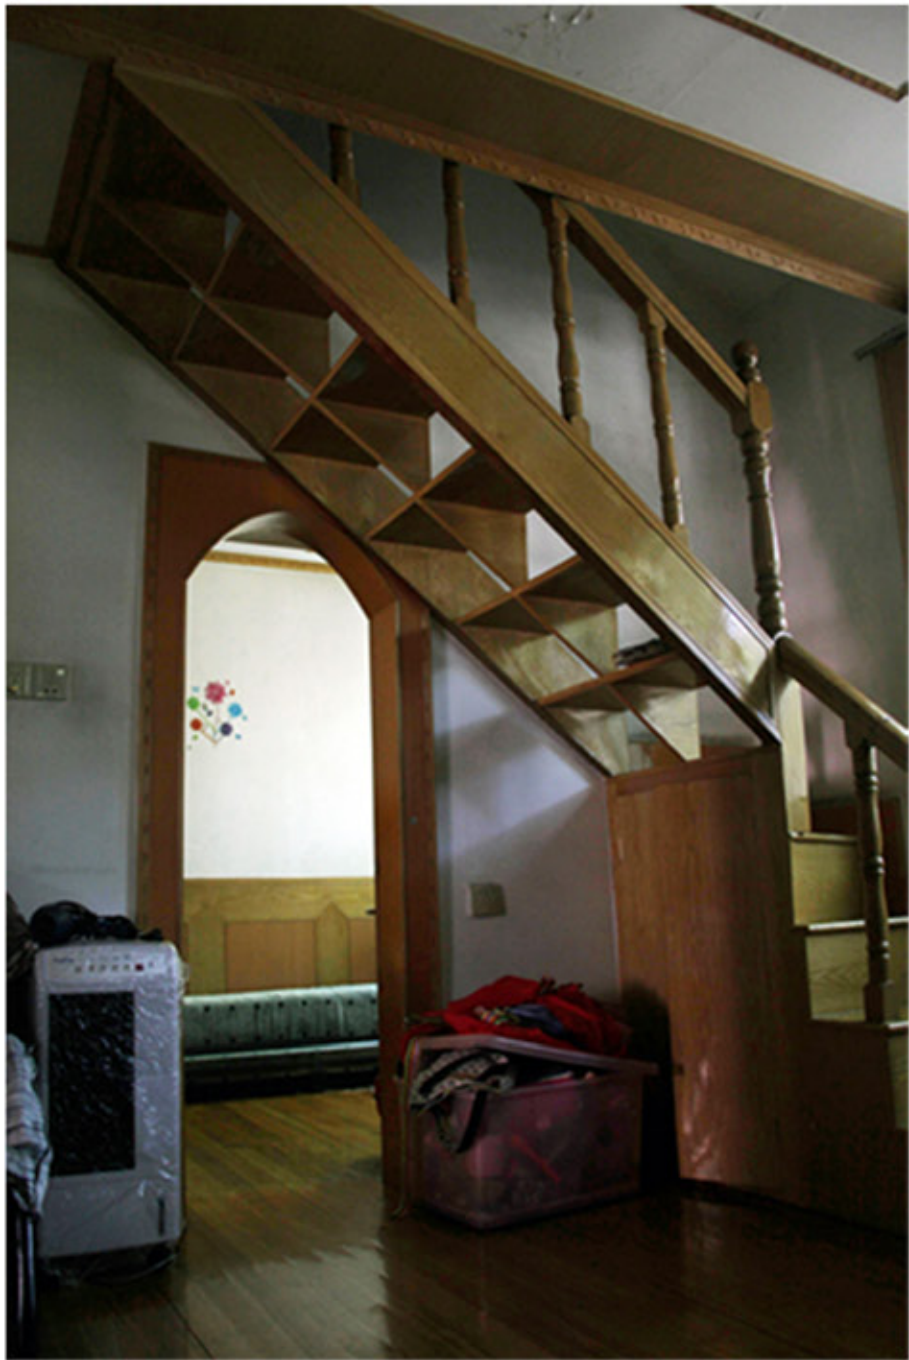
This is an apartment for a family of three - the couple are bank clerks of about 55 years old and their son is a 24 year-old doctor. In thirty years' living, their renovation focuses on area extension. The couple's bedroom was extended, while the duplex floor was built to provide an independent room for the son.

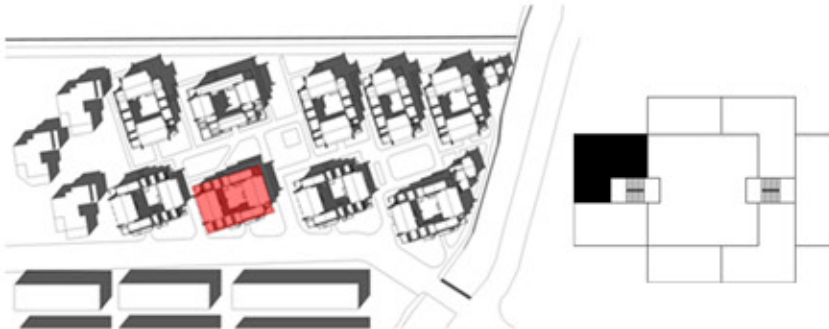
**Remove:**  
Walls of the kitchen and the balcony.

**Add:**  
A wall for the old balcony; and the second floor.

**Result:**  
The balcony was combined with the couple's bedroom; kitchen was opened; new balcony and son's room were built in the second floor.

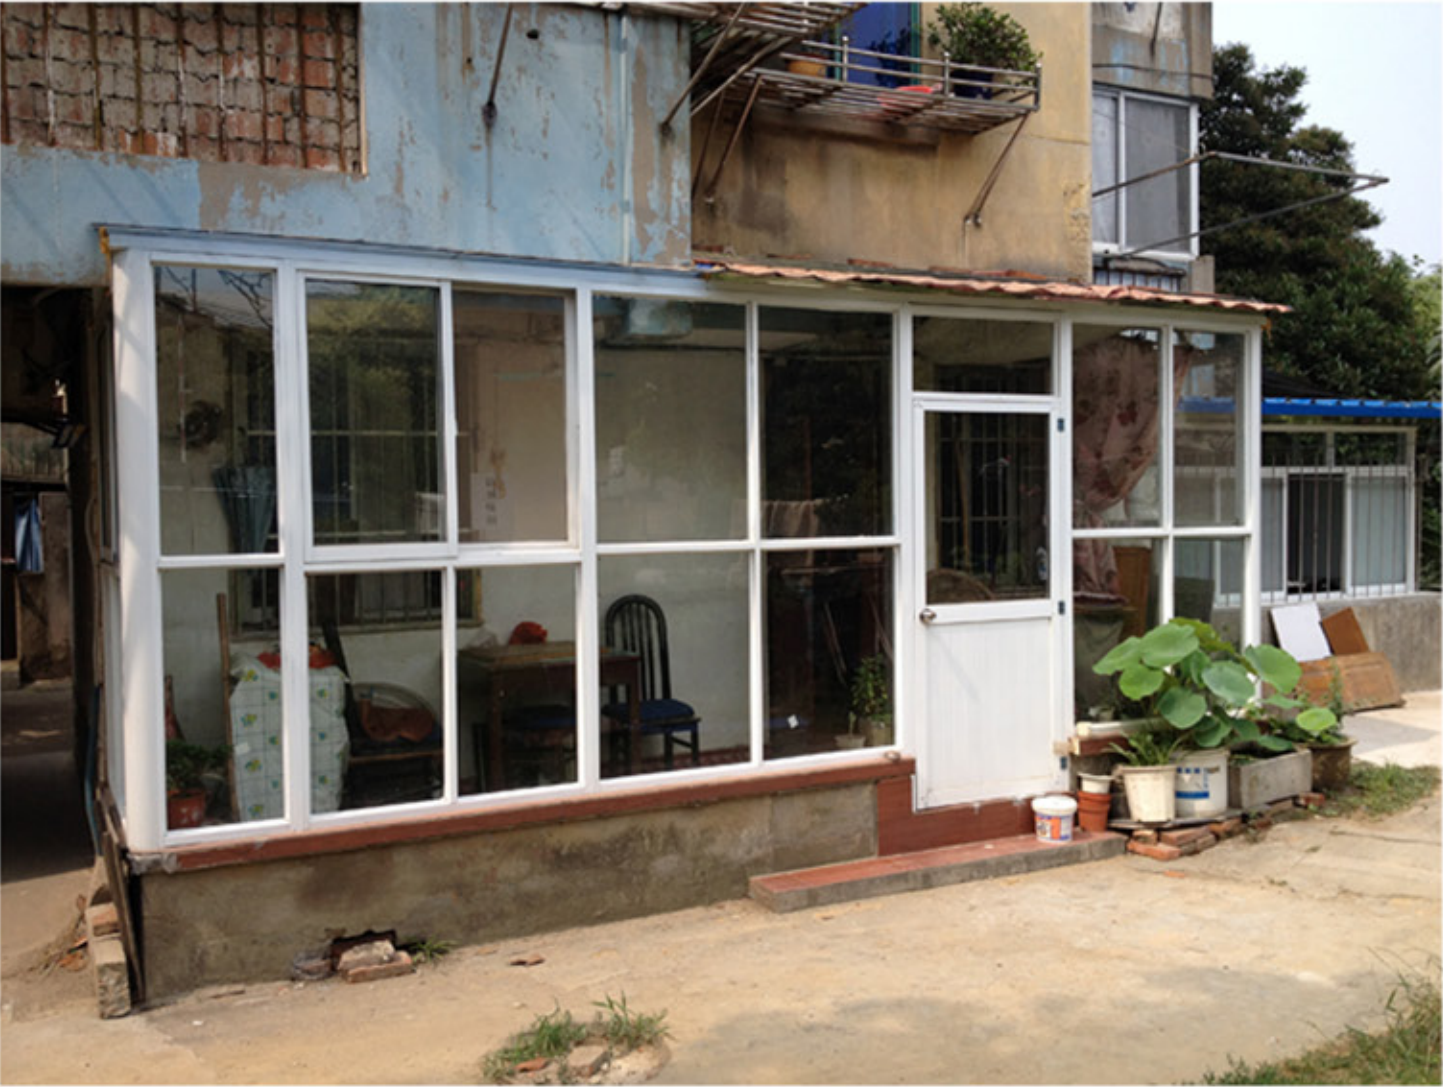
The current householder is a couple about 75 years old. In 1985, the man's single mother moved in the suite without making any renovation. After the mother's passing away in 2000, the couple moved here for its wonderful natural lighting. For enjoying the sunshine, they made the first renovation in 2013 - a sunshine room was built outside their house.

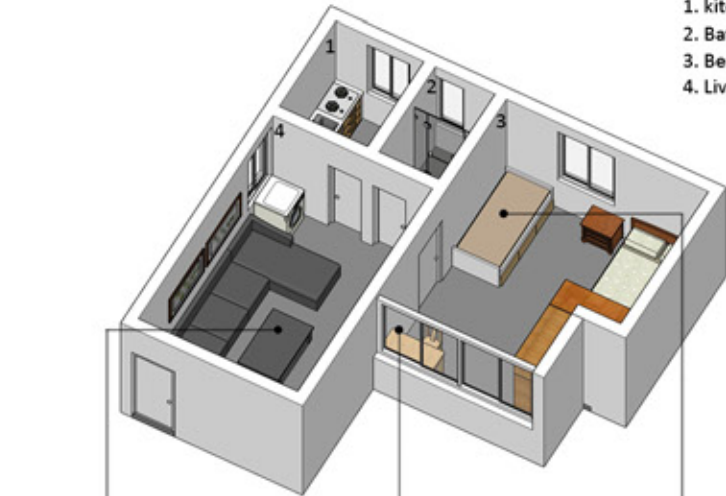
The old partition was removed so that the old bedroom was changed to a living room.

The balcony was closed, and a set of closet was customized.

The young son shares the same bedroom with his parents.
