# MOISTURE DEGRADATION OF OPEN-FACED SINGLE LAP JOINTS

L. Goglio<sup>#</sup>, M. Rezaei and M. Rossetto

Dipartimento di Meccanica, Politecnico di Torino

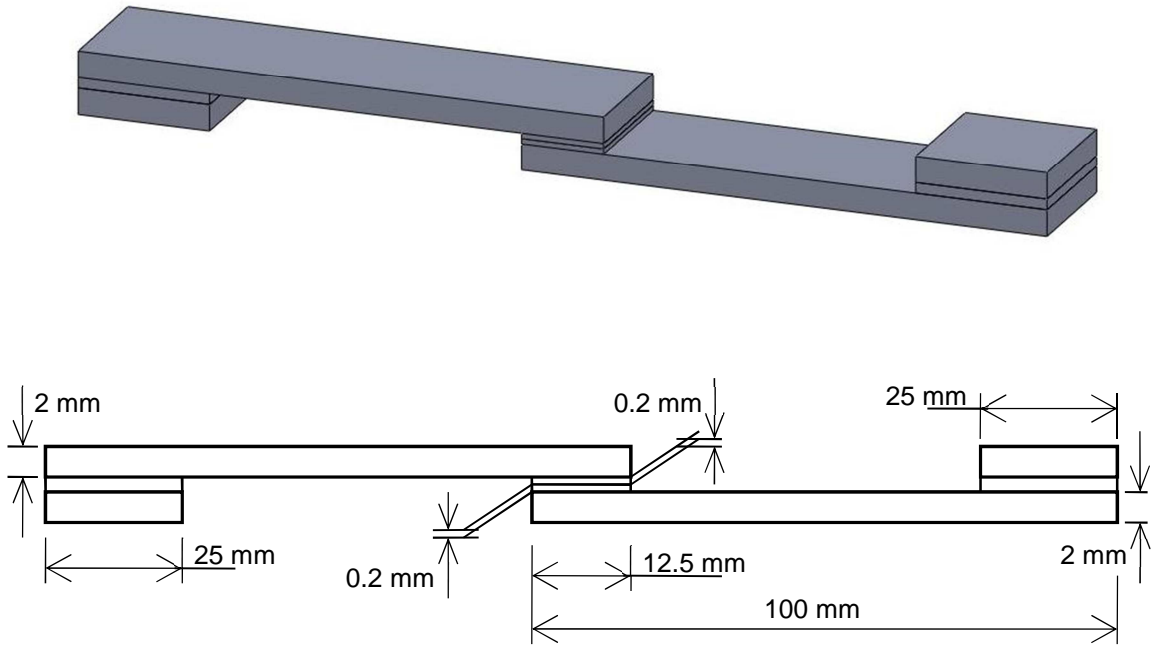
**Fig. 2.** Single lap joint geometry showing the thickness of primary and secondary adhesive;  
(width 25 mm).

As shown in Fig. 3, the primary adhesive layer (0.2 mm thickness controlled using brass wires as spacers) was cured on the first adherend using a backing plate coated with Teflon films, to avoid adhesion, as a second adherend. To keep the exact dimension of the overlap length, the non-overlapping part of the substrate was covered with an adhesive tape. The single lap joint configuration with details of primary and secondary bonding is shown in Fig. 2.

After drying at room temperature for one day, the backing plate and the protective adhesive tape were removed. After curing the primary adhesive, the specimens were protected with an anti-corrosion paint. The perimeter edge of the bondline was sealed with silicone to avoid moisture ingress. Then the specimens were exposed, as shown in Fig. 4, to warm and wet environment in a climatic cabinet at 50°C and 100% relative humidity (same conditions as in [1]); such a temperature was deemed high enough (compared to ambient temperature) to accelerate degradation and, at the same time, was sufficiently below  $T_g$  (72°C, [19]) to avoid an unrealistically high absorption rate. The test duration was varied in six levels from 0 to 5 weeks of exposure, thus longer than in similar works ([10,14]), to compensate for the lower temperature. At the end of the corresponding exposure period, the degraded specimens were dried in an oven of sufficient internal volume (to avoid saturation of water vapour inside the oven) at 70°C for 72 h. Then, to allow mechanical testing, the degraded open-faced specimens were completed, forming closed joints, by bonding the second adherend using an additional adhesive layer, termed “secondary adhesive”. As proposed in [16], to ensure mechanical interlocking between the primary and secondary adhesive layers, the primary adhesive layer surface was roughened using 100 grit sandpaper, then degreased with acetone before secondary bonding. Then the joint was cured in identical fashion to that used for the first adhesive. Tabs were bonded to the two ends of each specimen (Fig. 2) to avoid offset in the grips when loading.

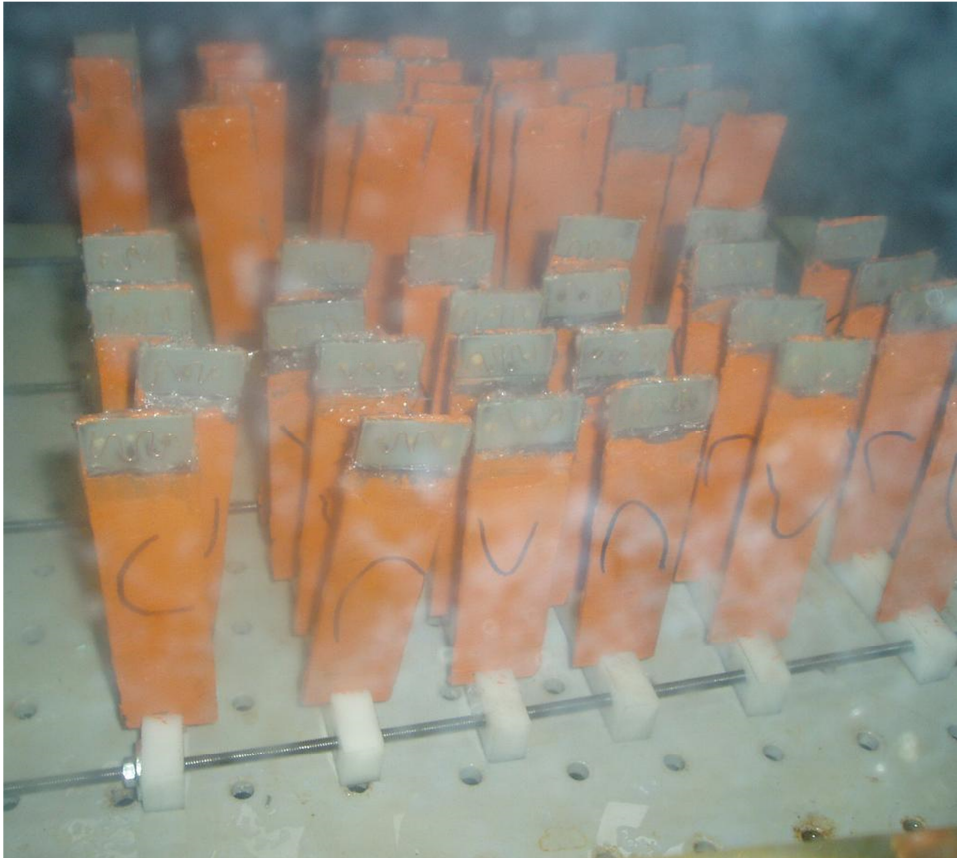
**Fig. 4.** Open-faced specimens during exposure to humid and warm environment.

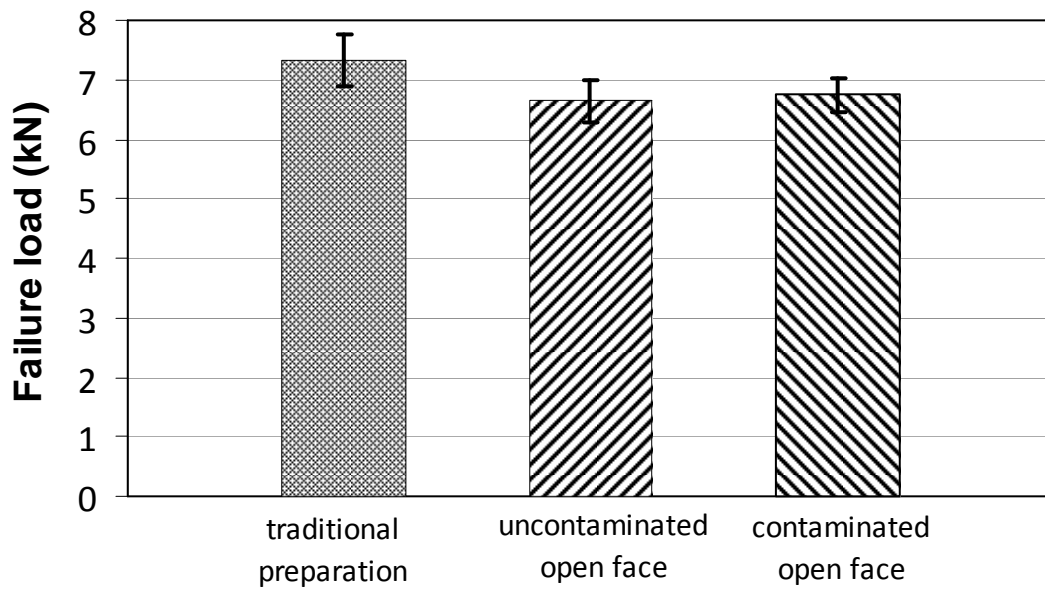
**Fig. 5.** Comparison of failure loads before exposure to humid and warm environment corresponding to different methods of SLJ preparation (bars show  $\pm 1$  standard deviations).

A preliminary group of tests was carried out to investigate the potential effects of the fabrication technique, open-faced, and contamination on the strength of the specimens, to ascertain if the joints fabricated with these procedures could be intrinsically weaker than those fabricated in standard way. Three sets of five specimens each, manufactured as standard (traditional), open-faced, open-faced contaminated, with a total thickness of 0.4 mm, were tested as fabricated (i.e. not exposed). The results are shown graphically in Fig. 5; it can be

seen that the mean failure load of the joints fabricated in standard way (7.32 kN) is about 10% higher than the remaining two (6.64 kN and 6.74 kN) which, considering also the scatter in the values, can be regarded as equal. In most of the open-faced specimens, failure occurred at the interface between primary and secondary adhesive.

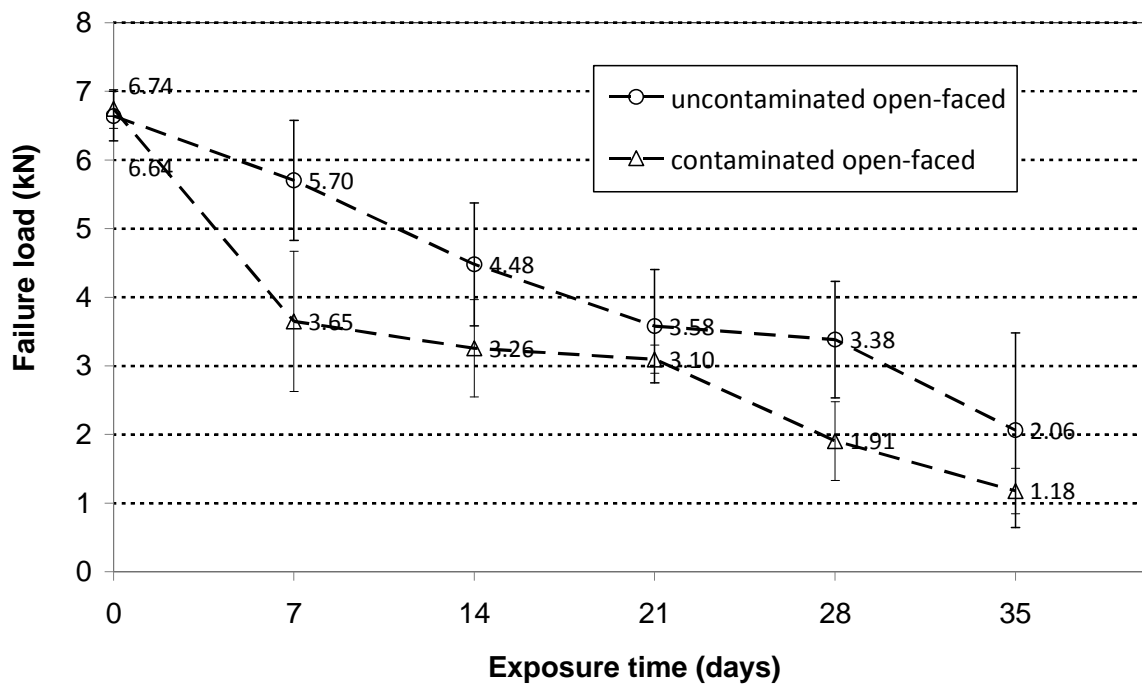
**Fig. 6.** Failure load reduction of the SLJ due to exposure to humid and warm environment (bars show  $\pm 1$  standard deviations).

Fig. 6 shows the reduction in failure load as a function of exposure time, for the two sets of specimens. In general, it can be noticed that the reduction is significant and proceeds over the entire time period, without any asymptotic tendency. The curve corresponding to the uncontaminated specimens exhibits a steady, more regular decrease; on the contrary, for the contaminated specimens, the strength drops dramatically after the first week –during which almost half of the total reduction occurs– then continues at lower rate. Analogous findings were obtained in [14] about the fracture energy  $G_c$ . After three weeks, the strength values of uncontaminated and contaminated specimens are similar and, subsequently, the two curves seem to decrease in a parallel fashion.

The reduction in the strength corresponds to the change in the failure mode from cohesive (as previously stated, after fabrication the specimens failed in the combined adhesive layer) to interfacial, i.e. at the substrate surface. The phenomenon is related to the progressive oxidation of the steel adherend. It is interesting to notice that after 1 week the type of failure for the contaminated specimens changed from cohesive to interfacial, and the surface of the adherend was covered by large amount of oxide layer. For the group of uncontaminated specimens this fact occurred after 2 weeks and the amount of oxide layer was not as much as for the previous case. A possible explanation is that the contaminant accelerates the formation

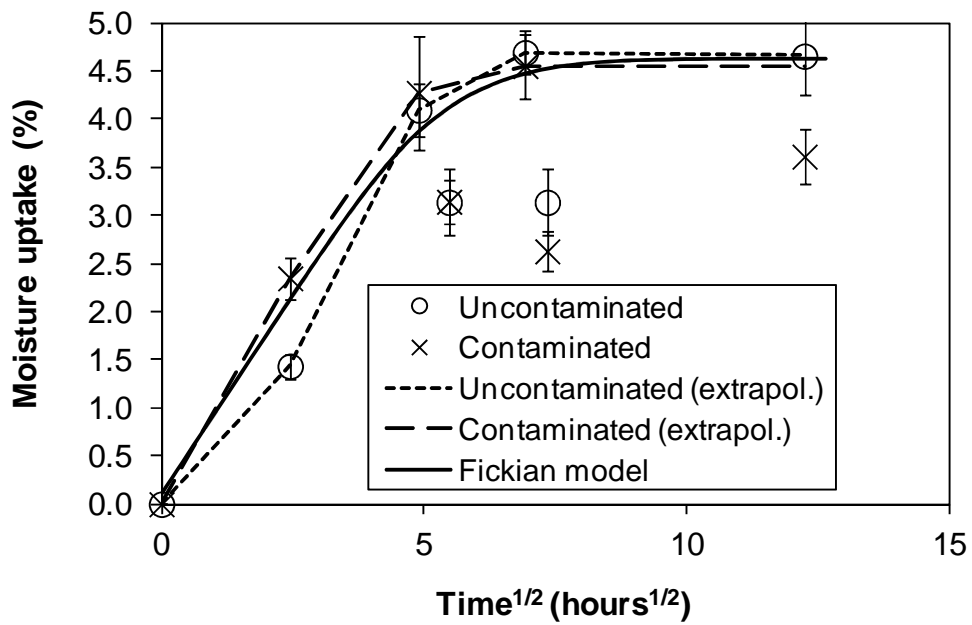
**Fig. 7.** Experimental moisture absorption curves for the uncontaminated and contaminated adhesive layers (bars show  $\pm 1$  standard deviations of the measurements), and related Fickian model.

where  $M_i$  and  $M_t$  are, respectively, the mass of the specimen under initial conditions and at time  $t$ . Surprisingly, as shown in Fig. 7, the measurements exhibited an oscillating behaviour after that the “knee” of the absorption curve was reached. Since a reduction in the absorbed moisture while the specimen is still exposed in the climatic chamber is physically implausible (some undetected and unexpected factor, causing inaccuracies, must have come into play), it appears reasonable to extrapolate the results by ignoring the descending values. This gives the dashed curves in the figure. The uncontaminated and contaminated cases do not appear significantly different in terms of absorbed moisture.

where subscripts 2 and 1 refer to two instants (points on the curve) in the linear part of the diagram (in practice point 1 can be the origin). The Fickian model, based on  $D = 2.69 \cdot 10^{-4} \text{ mm}^2/\text{h}$  given by equation (3) and  $l = 0.1 \text{ mm}$  is plotted as a solid line in Fig. 7.

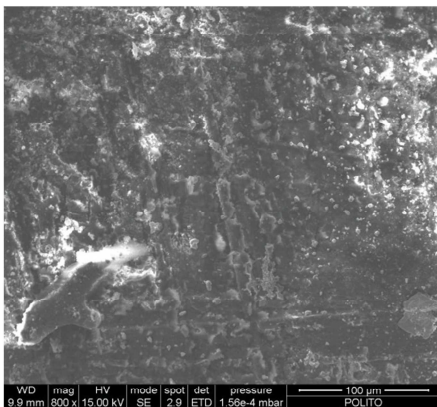
**Fig. 8.** SEM images (left) and EDX spectra (right) related to the fracture surfaces of unexposed specimens: a) uncontaminated case; b) contaminated case.

The SEM images of the fracture surfaces and the EDX spectra of the unexposed joint (as noticed previously, in this case fracture occurs in the combined adhesive layer) are shown in Fig. 8. The aspects of the surfaces are similar, as well as the element content related to the adhesive composition (note that Ag is added by the metallization process required for SEM observation).

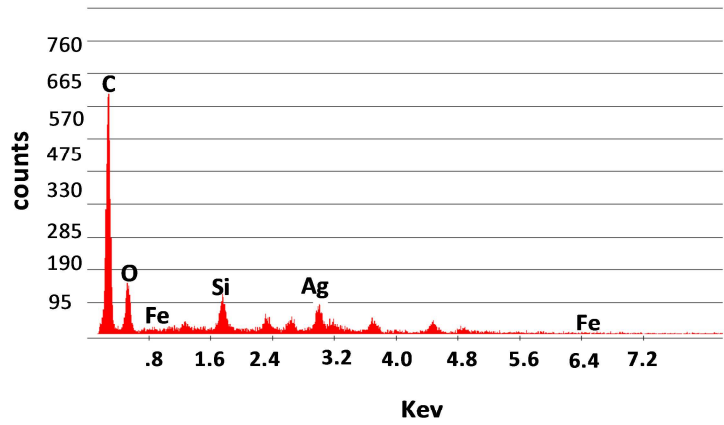
**Fig. 9.** SEM images (left) and EDX spectra (right) related to the fracture surfaces (adhesive side) after 1 week exposure to humid and warm environment: a) uncontaminated case; b) contaminated case.

After one week of exposure, the situation starts changing, as visible in Fig. 9 where the SEM pictures show the fracture surfaces of the adhesive side: in the uncontaminated case of Fig. 9(a) the rupture is still cohesive, whilst in the contaminated case of Fig. 9(b) it occurs at the interface with the adherend. The smoother aspect of the latter case reproduces the flat surface of the adherend. The compositions are not significantly different.
