Stabilization of earthen plasters: Exchange of knowledge and experiences between Italy and Morocco

M. Mattone<sup>1,3</sup>, M. Ibnoussina<sup>2</sup>, S. Rescic<sup>3</sup>, F. Fratini<sup>3</sup>, D. Magrini<sup>3</sup>, A. M. Mecchi<sup>3</sup>,  
M. Nocairi<sup>2</sup>

### Abstract

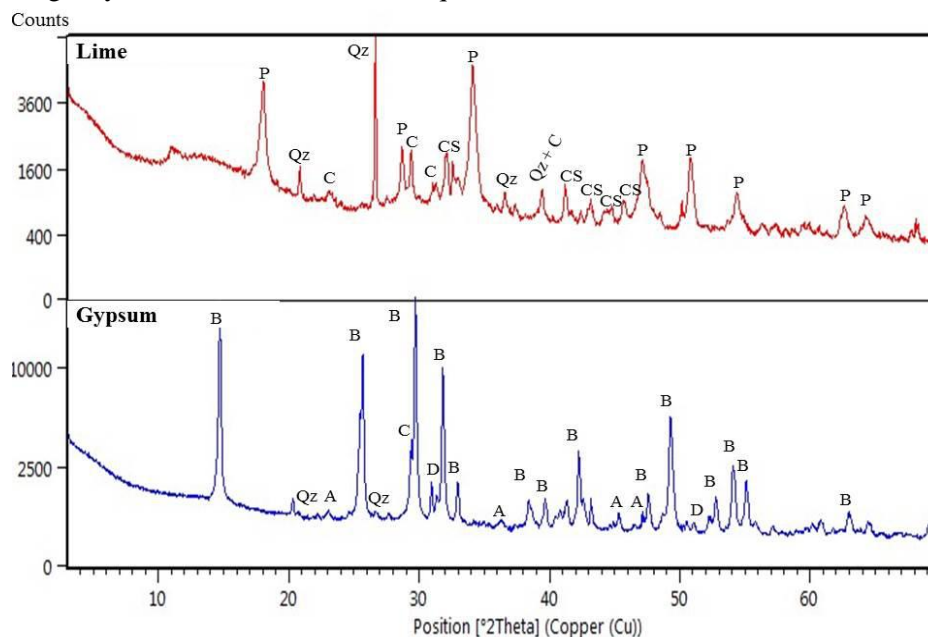
The composition of the Moroccan starting materials carried out by XRD analysis is described in Table 3 and Figure 3.

**Figure 3:** XRD spectra of Moroccan lime and gypsum. Calcium silicate (larnite) is a typical compound of hydraulic lime (P=portlandite; CS=calcium silicate; B= bassanite; A= anhydrite; Q=quartz, C=calcite, D=dolomite).

The mineralogical investigation made it possible to verify that the gypsum can be ascribed to a “soluble anidrite” while the lime is a natural hydraulic lime due to the presence of  $\beta$ -calcium silicate (larnite). After 28 days of curing, as new mineralogical phases, we have evidenced the presence of calcite in earthen plaster stabilized with lime and presence of calcite in earthen plaster stabilized with gypsum (Fig.4). Hydraulic phases due to hydration of larnite (CS) or pozzolanic reaction between calcium hydroxide (portlandite) with clay minerals have not been identified (may be due to amorphous state or low crystallinity).
