MULTITEMPORAL 3D MODELLING FOR CULTURAL HERITAGE EMERGENCY DURING SEISMIC EVENTS: DAMAGE ASSESMENT OF S. AGOSTINO CHURCH IN AMATRICE (RI)

F. Chiabrando^a, A. Di Lolli^b, G. Patrucco^a, A. Spanò^a, G. Sammartano^{a*}, L. Teppati Losè^a

KEY WORDS: UAV photogrammetry, multi-temporal model, structural assessment, seismic emergency, Cultural Heritage

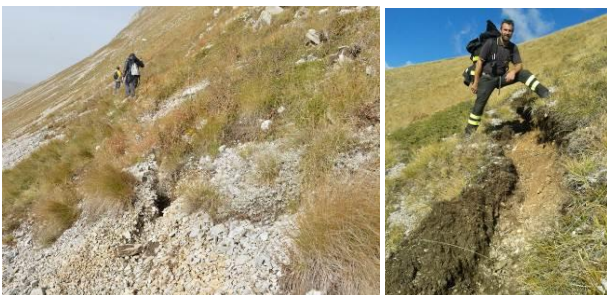
Figure 1. The Fault of Mt. Vettore before the earthquake of Norcia (Left) and after (right)

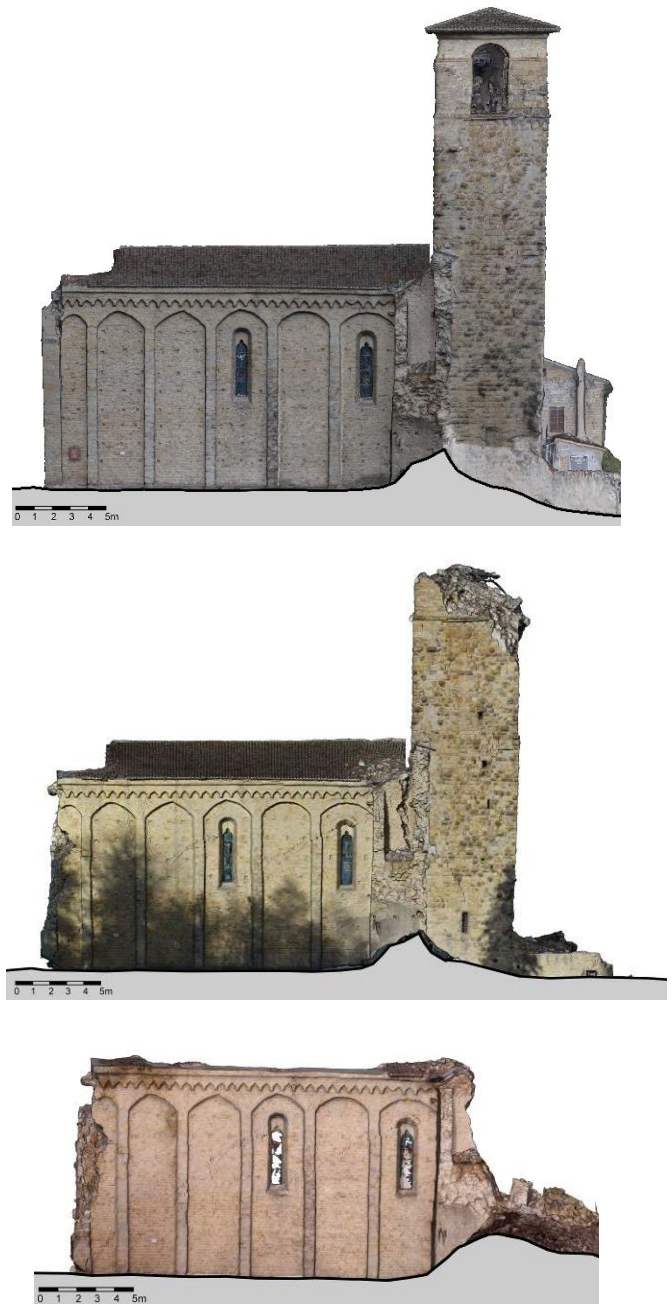
As is possible to deduce from the orthophotos of the west façade realized according to the three employed dataset (t1, t2 and t3) showed in the next Figure 7, the influence of the sunlight seriously affect the radiometry of the final output. Despite an image pre-processing that as usual was performed for the acquired images, especially in the DJI sensor is very difficult to correct those effects. Some analysis are ongoing in the research group according to the national and international research on this topic (He et al., 2013; Milanfar, 2013; González-Aguilera et al., 2016) in order to define the better strategy for image pre-processing.

Figure 7. Orthophoto of East wall. Top: September (t1); centre: December (t2); down: January (t3)

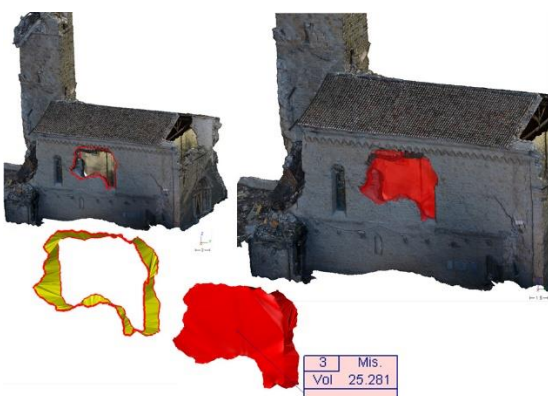
Figure 12. Analysis on West wall where the damage mechanisms caused the collapse of the central part of the masonry by shear failures.

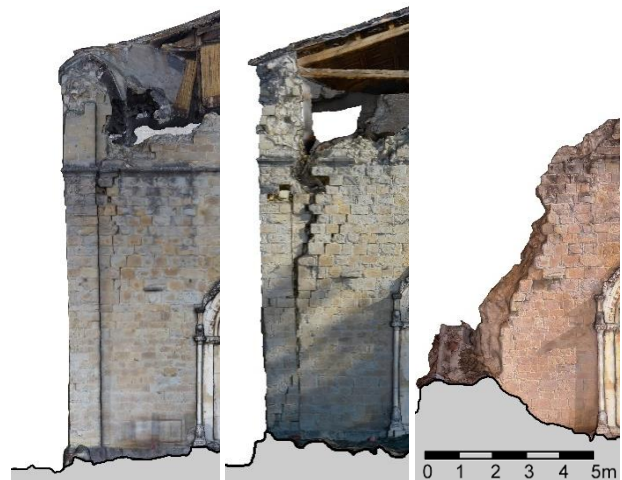
In this specific focus on the left connection with the West wall (Figure 14) the progressive evolution of collapse a series of break lines traces were detected in t1 in relation to the ones identified in t2 before the decisive collapse.

Figure 14. Orthoimages of the main façade in t1, t2, t3.

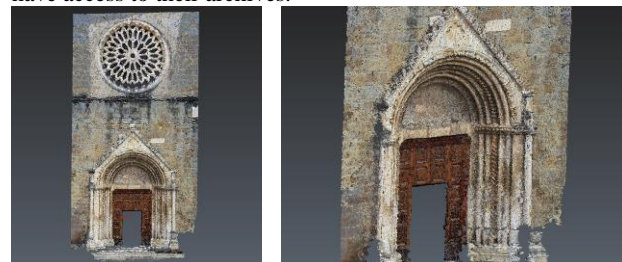
In March 2017, we started a new project to evaluate if it would be possible to create a 3D model of the church of S. Agostino through an online campaign of crowdsourcing. In the first phase of the project we wanted to evaluate the type of images that were online available for the church and the quality of the results we can expect. We performed some researches on the major online platforms for the storage and sharing of images and we selected a set of around 20 images. The images were selected depending on size, quality and presence of metadata and were all focussed on the decorated portal of the church. The same solution for SfM (Agisoft Photoscan) was used in this first phase and some encouraging results have been reached (Figure 17).

Figure 17. First test of point cloud generation of the portal before the earthquakes
