Quantifying the seismic resilience of bridges: a pathway towards a Resilience-Based Design

# Quantifying the seismic resilience of bridges: a pathway towards a Resilience-Based Design

A.I. Sarkis & A. Palermo

O. Kammouh & G.P. Cimellaro

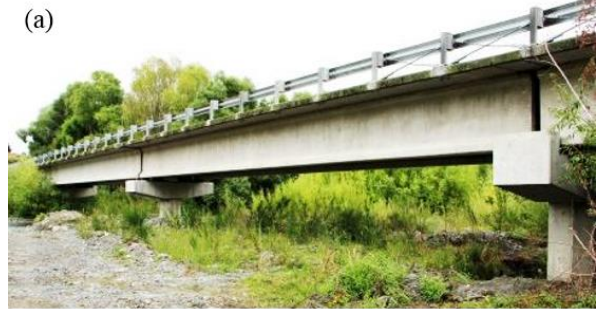
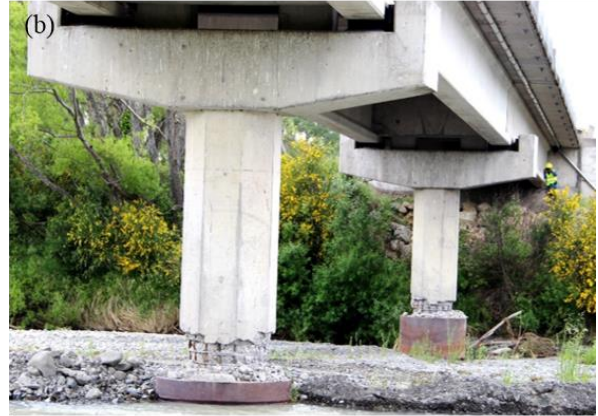
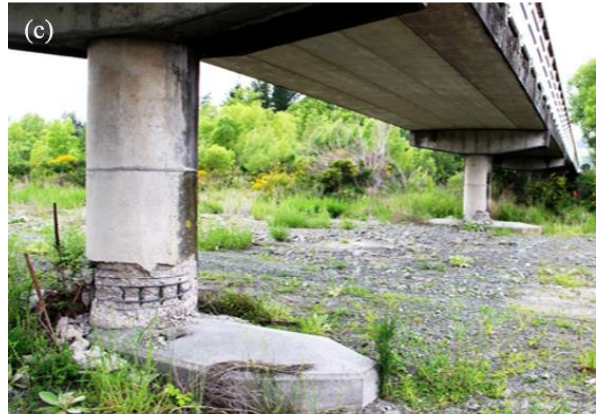
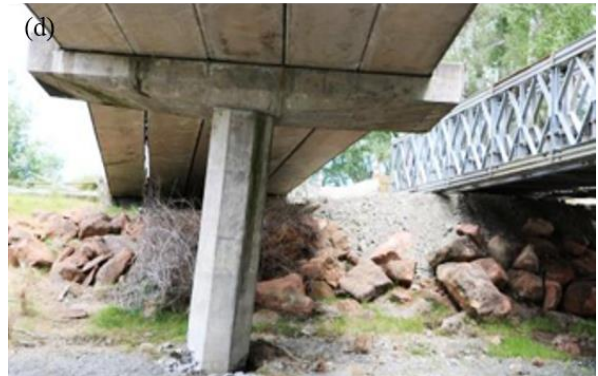
The Lottery River, Lower Mason River, Mason River, and Wandle River bridges (Figure 3) are structurally similar to one another. They are all multi-span precast concrete bridges supported on single column piers with hammer head pier caps. Further structural details are summarized in

Figure 3. Bridges under study: (a) Lottery River Bridge; (b)

Lower Mason River Bridge; (c) Mason River Bridge; (d) Wandle River Bridge (Palermo et al., 2017).

In the way they resist lateral loading, the Lottery River (Figure 3a) and Lower Mason (Figure 3b) bridges are identical. The transverse interaction has been isolated by the omission of transverse shear keys at the central pier (Palermo et al., 2017). In addition, they use a rudimentary form of seismic isolation under transverse loading such that they can displace an appreciable amount on the supporting elastomeric bearings before contacting the shear keys. As a result,

Similarly, the Mason River Bridge (Figure 3c) is split in two with a central movement joint. There are transverse shear keys at the abutments and internal longitudinal shear keys and linkage bars over all of the piers except the central pier. At the central pier, provision is made for longitudinal movement with loose linkage bars but steel plate lateral support stubs cast into the piers restrain the transverse movement. Therefore, the overall transverse response can be thought of as the deck having a curved displaced shape where the largest transverse displacement occurs at the central pier (Palermo et al., 2017).

The Wandle River Bridge (Figure 3d) is curved in plan and has a slope in the longitudinal direction. Linkages, shear keys and elastomeric bearings restrain the transverse and longitudinal movement over the piers, but only linkage bars resist both the transverse and longitudinal movement at the abutments. Longitudinal movement towards the backfill at the abutments is resisted by the abutment back-wall which is cast against the beams.

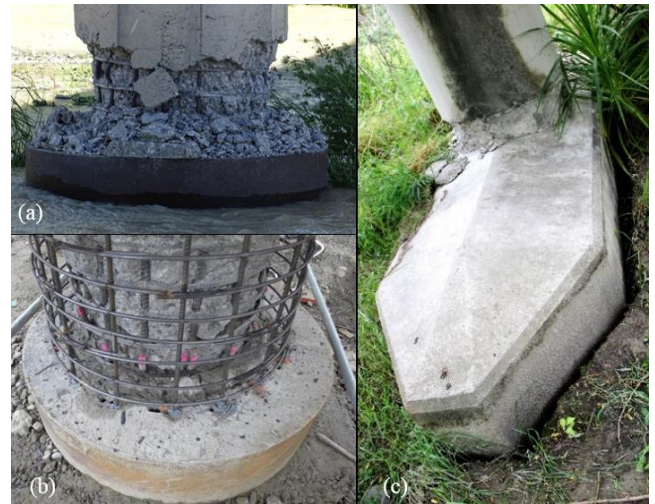
Figure 8. Plastic hinge repair: (a) PH in Lower Mason Bridge; (b) repair of PH by epoxy grout bars; (c) geometry at Mason River Bridge PH zones.

The structural scheme can play a part in the repair strategy, costs and hence resilience. In the case of monolithic bridges, repair of PH should be considered at the design stage. On the Lottery and Lower Mason bridges, the 1.5m diameter cylinder foundations located directly beneath the 1.0m diameter columns of the piers simplified the repair (Figure 8a). New reinforcement could be doweled into the existing pile and the pier re-cast, restoring the moment capacity of the column (Figure 8b). In contrast, for the Mason Bridge, repair is more difficult due to the shape and size of the pier cap (Figure 8c), as the geometry will make it very difficult to dowel in additional bars in and re-cast concrete. The result will be a significant repair cost and potential downtime for the structure.
